Agricultural Waterway Buffer Study
Whatcom County, Washington
2012

Summary

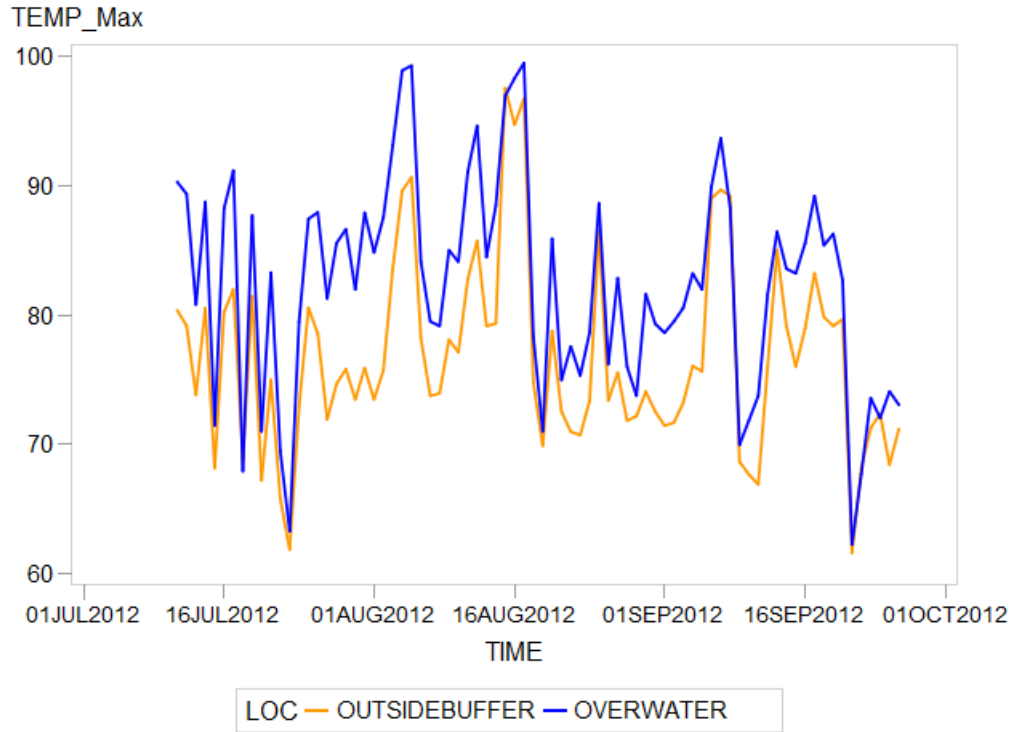
Appendix 6. Average Daily Maximum Temperature in 0' Buffer (Fourmile Creek) by Sensor Location, 2012.

In the 0' (non-planted, but vegetated with reed canary grass) buffer there was no statistical difference in average temperature, but maximum temperatures were significantly higher and minimum temperatures significantly lower in sensors placed over the waterway as compared to the sensors located "outside" of the waterway.

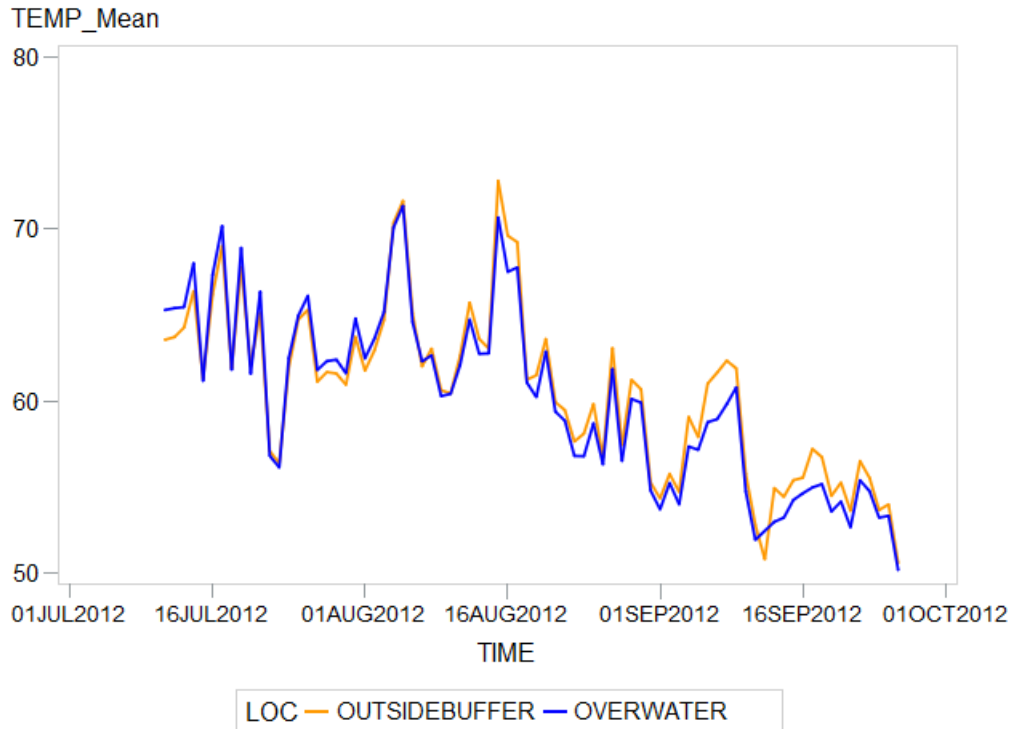
Appendix 8. Average Daily Mean Temperature in 0' Buffer (Fourmile Creek) by Sensor Location, 2012.

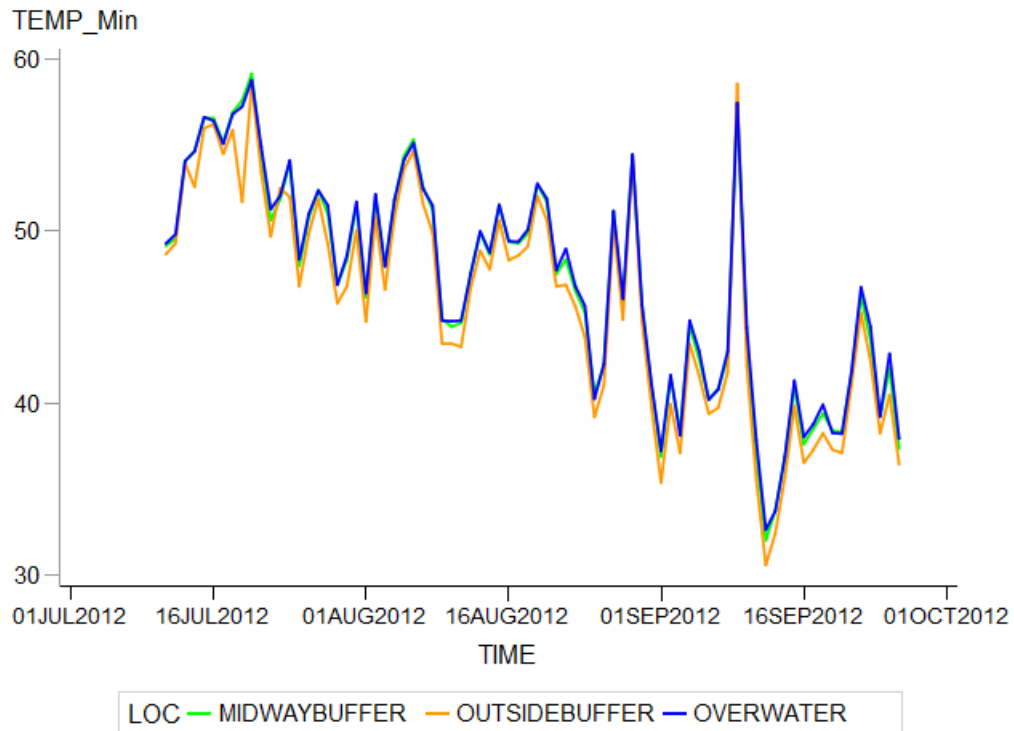
Appendix 10. Average Daily Minimum Temperature in 5' Buffer (Fourmile Creek) by Sensor Location, 2012.

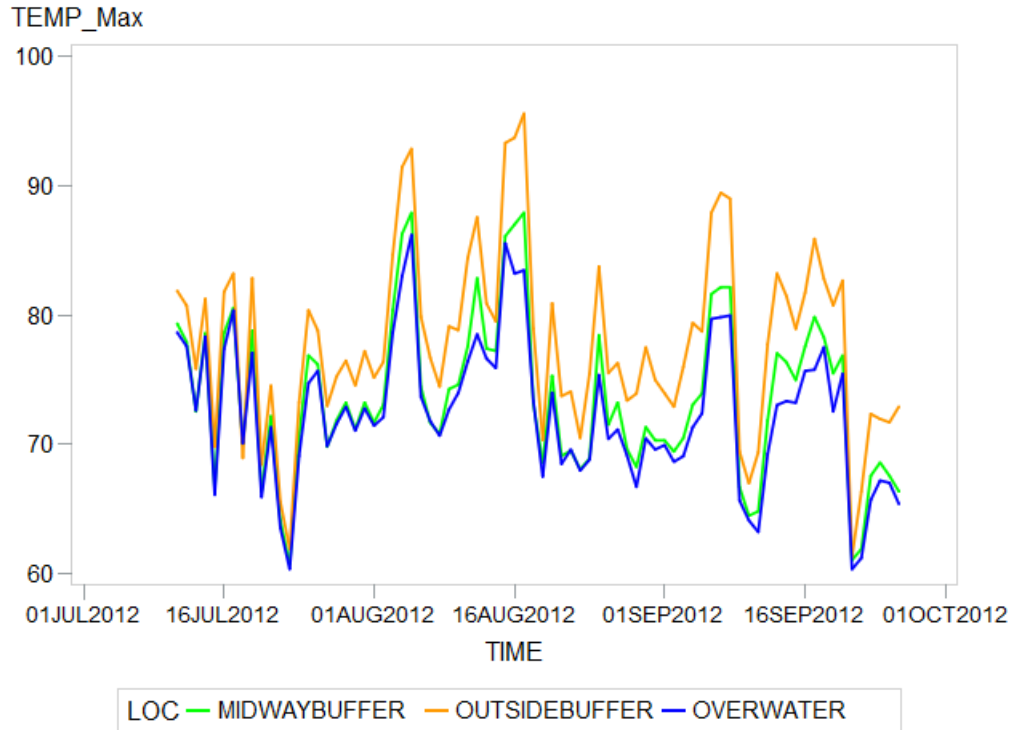
Appendix 18. Average Daily Maximum Temperature in 180' Buffer (Scott Ditch) by Sensor Location, 2012.

In the 180' buffer, average and minimum temperatures showed no significant difference when sensor location was compared, but maximum temperatures were significantly higher outside of the buffer as compared to inside.

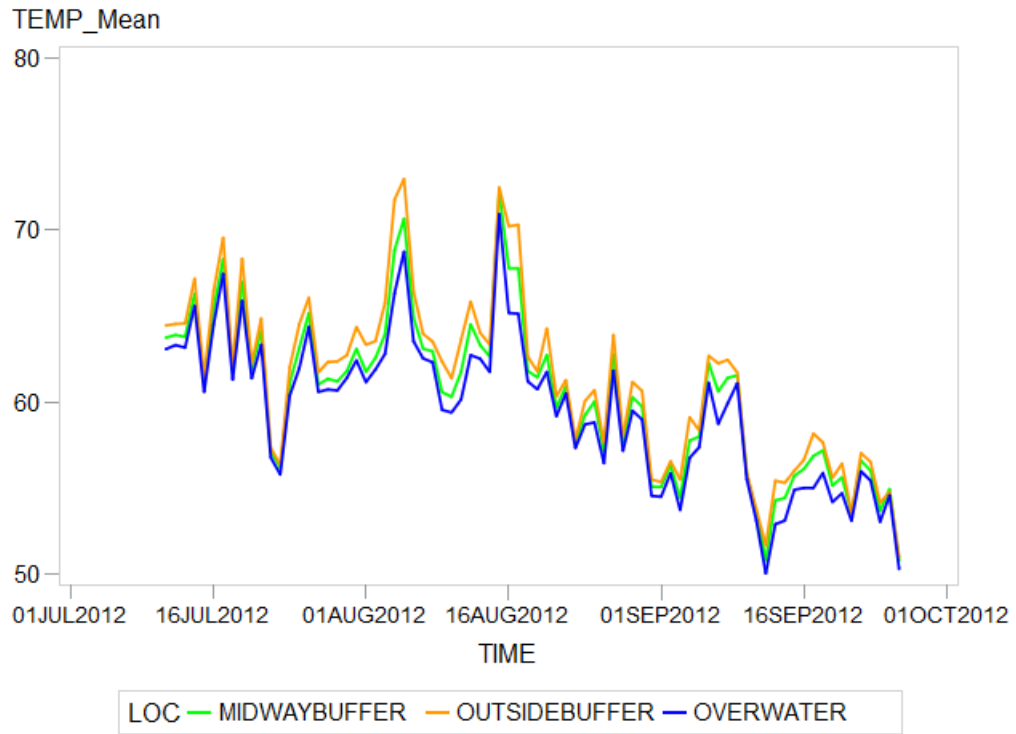
Appendix 20. Average Daily Mean Temperature in 180' Buffer (Scott Ditch) by Sensor Location, 2012.

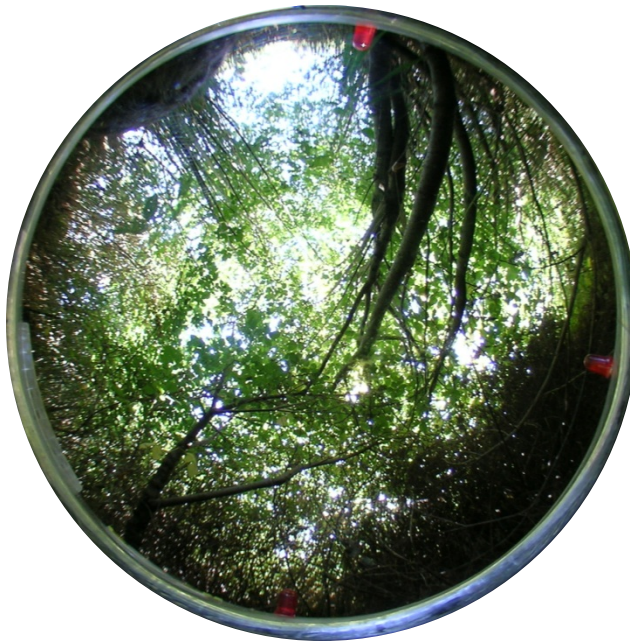
Appendix 25. Sample hemispherical Photo from 5' buffer, calculated effective shade of 90%.

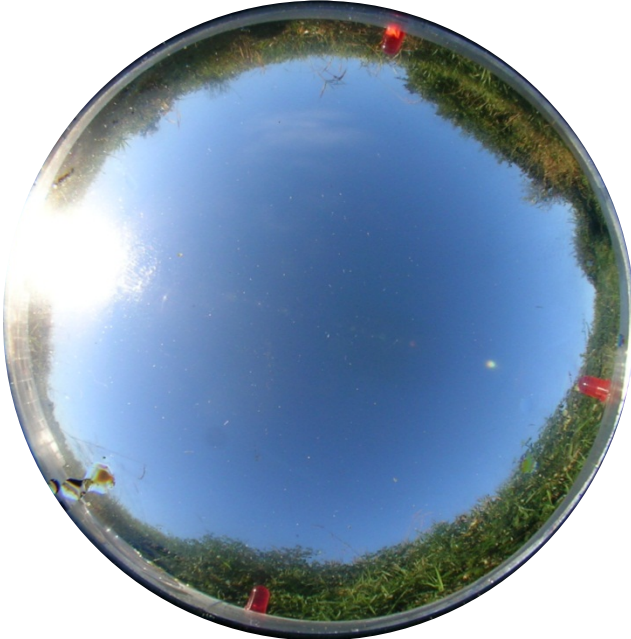
Appendix 26. Sample hemispherical Photo from 0' buffer, calculated effective shade of 3%.
