July 2023
Colony Creek and Harrison Creek Assessment and Modeling

Summary and Recommendations Report

Prepared for Skagit Conservation District

Prepared by
Anchor QEA, LLC
1605 Cornwall Avenue
Bellingham, WA 98225

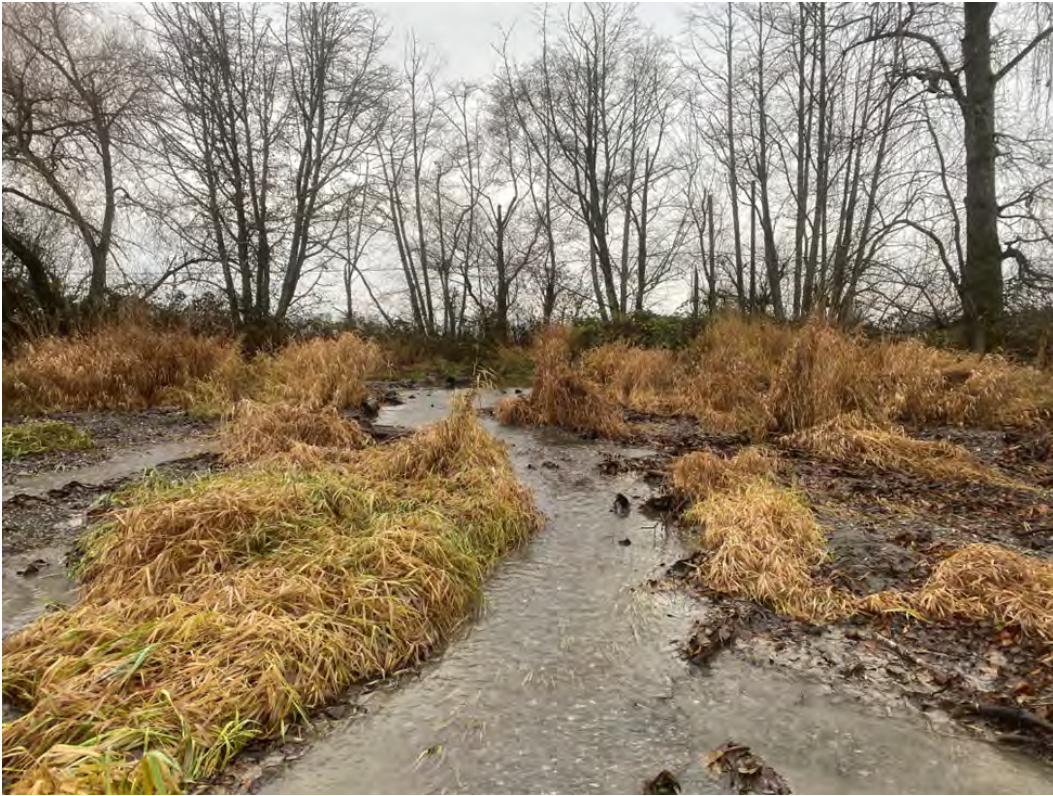
Photo 2-1
Colony Creek Avulsion Area

At the upstream end of the observed reach (along the Macken property), Colony Creek remains in its previous alignment along Colony Road for approximately 340 feet downstream of Colony Mountain Road before avulsing through the Macken property (Figure 2-2; Photo 2-1). The former creek alignment along Colony Road shows significant fine sediment deposition within the channel. The existing Colony Creek channel cuts through the right bank and flows east. Through the avulsion area,

there is no single defined channel; the avulsion area has a more braided morphology, and clean gravels were observed though this area. The avulsion path flows eastward for approximately 200 feet before flowing to the north along the hillside (right bank). In general, as Colony Creek flows north through the Macken property, the channel lacks any definition and is entirely dominated by reed canary grass (Photo 2-2). Colony Creek flow then enters a large 2- to 3-foot-deep pond (Photo 2-3). Though the outflow is undefined, downstream of the pond, Colony Creek flow continues north, flowing on both sides of a private road on the Macken property. Colony Creek's flow eventually joins Harrison Creek upstream where Harrison Creek flows beneath a private driveway to the Wrucha property.

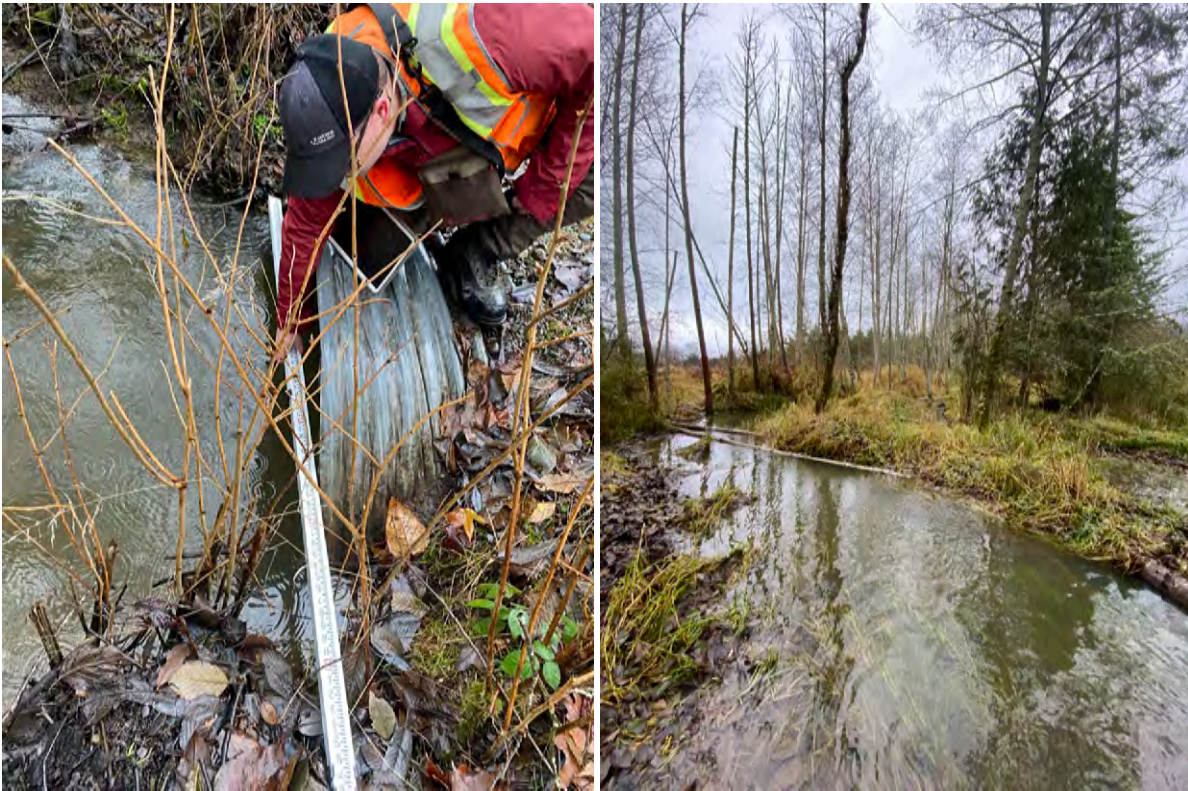
Photo 2-4

The combined flows of Colony and Harrison Creek flow through the 5-foot-diameter driveway culvert, which has approximately 2 feet of sediment in it (Photo 2-4). Just downstream of the culvert, the creeks are somewhat channelized and more defined than upstream. In this reach, there are downed alders, and, in some areas, gravel (1- to 2-inch) deposition has occurred around the large wood. Wooden posts were also observed in the channel, suggesting some restoration work has occurred in Harrison Creek in the past. Downstream of the wooden structures, though the channel is still defined, the floodplain becomes more inundated; a patch of conifers along the left bank floodplain were in a few inches of ponded water. Just downstream, the channel widens and deepens, and the floodplain area continues to be dominated by reed canary grass. The channel continues through the Wrucha property, but the group was not able to access the property.

Wrucha Private Road Culvert and Combined Colony/Harrison Creek Flow Just Downstream

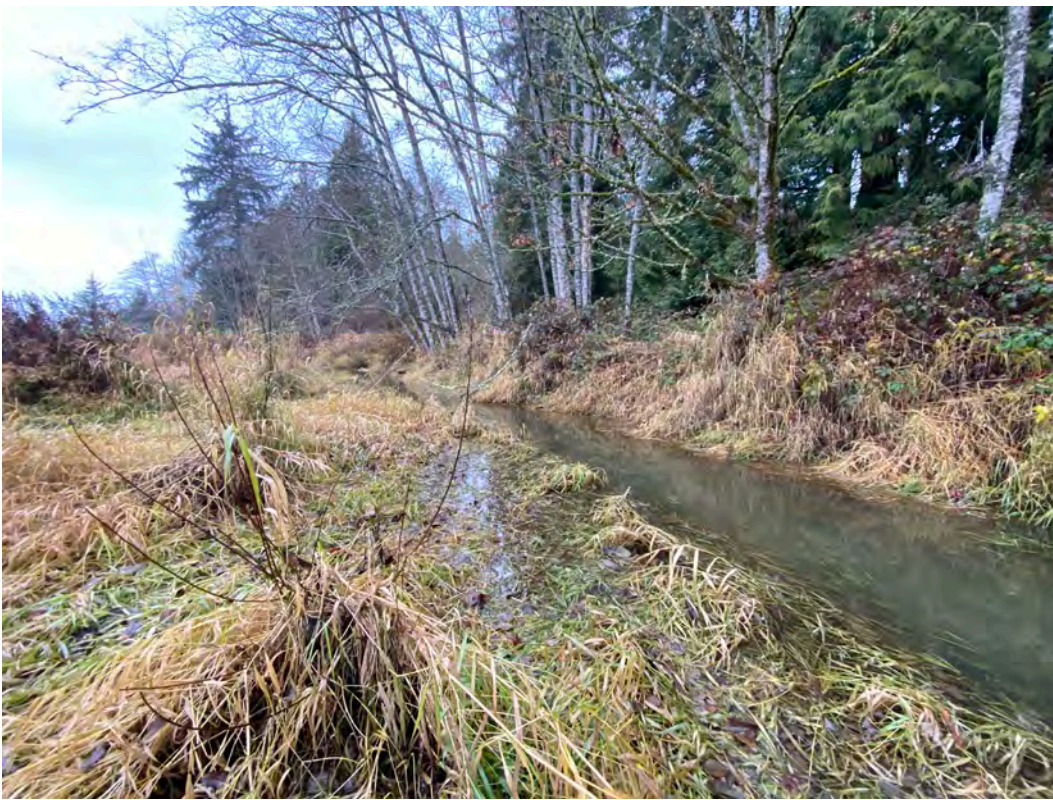
Approximately 245 feet downstream of the channel-spanning log, the channel begins to lose definition and the left bank is low and wet (Photo 2-5). These conditions continue downstream, and the floodplain area is dominated by reed canary grass. Approximately 600 feet downstream of where the channel loses definition, a beaver dam was observed within the channel. There is ponding and channel widening upstream of the dam, and immediately downstream, the channel has a bankfull

Colony/Harrison Creek Channel and Floodplain Dominated by Reed Canary Grass

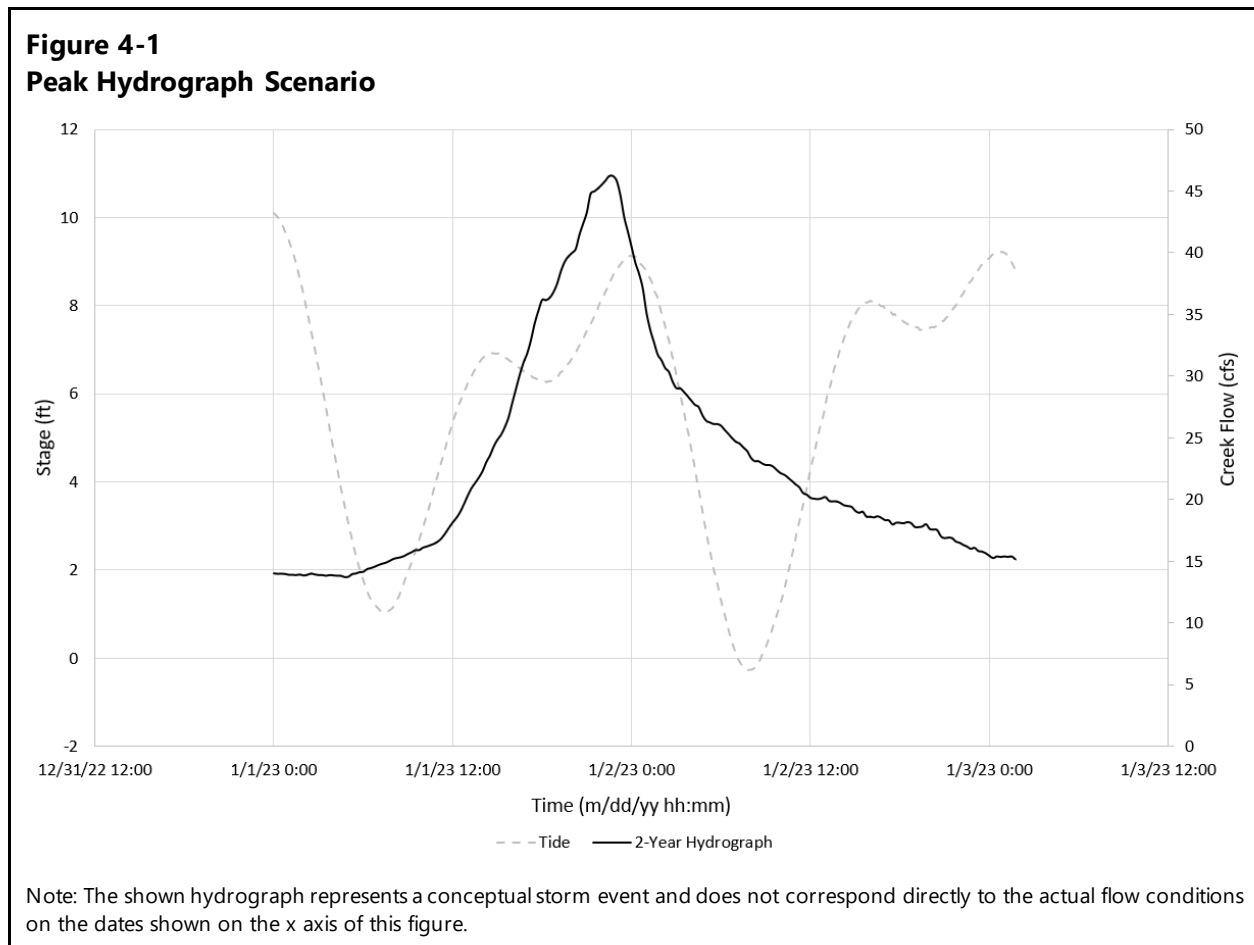
The peaks from the tributary hydrographs were temporally aligned and were slightly offset from the arrival of the peak tide (Figures 4-1 and 4-2). The peak streamflow was aligned to arrive during the falling limb of the tidal hydrograph. This scenario was intended to measure how the tide gate system was able to store flood waters while tides were receding. This scenario is potentially the worst case for an actual storm arriving during the annual peak tide, but this analysis is considered conservative to design restoration alternatives that are designed to function during the largest flood events.

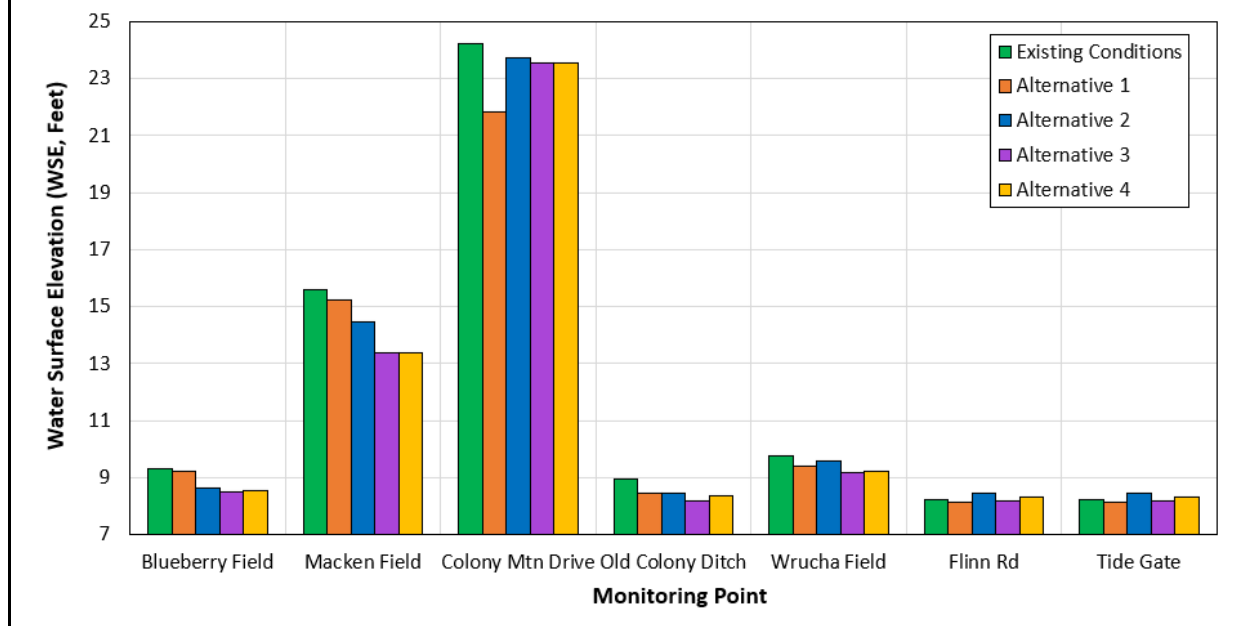
Modeled Maximum Water Surface Elevation at Monitoring Points: Peak Hydrograph

Figure 4-7 shows the modeled maximum WSE for existing and proposed conditions at all monitoring points under the peak hydrograph scenario. Table 4-3 summarizes the modeled maximum WSE results under the peak hydrograph scenario.

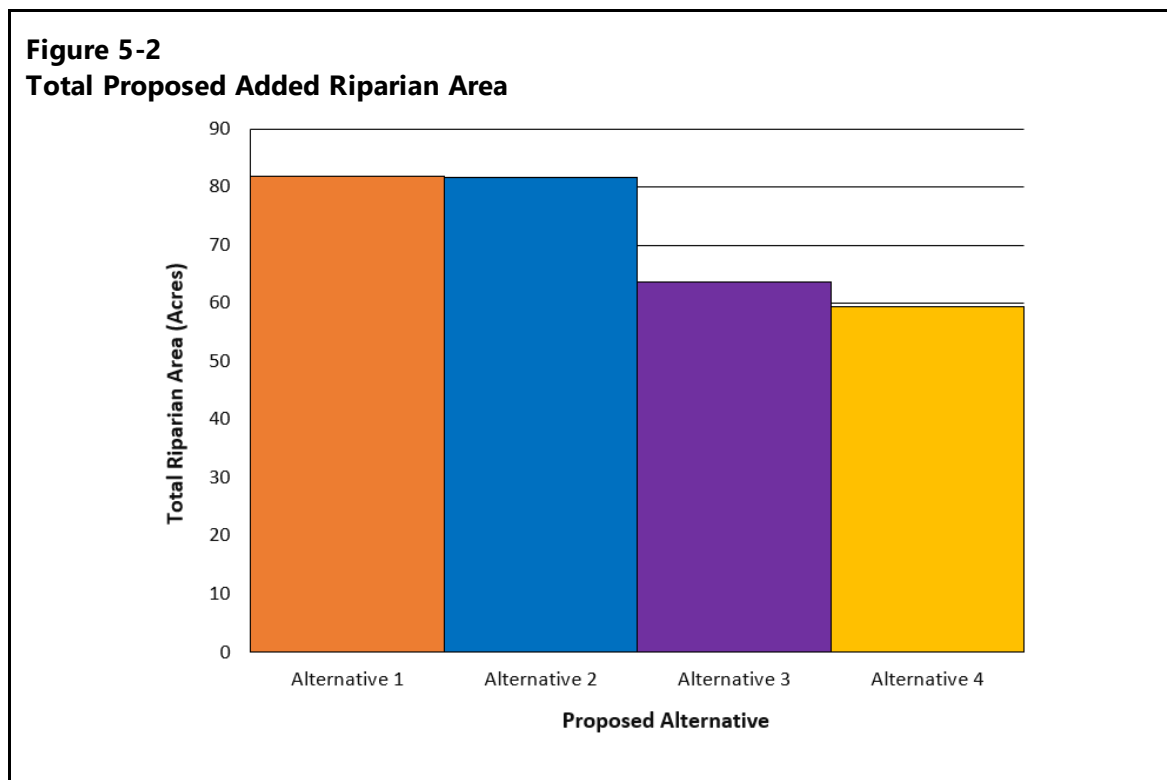
It should be noted that though it is not specifically quantified, proposed large wood density is directly related to available riparian/floodplain area, so ranking for proposed large wood density is assumed to be the same as the ranking for total proposed riparian area (Figure 5-2).

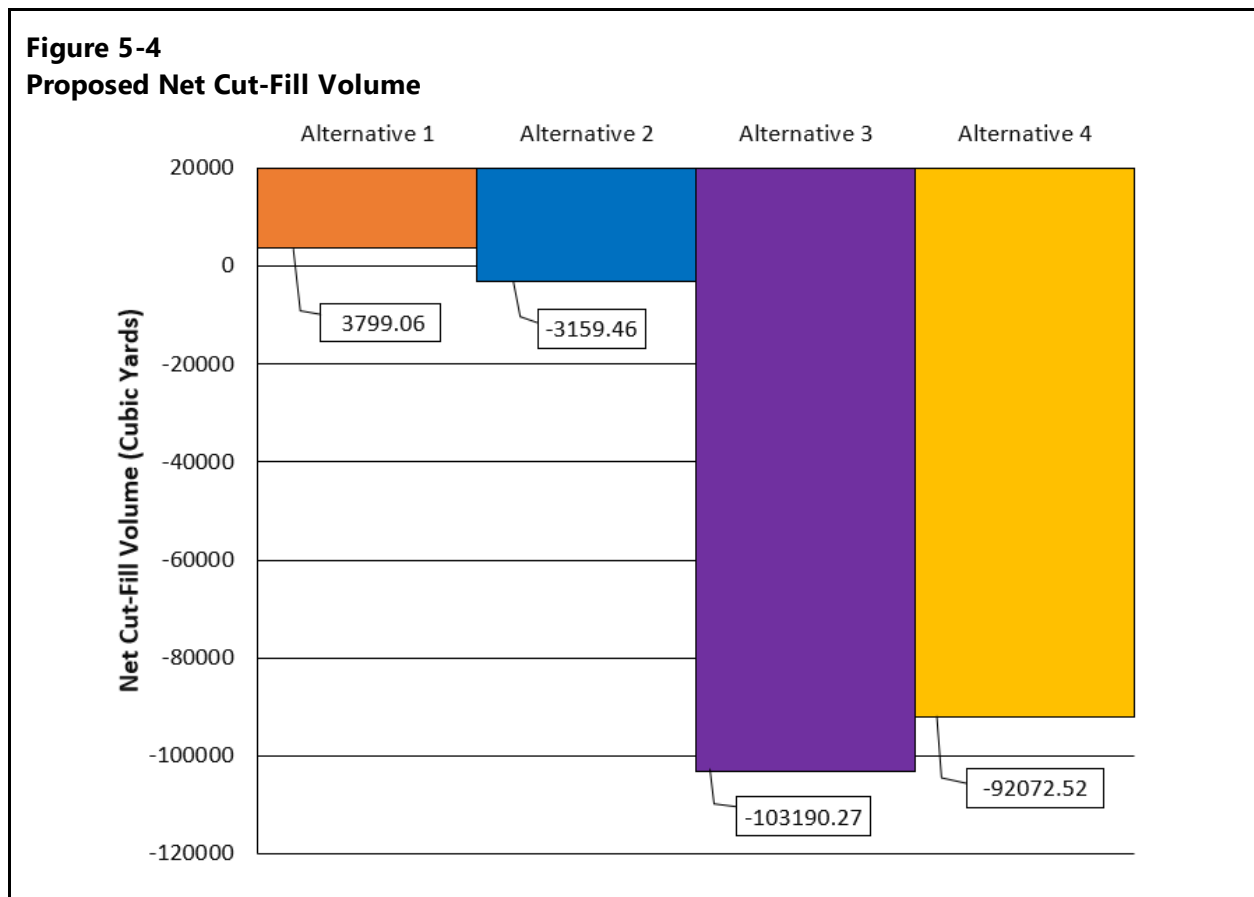
Though the other three alternatives, particularly Alternatives 3 and 4, provide significant amounts of sediment storage within the inset floodplains, Alternative 1 does realign the channel to a more natural location, and while Alternative 1 does not remove existing material, it does reconnect Colony Creek to its historic alluvial fan and provides a wide floodplain so natural depositional processes can be restored.

Sediment storage is a known concern within the project area. Due to the unnatural alignment of Colony Creek discussed in Section 2, natural alluvial fan deposition is not possible under the existing conditions. All four alternatives address the sediment storage concerns in different ways, resulting in a range of net cut-fill volumes shown in Figure 5-4. Positive net volume values indicate that more material is added to the project area than is removed, while negative net volumes indicate that more material is removed from the project area than is added.
