CSN TECHNICAL BULLETIN

Bioretention Illustrated:

A Visual Guide for Constructing, Inspecting, Maintaining and Verifying the Bioretention Practice

Version 2.0
October 20, 2013

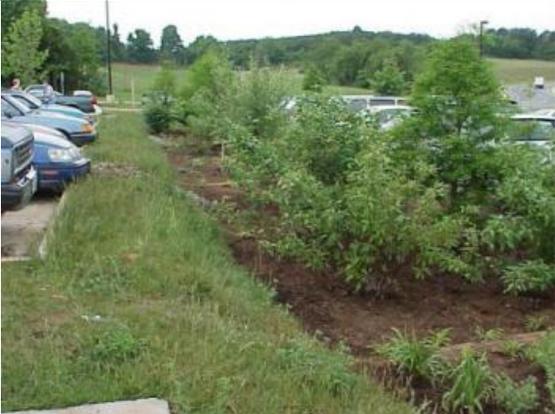
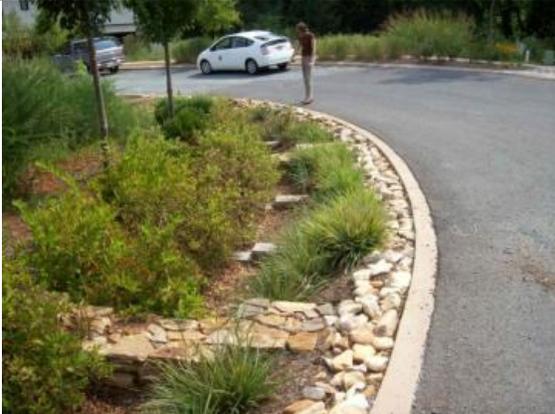
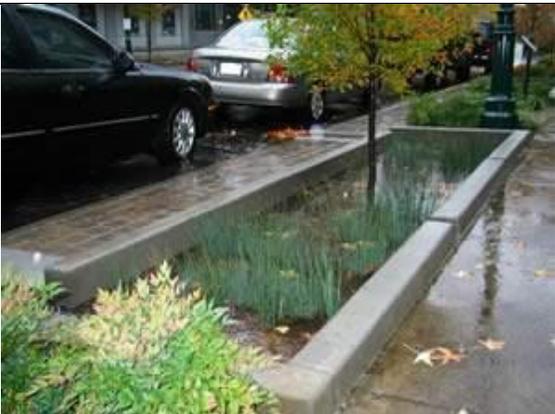
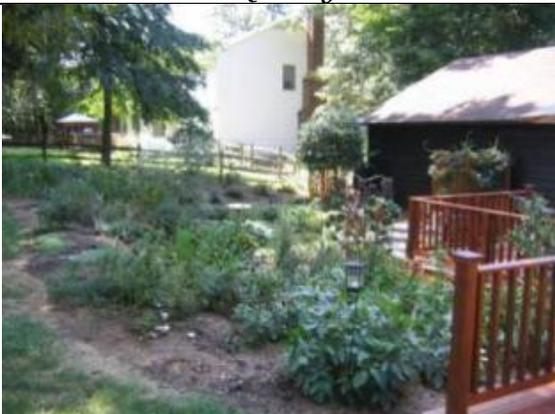
| Table 1. Bioretention Pseudonyms | |

| Table 1. Bioretention Pseudonyms | |
|---|--|
| <i>Bioretention</i> | <i>Water Quality Swale</i> |
| <i>Urban Bioretention</i> | <i>Residential Rain Garden</i> |

Bioretention facilities are known by many different names but they all operate in the same basic way. Table 1 shows some of the different varieties of bioretention facilities.

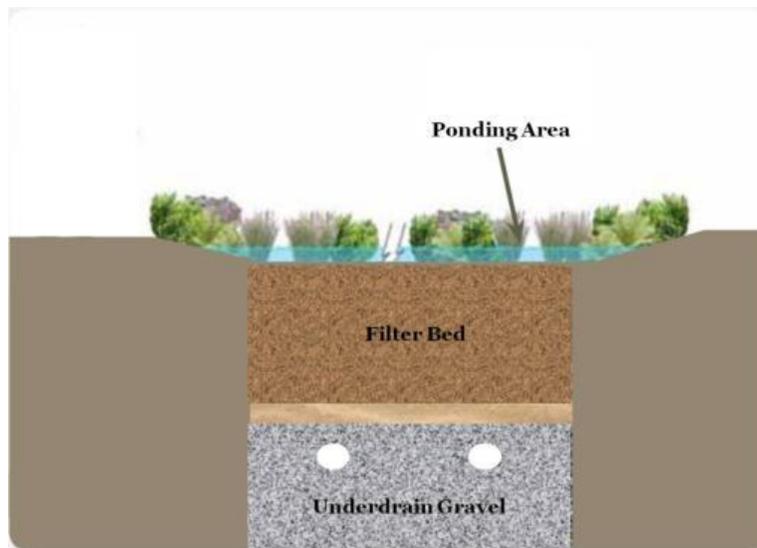
Figure 1. Bioretention Schematic (WVDEP)

Regardless of the form the bioretention may take, there are several basic design components that are present to ensure the practice's ability to reduce runoff and remove pollutants. These may include: a ponding area, filter bed (or soil media), stone layer (with or without underdrain), an inlet, overflow device or outlet, and vegetative cover (Figure 1).

The way a bioretention facility works is that stormwater flows into it and temporarily ponds on the surface in the **ponding area**. Water then slowly filters through the **filter bed** (or media layer) where it may be collected by the **underdrain** (a perforated pipe beneath the filter bed) and conveyed to the storm sewer system. Not all bioretention practices are designed to have an underdrain, in areas of “good” soils (soils that meet a specific infiltration capacity) a practice can be designed to allow the water to infiltrate into the underlying soils.

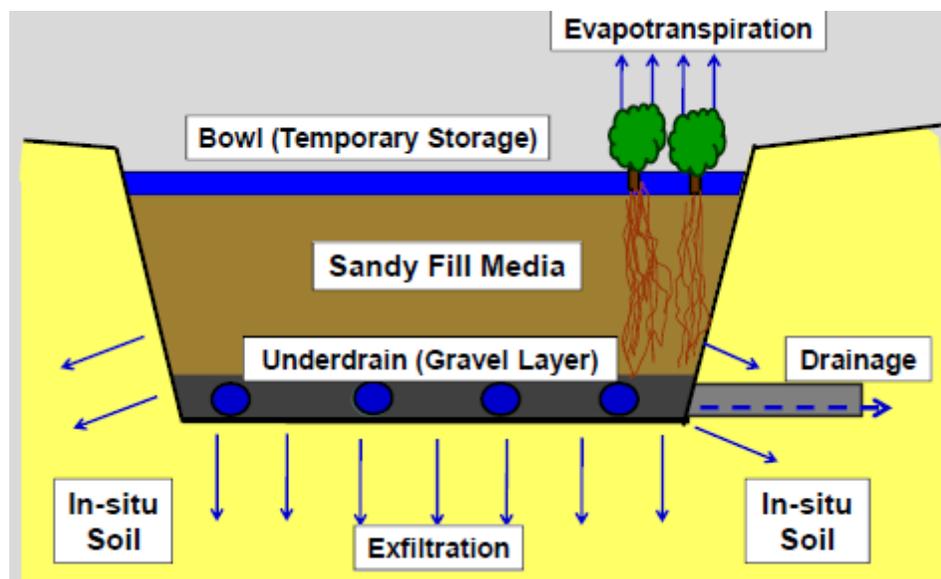
Figure 2. Bioretention Processes (Photo credit: NCSU Stormwater Engineering Group)

Vegetation is a very important component of a bioretention system. As stormwater makes its way through the practice, it is taken up and utilized by the vegetation along with the corresponding nutrients. Figure 2 demonstrates how runoff makes its way through the bioretention area.

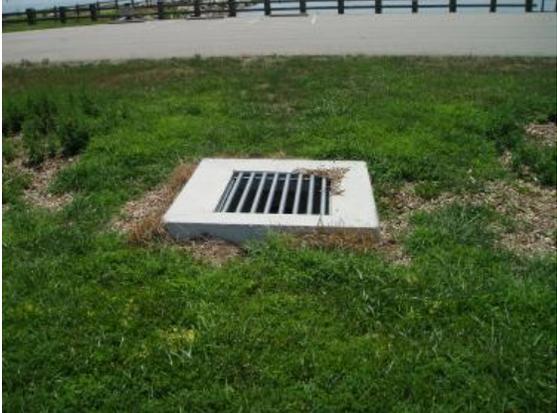
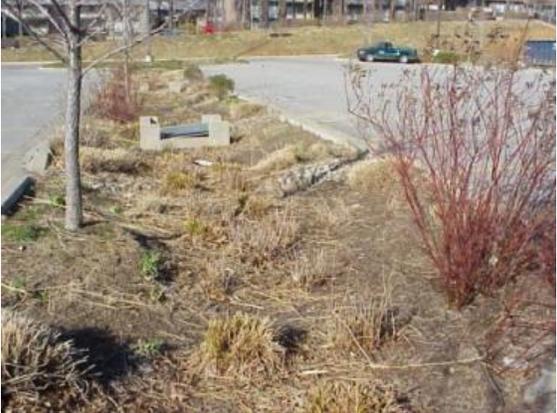
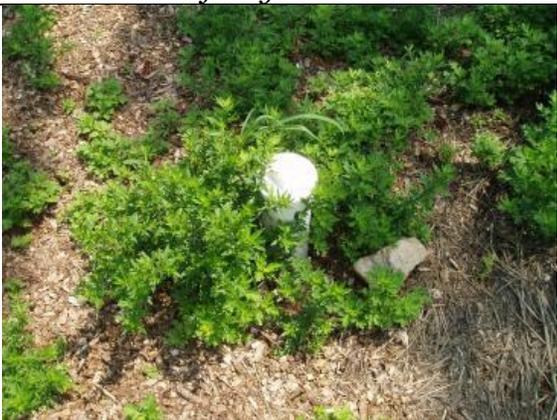
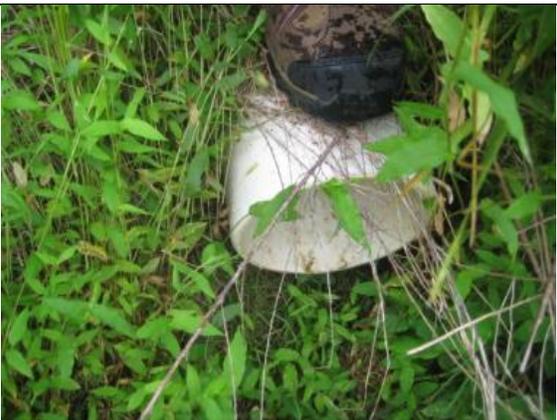
| Table 5. Bioretention Outlet Structures | |

| Table 5. Bioretention Outlet Structures | |
|---|--|
| <p><i>Inlet structure: yard inlet placed at the maximum ponding depth to allow for bypass of larger storms</i></p> | <p><i>Inlet Structure as Overflow Device</i></p> |
| <p><i>Observation well or clean out: to inspect drainage in the filter media or the condition of the underdrain</i></p> | <p><i>Underdrain outlet: where the water collected by the underdrain is discharged</i></p> |

Table 5 shows several different types of outlet structures commonly used for bioretention.

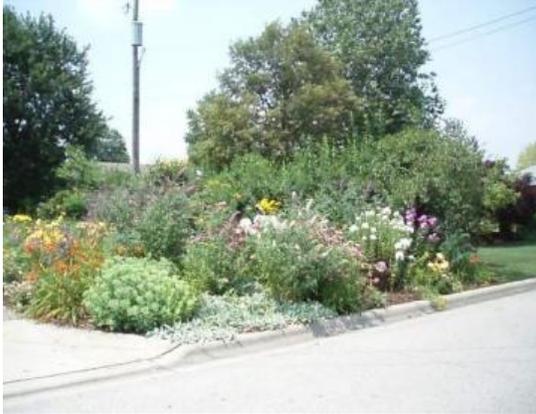
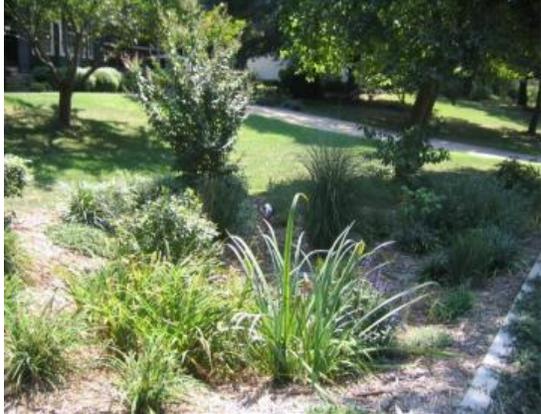
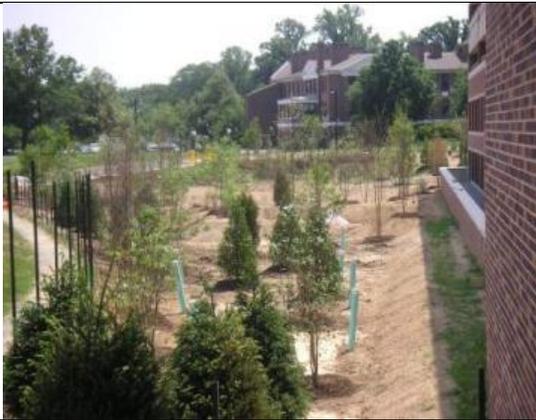
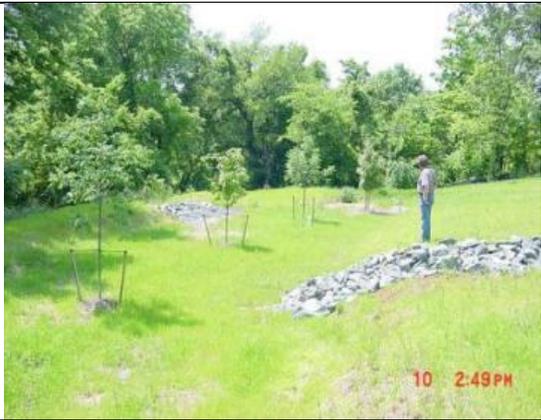
| Table 7. Typical Landscaping Regimes for Bioretention | |

| Table 7. Typical Landscaping Regimes for Bioretention | |
|--|---|
| <i>Perennial Garden</i> | <i>Perennial- Shrub</i> |
| <i>Tree-shrub-mulch</i> | <i>Turf-tree</i> |

Table 7 demonstrates four different typical landscaping regimes for bioretention.

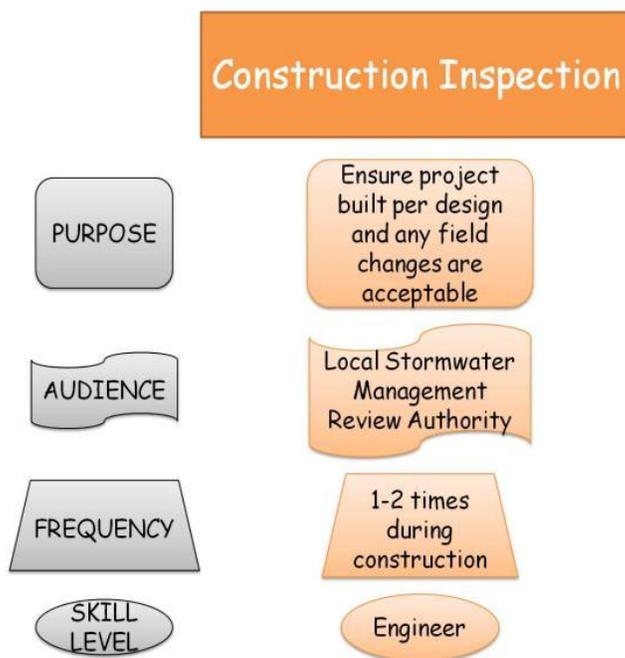
Figure 3. The Construction Inspection Process

The construction inspection is performed in order to meet requirements for the local stormwater management review authority, and is typically conducted by an engineer or trained stormwater professional at critical points in the construction process. (Figure 3).

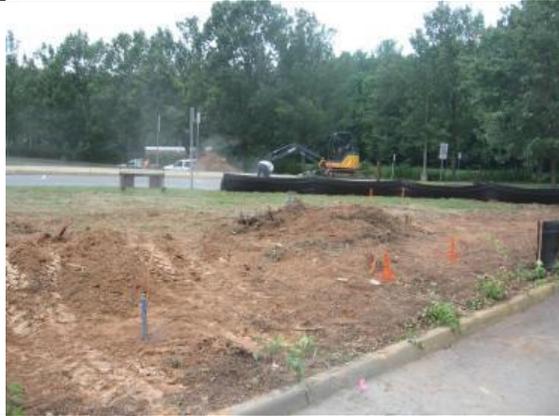
| <p>Table 8. A Typical Construction Sequence for a Bioretention Facility</p> | |
|--|--|
| <p>Step 1. Construction of the bioretention area may only begin after the entire Contributing Drainage Area (CDA) has been stabilized with vegetation.</p> <p>It may be necessary to block certain curb or other inlets while the bioretention area is being constructed. The proposed site should be checked for underground utilities prior to any excavation.</p> | |

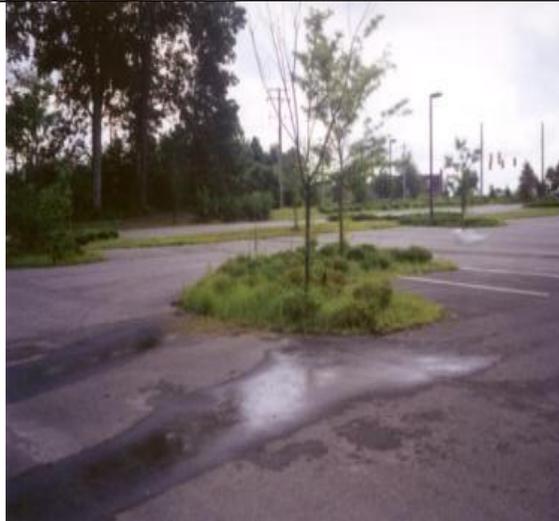
| <p>Table 8. A Typical Construction Sequence for a Bioretention Facility</p> | |
|--|--|
| <p>Step 2. The designer and the installer should have a preconstruction meeting, checking the boundaries of the CDA and the actual inlet elevations to ensure they conform to original design. Since other contractors may be responsible for constructing portions of the site, it is quite common to find subtle differences in site grading, drainage and paving elevations that can produce hydraulically important differences for the proposed bioretention area. The designer should clearly communicate, in writing, any project changes determined during the preconstruction meeting to the installer and the plan review/inspection authority.</p> | |

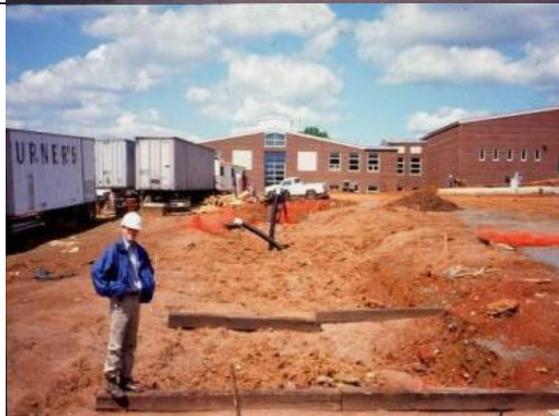
| <p>Table 8. A Typical Construction Sequence for a Bioretention Facility</p> | |
|--|--|
| <p>Step 3. Temporary erosion and sediment controls are needed during construction to divert stormwater and sediments away from the bioretention area until it is completed.</p> <p>Special protection measures such as erosion control fabrics may be needed to protect vulnerable side slopes from erosion during the construction process.</p> | |

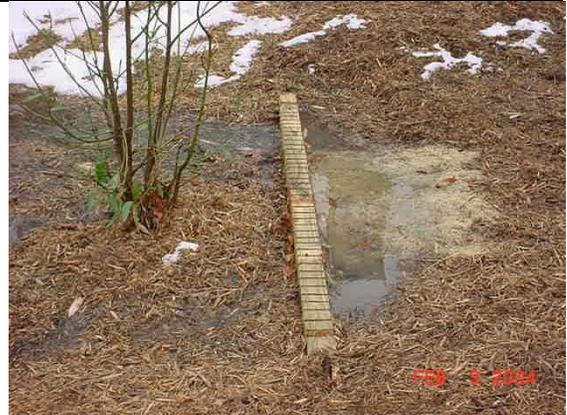
Step 4.

Any pre-treatment cells should be excavated first to trap sediments.

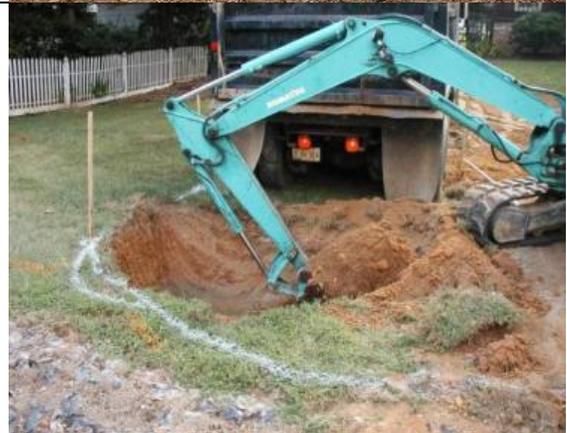
Step 5.

Excavators or backhoes should work from the sides to excavate the bioretention area to its appropriate design depth and dimensions. Excavating equipment should have scoops with adequate reach so they do not have to sit inside the footprint of the bioretention area.

Contractors should use a cell construction approach in larger bioretention basins, whereby the basin is split into 500 to 1,000 sq. ft. temporary cells with a 10-15 foot earth bridge in between, so that cells can be excavated from the side.

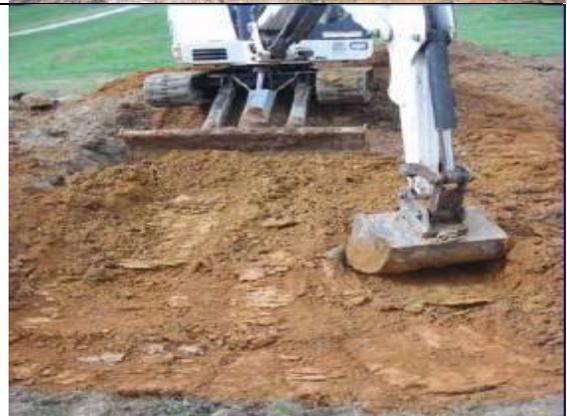
Step 6.

It may be necessary to rip (loosen) the bottom soils to a depth of 6 to 12 inches to promote greater infiltration.

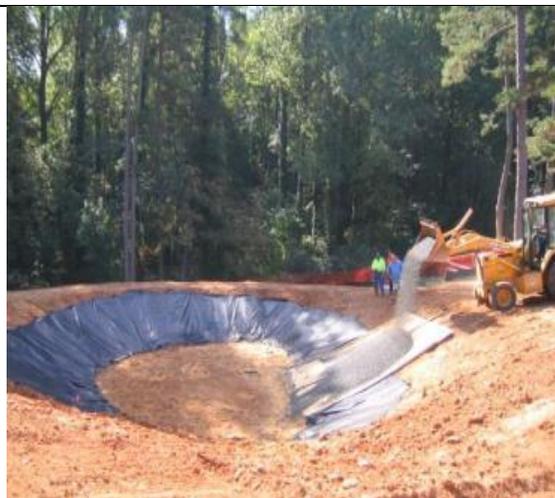
Step 7.

If using a filter fabric on the sides, place the fabric with a 6-inch overlap where the ends meet. If an underdrain stone storage layer will be used, place the specified depth of No.57 stone on the bottom, install the perforated underdrain pipe, and place No.57 stone to 3 inches above the underdrain pipe.

On top of the No.57 stone, add 2 inches of choker stone (No.8 or No.89 stone) as specified and then construction sand to the specified depth (often 2 to 4 inches) as a filter between the underdrain and the soil media layer. If no stone storage layer is used, start with 6 inches of No.57 stone on the bottom, and proceed with the layering as described above.

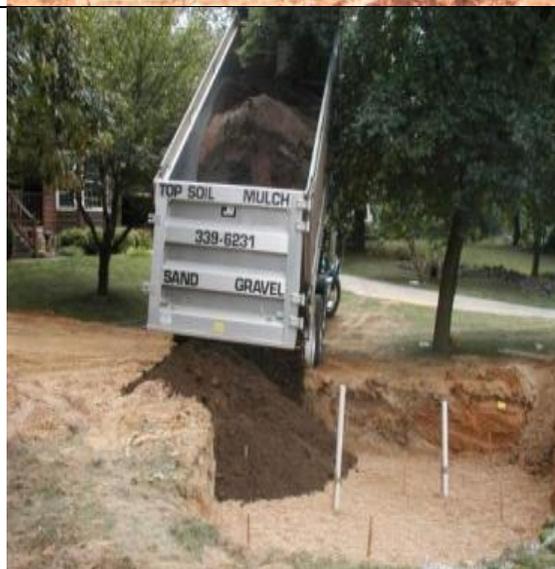
Step 8.

Deliver the soil media from an approved vendor, and store it on an adjacent impervious area or plastic sheeting. Apply the media in 12-inch lifts until the desired top elevation of the bioretention area is achieved. If heavy machinery is used, make sure the machinery works from the edges to avoid compacting any soils or side slopes. Filter media should be hydraulically compacted to avoid future settling. This process involves flooding the soil media after the initial installation to facilitate settling under natural operation conditions. Wait a few days to check for settlement, and add additional media, as needed, to achieve the design elevation. Plantings and mulch will raise the elevation, so where necessary adjust the design elevation to compensate for the soil volume of new plants.

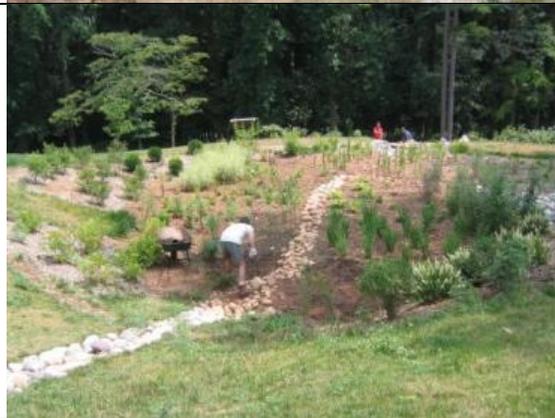
Step 9.

Prepare planting holes for any trees and shrubs, install the vegetation, and water accordingly. Install any temporary irrigation.

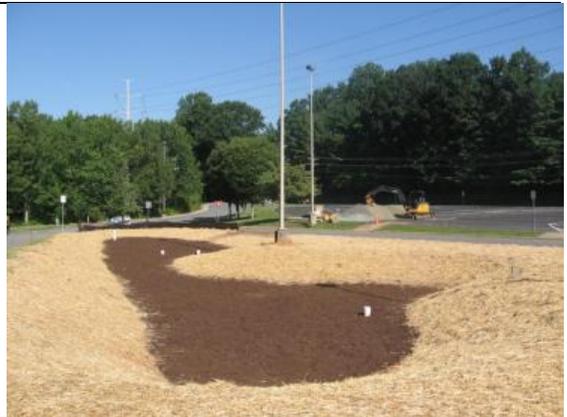
Step 10.

Place the surface cover (double shredded mulch, river stone or turf), depending on the design. If coir or jute matting will be used in lieu of mulch, the matting will need to be installed prior to planting (**Step 9**), and holes or slits will have to be cut in the matting to install the plants. Side slopes should be graded to a preferred maximum slope of 3:1 and capped with at least three inches of topsoil and appropriate mulch or matting.

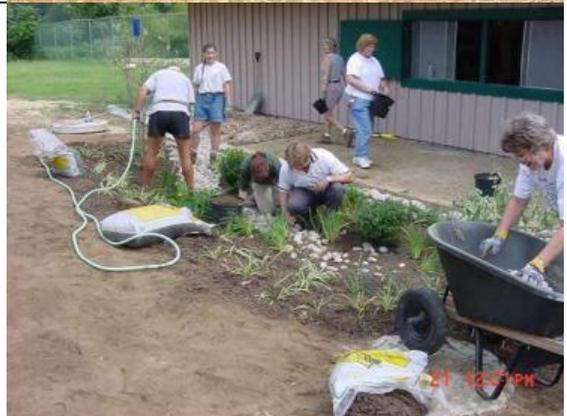
Step 11.

Install the remaining plant materials as shown in the landscaping plan, and water them during weeks of no rain for the first two months.

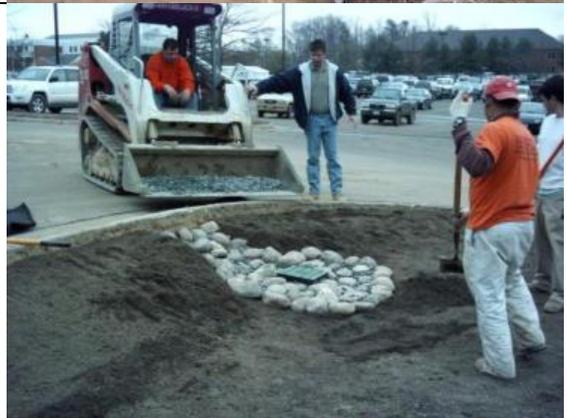
Step 12.

If curb cuts or inlets are blocked during bioretention installation, unblock these after the drainage area and side slopes have good vegetative cover. It is recommended that unblocking curb cuts and inlets take place after two to three storm events if the drainage area includes newly installed asphalt, since new asphalt tends to produce a lot of fines and grit during the first several storms.

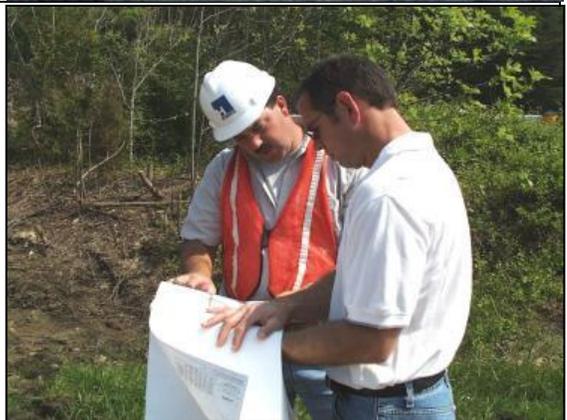
Step 13

Conduct the final inspection, then log the GPS coordinates for each bioretention facility and submit them for entry into the local maintenance tracking database.

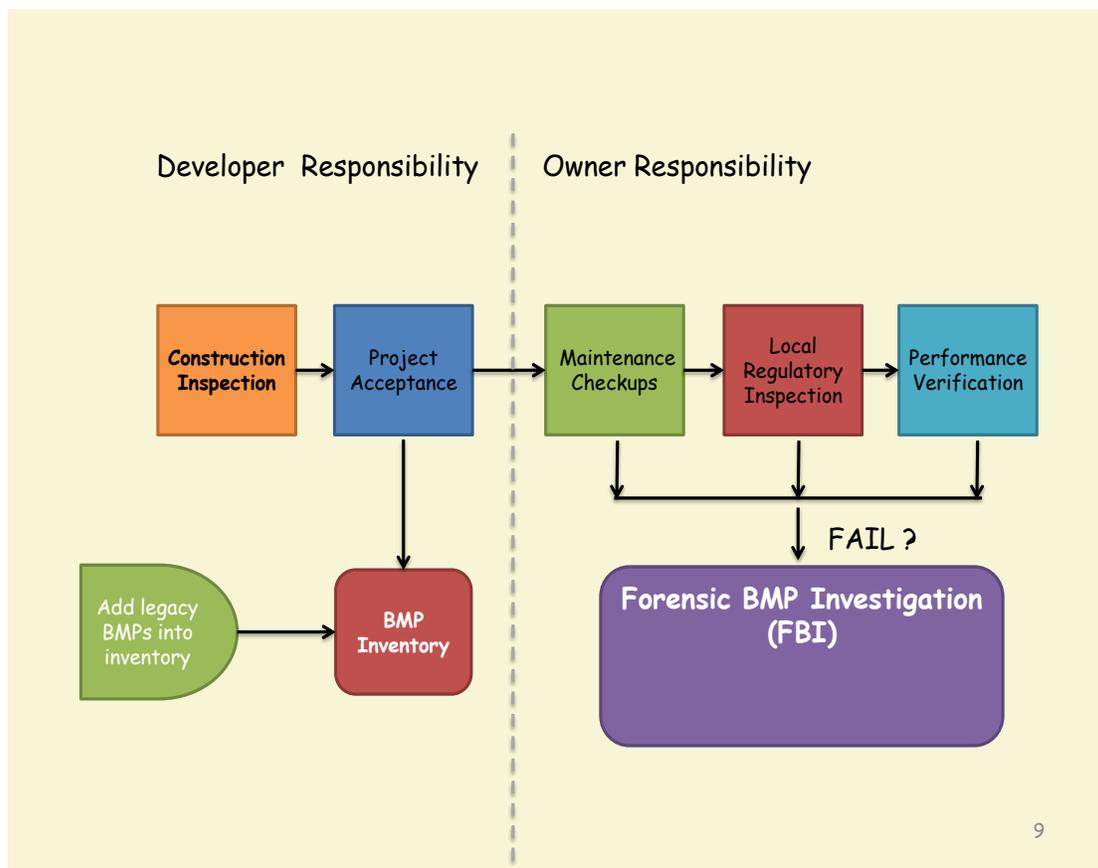
Figure 4. The Visual Inspection Framework

Each kind of inspection assesses the function of the bioretention area for a slightly different purpose. Figure 4 shows how the different types of inspection interconnect with each other to maintain the function of the bioretention area over its design life.

The visual inspection framework should be employed during every stage of the lifecycle of a bioretention area, including:

- Construction Inspection
- Project Acceptance
- Maintenance Checkups
- Periodic Local Inspection
- BMP Performance Verification
- Forensic BMP Investigations

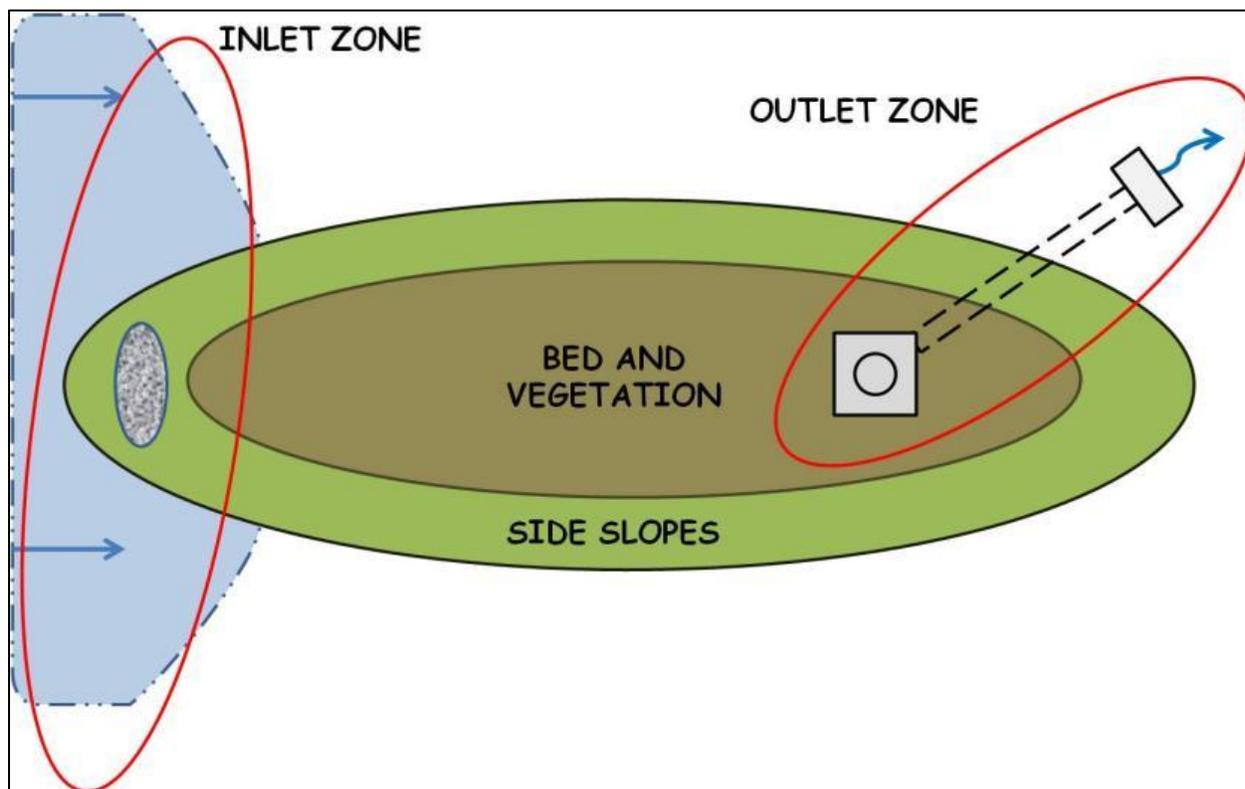
Figure 5. An overhead shot of a typical bioretention area with the inspection zones

Figure 5 shows where the five different inspection zones are located within a typical bioretention area.

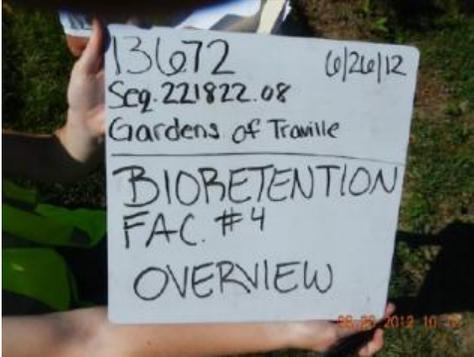
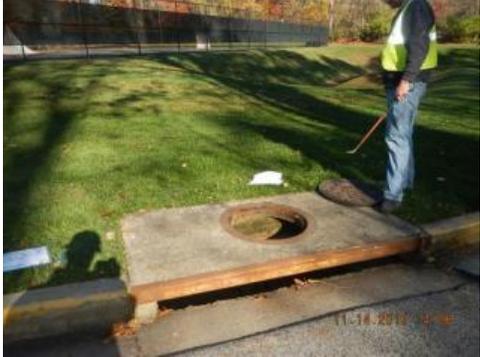
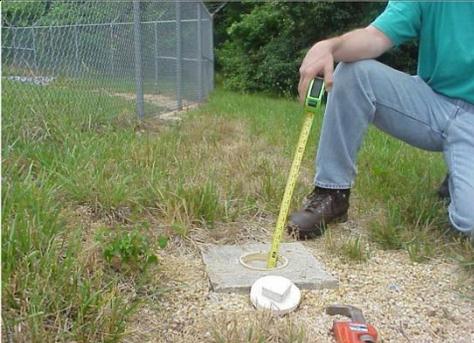
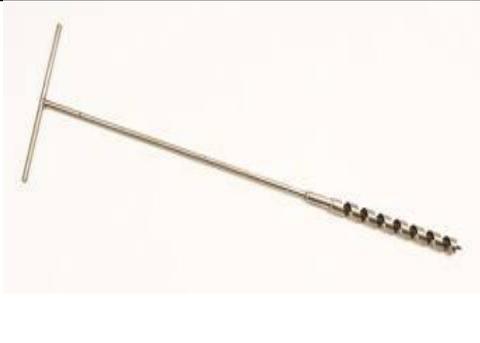
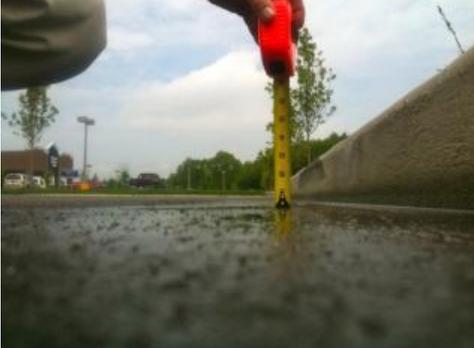
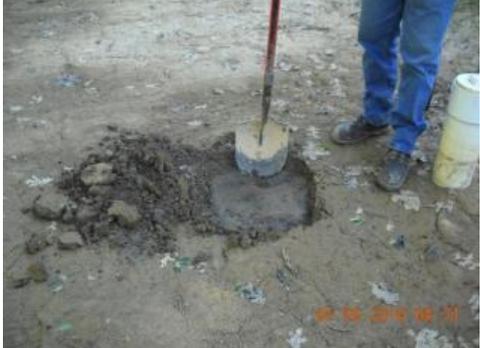
| Table 10 Tools to Bring When Conducting Inspections | |

| Table 10 Tools to Bring When Conducting Inspections | |
|--|--|
| <p><i>White board and digital camera: Used to note observations made in the field and rapidly record them</i></p> | <p><i>Manhole lifting device (i.e., pick, hand hook, etc): Used to open manholes or other structures associated with the bioretention area</i></p> |
| <p><i>Various wrenches (channel lock wrench, socket wrenches): Used to open observation pipes, monitoring wells etc.</i></p> | <p><i>Soil auger: For investigating soil conditions at a site and the soils ability to infiltrate</i></p> |
| <p><i>Measuring tape & 100' tape: Used to measure the surface area and depth</i></p> | <p><i>Shovel and rake: Used to inspect the mulch and media of the bioretention</i></p> |

For any visual inspection there is a standard process and set of equipment that can help facilitate the process. It is beneficial to have a whiteboard and a digital camera to note observations in the field and document the inspection. For inspecting the facilities from the ground surface, there are many different tools that can be of benefit, the most necessary of which are listed in Table 10.

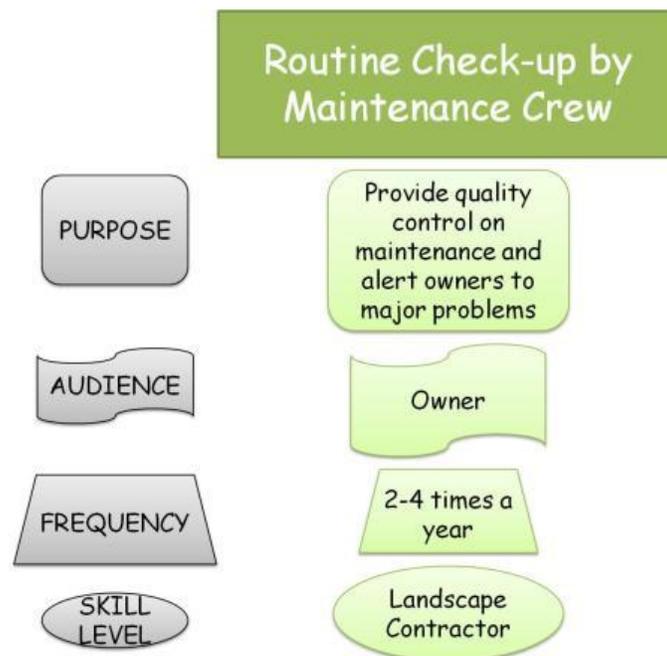
Figure 7: Key Elements of Routine Check Up by the Maintenance Crew

Routine maintenance checkups occur 2-4 times a year as part of a regularly scheduled maintenance visit and are necessary in order to provide quality control on maintenance activities and/or to alert owners of any major problems that may be developing. The purpose of a routine maintenance checkup is to “catch” minor problems before they turn into more serious problems. The checkup is usually conducted by the same landscape contracting company that provides ongoing maintenance or the property manager (Figure 7).

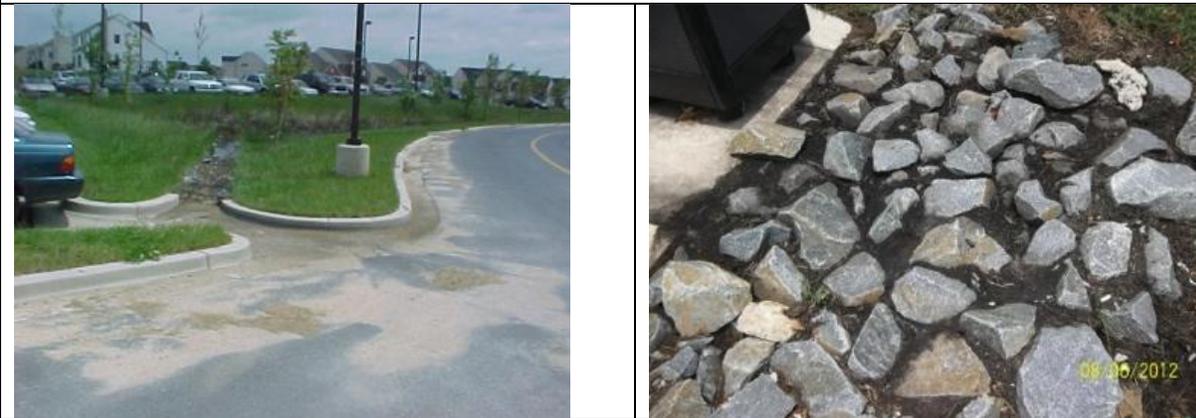
Indicator #1: Severe Inlet Obstruction

Problem: Severe accumulation (greater than 3”) of sediment or debris at the inlet so that most of the runoff cannot enter the bioretention facility. Photo on the left shows severe sediment build-up in the crevices between the stones.

Solution: Locate source of the sediment, mitigate and evaluate the need for enhanced pretreatment. Remove riprap, stone, or mulch contaminated with sediment. Clean all sediment from the inflow area. If riprap is used, clean off and replace with original stone, supplemented as needed. If stone or mulch is used, add new material to attain appropriate elevations and flow characteristics. Check inlet elevations and adequate drops from pavement edge to inlet channel. Inlet may need to be reshaped to have adequate drop or slope to filter bed surface so it is not prone to routine clogging. Arrange for more frequent cleaning of sediment from inlet.

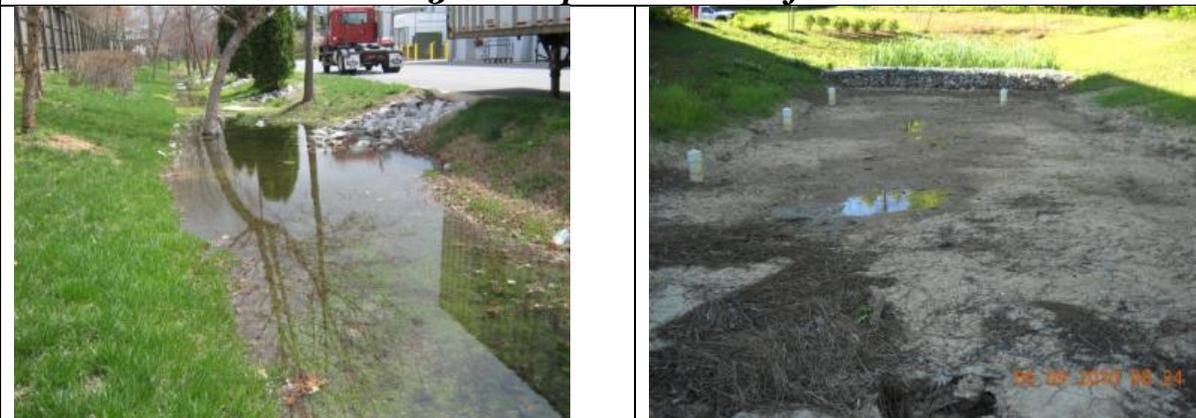
Indicator #3: Inadequate or Lack of Pretreatment

Problem: Severe accumulation of sand or sediment within the bioretention facility or the pretreatment area. Evidence of standing water in the pretreatment area or bypass of the bioretention facility altogether.

Solution: Locate the source of the sediment, mitigate and evaluate the need for enhanced pretreatment, corrected or more frequent maintenance, and/or design remediation. In many cases, ensuring that maintenance personnel are removing minor amounts of sediment while performing routine maintenance can help correct the lack of pretreatment.

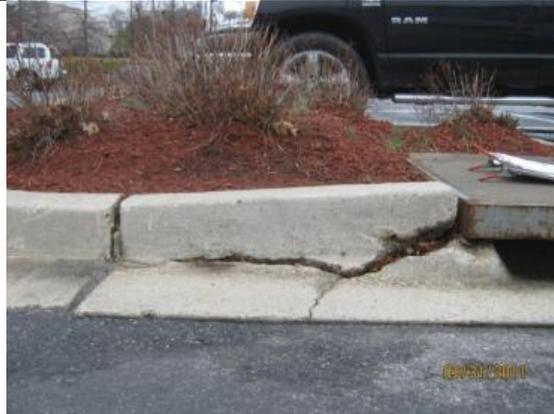
Indicator #4: Structural Integrity

Problem: Curbs, pavement, or drainage structures are damaged to the point where it impairs the function of the bioretention.

Solution: Schedule a visit by a project estimator with relevant project experience to develop a solution and conduct repairs. Depending upon the type of structure involved, such as with a retaining wall, an engineer may need to be consulted to design a solution.

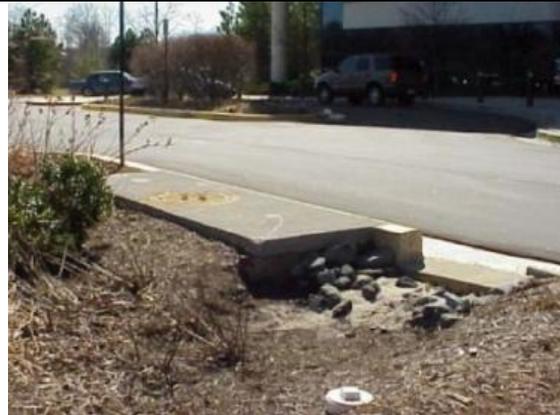
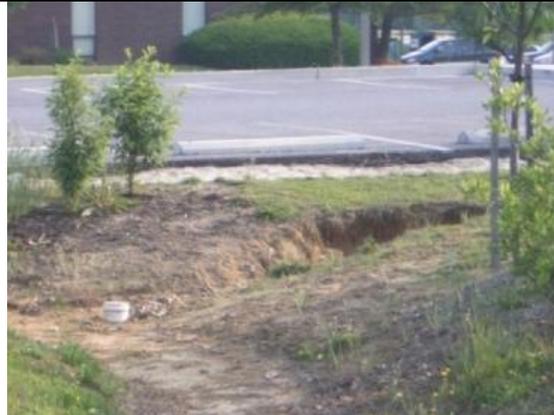
Indicators #2, #6, #14: Severe Inlet, Side Slopes or Bed Erosion

Problem: A foot or more of gully erosion at the inlet or in the bed of the bioretention facility. Greater than 3” of erosion in the side slopes.

Solution: In general, the solution is to determine the cause of the erosion and repair it. This differs depending on where the erosion is occurring. At the inlet, it may be necessary to implement protection measures to ensure that runoff is being dissipated and prevented from entering the facility in a concentrated flow or to extend the protection onto the flat bed area. On the side slopes of the bioretention, it may be necessary to re-grade and evaluate the topsoil and vegetation to determine if there is sufficient vegetative cover to stabilize the slopes. When erosion occurs within the bed of the facility, it is necessary to evaluate the flow patterns and the condition of the bed materials to determine if they are appropriate for the runoff volume. Supplemental protection may be required to match the flow conditions. Soil media should be utilized for any bed repairs to ensure the intended flow characteristics are preserved.

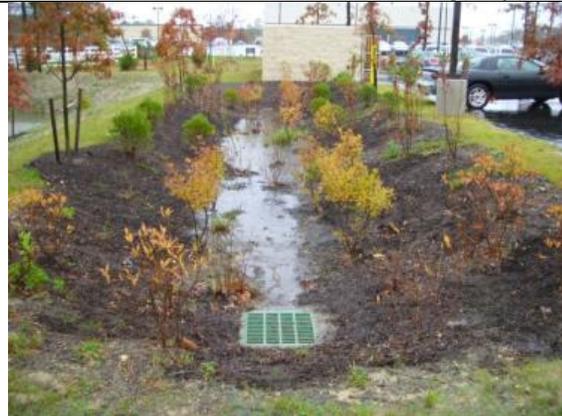
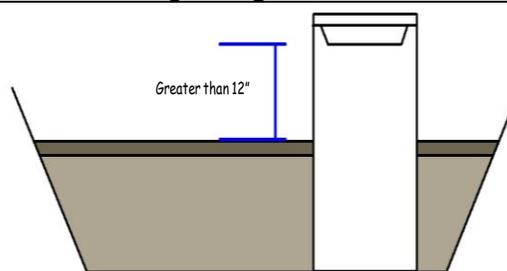
Indicators #5, #7, #11: Severe Design Departures

Problem: A greater than 25% departure from the design assumptions for surface area, storage, ponding depth or contributing drainage area.

Solution: Conduct a topographic survey and consult site plans to determine the cause and degree of the deviation. In the case of ponding depth, adjust grade by removal or addition of mulch and/or media. In the case of surface area and storage, re-grade the facility to meet design areas and volumes. If increasing the surface area, evaluate the dewatering capabilities of the existing soil media area and adjust accordingly. In the case of changes to the drainage area, delineate the actual CDA, re-compute the facility performance, and modify as needed to meet minimum design criteria.

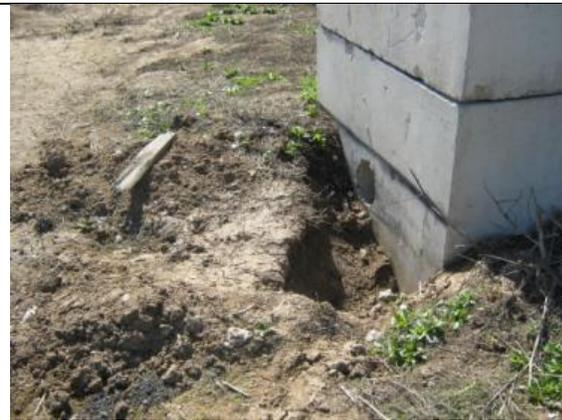
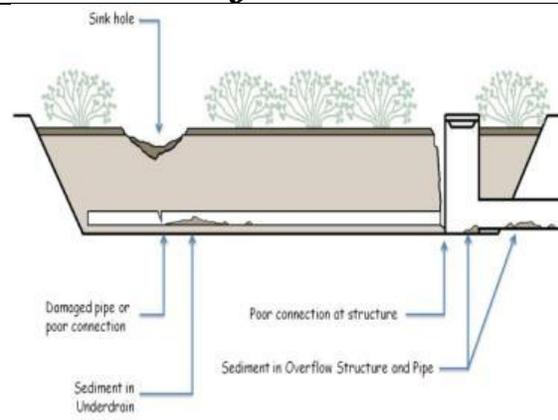
Indicator #8: Severe Bed Sinking

Problem: Greater than 1' of localized bed sinking and/or sediment is observed in the underdrain or overflow. The discovery of sediment in the underdrain or overflow structures indicates the movement of sediment through the facility.

Solution: Severe bed sinking is often a result of breached material layers, poor connections, or damaged pipes within the bioretention facility. Conduct a test pit excavation to provide detailed visual examination of subsurface conditions. Test pitting should occur by hand to minimize compaction of the bed. Make sure dissimilar materials are kept separate and not cross contaminated during the test pitting operation. Be prepared to repair the system (i.e., with new filter cloth or choker stone) to full functionality at test pit completion. Remove mulch, and evaluate the soil media for sediment and/or discoloration throughout the profile. Once through the soil media, cut filter cloth or hardware cloth or, if choker stone is used, remove the next level of stone to gain access to the underdrain stone. Look for voids, loss of material, staining or failure of any of the layers. There should be no evidence of soil media at the underdrain stone layer. If needed, excavate to the underdrain pipe and check pipe and joint condition. All materials should be replaced in appropriate layers to ensure full intended functionality without cross contamination of the individual material layers.

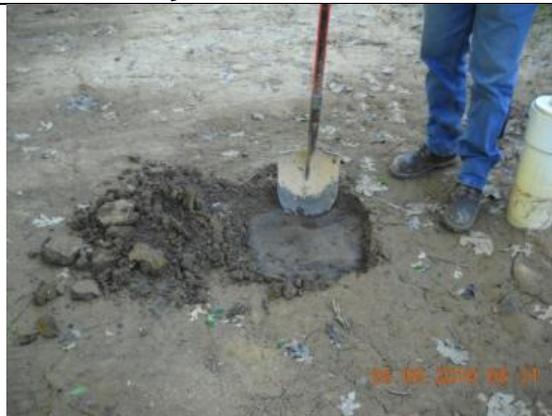
Indicator #9: Severe Sediment Caking

Problem: Greater than 2" of sediment deposition within the bioretention facility or a hard-pan surface due to sediment sealing the surface of the mulch or soil media.

Solution: Sedimentation in the bioretention facility can result from a variety of causes. It can be from a sediment source in the contributing drainage area or from erosion within the facility itself. Conduct a full cleanout of sediment, mulch and soil media in the affected area to depth of 6" within the bed surface or to the point where sediment is no longer observed in the soil media. Identify source of sediment and work to remediate it.

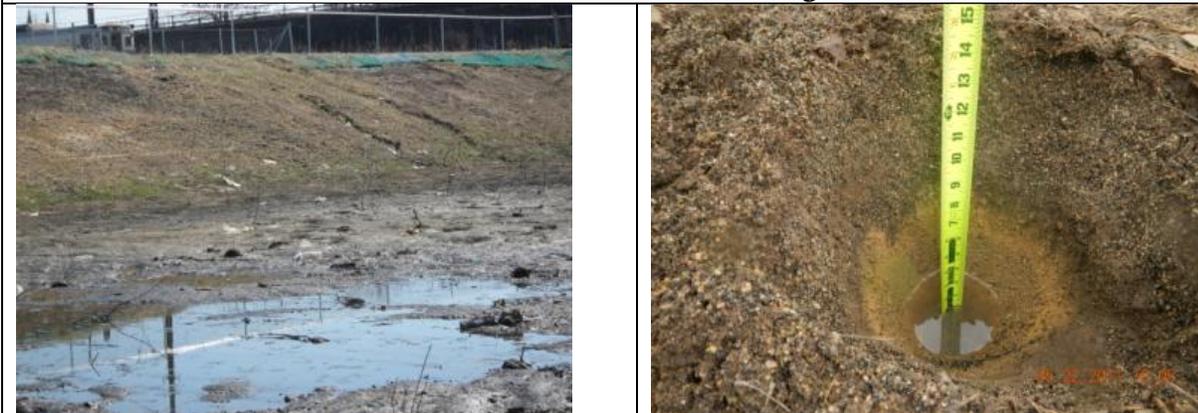
Indicator #10: Severe Standing Water

Problem: Standing water in the bioretention facility 24-48 hours after a design storm indicates the facility is not functioning as designed.

Solution: Confirm that the underdrain pipe is perforated and not blocked. Pump down the water and conduct a test pit excavation (as described in Indicator #8) to investigate the mulch, soil media and possible presence of filter cloth (which should NOT be used a separation barrier between the soil media and underlying underdrain stone layer). All pumping should be discharged through a geotextile bag. Evaluate the condition of the materials and look for signs of sediment and saturation in the soil media profile. First, determine if sediment is clogging the surface of the mulch or soil media. Then determine if the soil media contains too many fines with either a simple field test or laboratory analysis. If filter cloth is present, determine if it is functional and of the correct specification (non-woven geotextile fabric with a flow rate of > 110 gal./min./sq. ft.). If choker stone is present, determine if the in-place stone matches the specification (typically #8 or #89 washed gravel).

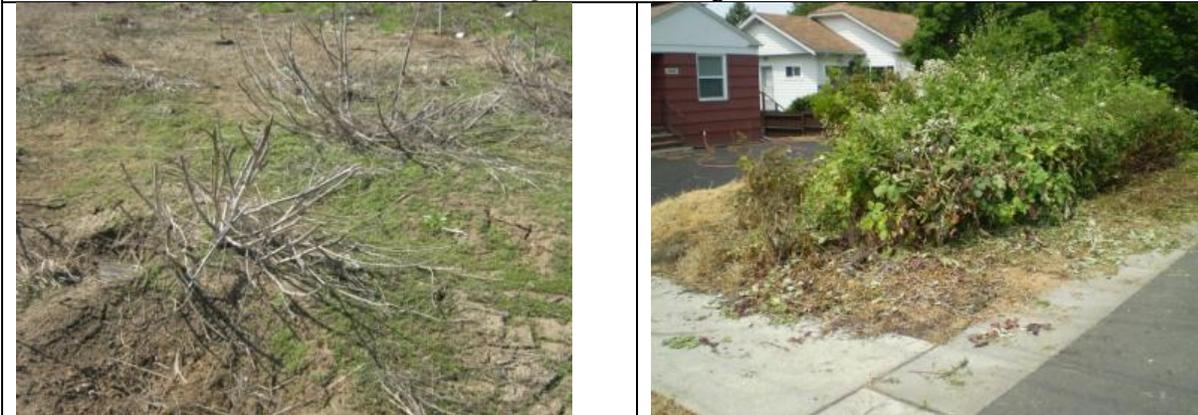
Indicator #15: Severe Vegetative Cover

Problem: When the bioretention facility suffers from less than 35% vegetative coverage, dead or diseased plants or overgrown with invasive species.

Solution: Evaluate the cause of the plant failure (soils, species, disease, design) and create a new planting plan based on the outcomes of those findings. The analysis of the plant material should include a soil test to determine if critical parameters, such as pH, organic matter, and moisture are a match for the intended species. For invasive species control, design and implement an eradication plan. Following the remediation, ensure that appropriate plant maintenance, such as mulching, fertilizing, weeding, disease intervention, etc. occurs to avoid a re-occurrence of the failure.

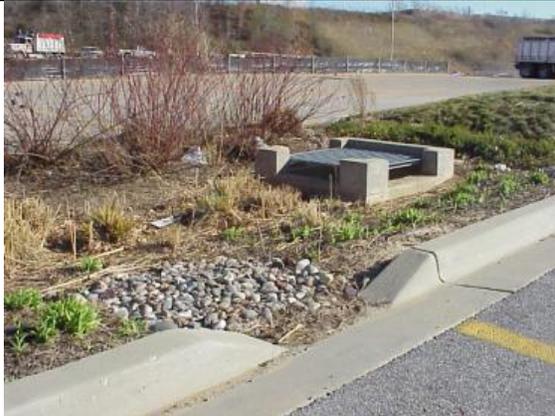
PASS

This inlet is clean and in good condition.

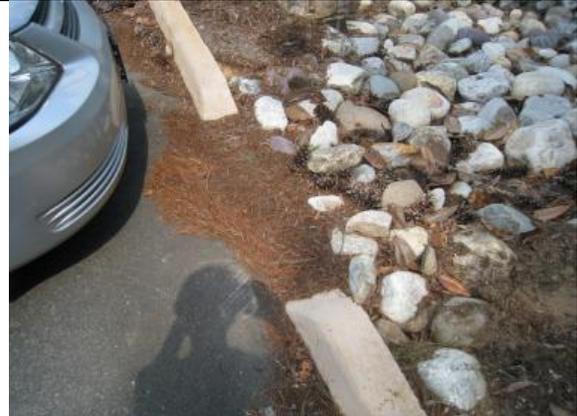
MINOR

There is a minor amount of sediment and/or debris build up at the inlet.

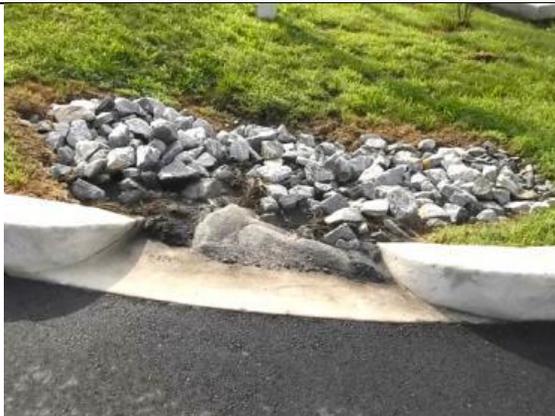
MODERATE

The moderate amount of sediment accumulation at this inlet indicates an entry problem that could lead to a risk of blockage.

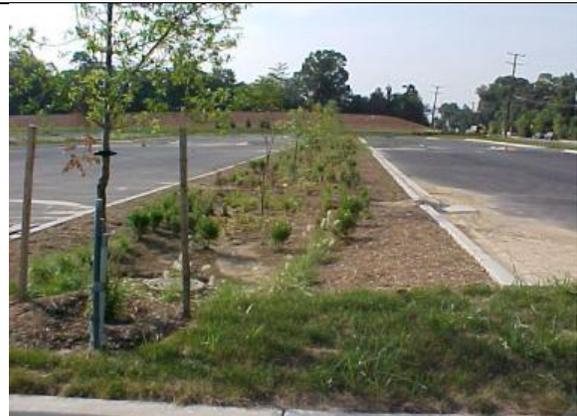
SEVERE

Sediment build-up or staining indicates that water is ponding and a significant amount of runoff is not getting into the facility.

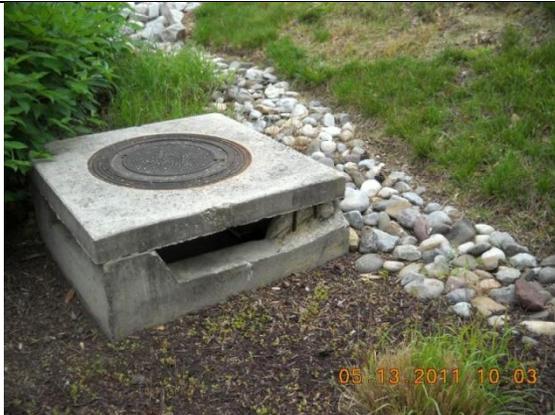
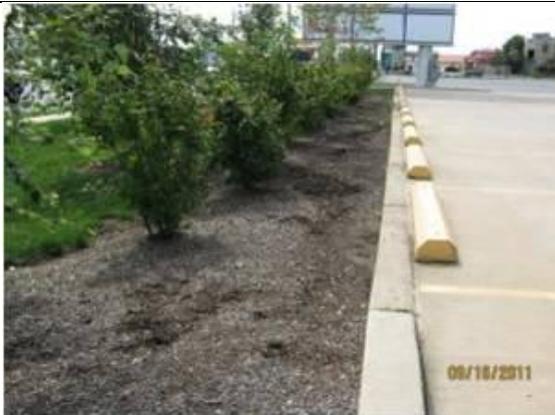
| PASS | MINOR |

Description: Investigate the inlet for evidence of channelized erosion or scour. This indicator determines if upland erosion is delivering sediment to the bioretention area, and may also indicate improper elevations or a preferential flow path within the facility.

| PASS | MINOR |
|---|---|
| <p data-bbox="233 942 792 1003"><i>Inlet (stone channel) in good condition, no evidence of erosion.</i></p> | <p data-bbox="812 942 1396 1003"><i>Surface runoff from parking lot causing minor erosion of mulch at inlet.</i></p> |

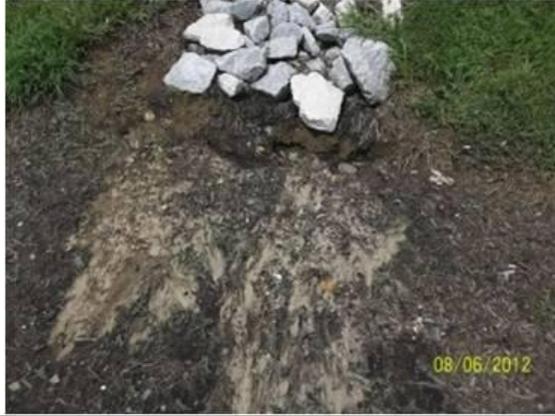
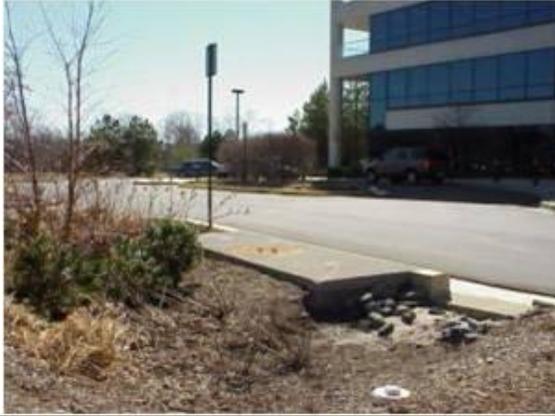
| PASS | MINOR |
|---|---|
| MODERATE | SEVERE |

| PASS | MINOR |
|---|---|
| <p data-bbox="233 1457 792 1543"><i>Concentrated flow results in moderate erosion at inlet. Investigation into cause is necessary as could result in more severe condition.</i></p> | <p data-bbox="812 1457 1396 1543"><i>Scour is occurring at the inlet indicates a possible design flaw.</i></p> |

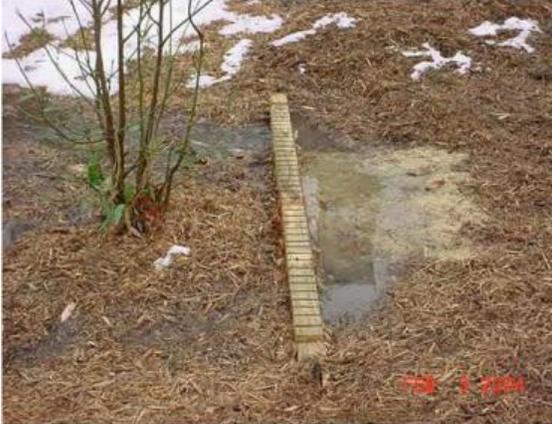
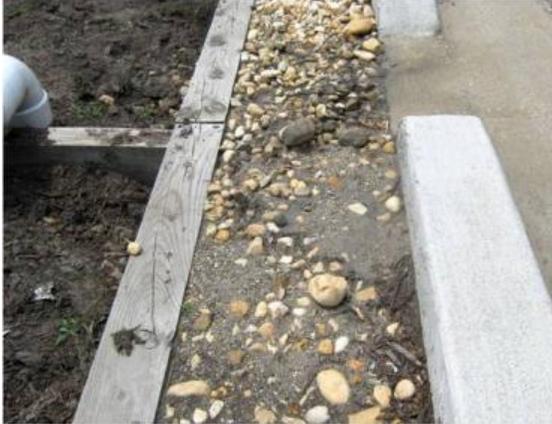
| PASS | MINOR |

| PASS | MINOR |
|---|--|
| <p><i>This pretreatment measure is free and clear of sediment/debris.</i></p> | <p><i>Slight accumulation of sediment in the pretreatment cell.</i></p> |
