CSN TECHNICAL BULLETIN

Bioretention Illustrated:

A Visual Guide for Constructing, Inspecting, Maintaining and Verifying the Bioretention Practice

Version 2.0
October 20, 2013

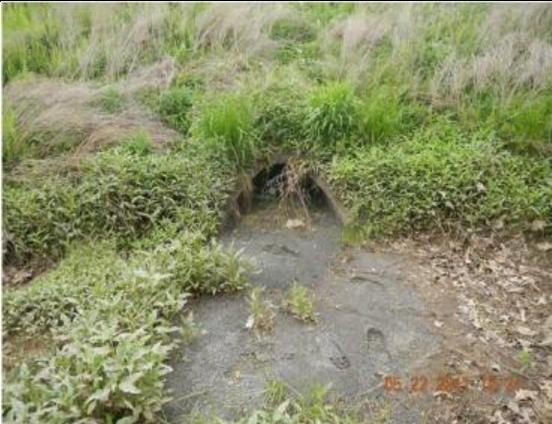
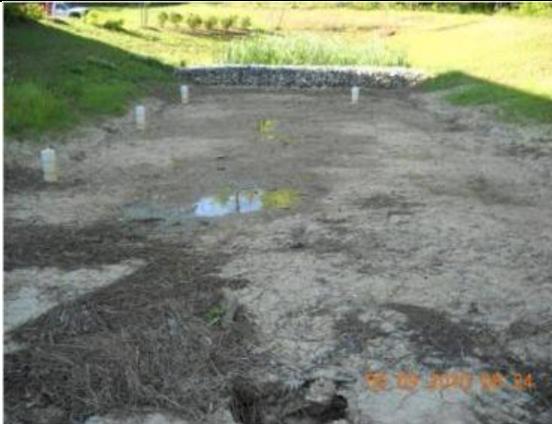
| PASS | MINOR |
|---|--|
| MODERATE | SEVERE |

| PASS | MINOR |
|---|--|
| <p><i>Pretreatment measures needed at this facility. Sediment deposition has almost entirely clogged the inlet.</i></p> | <p><i>Lack of pretreatment or inadequate pretreatment has led to facility failure.</i></p> |

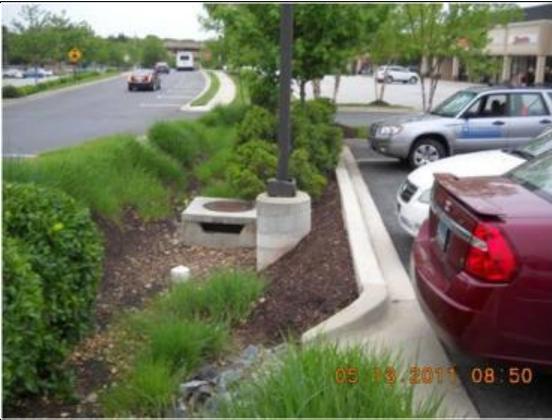
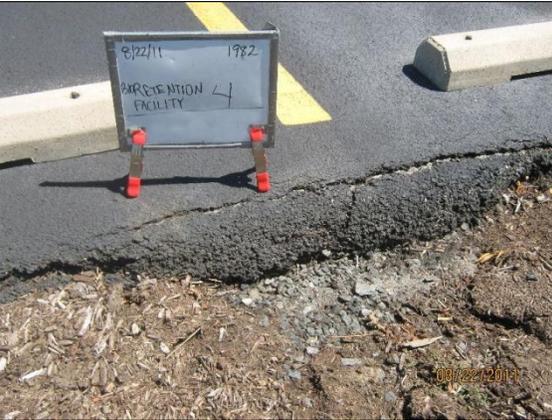
| PASS | MINOR |

Description: This indicator assesses whether the facility is causing damage to adjacent pavement and curbs. Flows, scour or water seepage are usually the cause of the damage.

| PASS | MINOR |
|--|---|
| <p><i>Surrounding curbs and pavement are in good condition.</i></p> | <p><i>Some pavement cracking occurring in surrounding pavement.</i></p> |

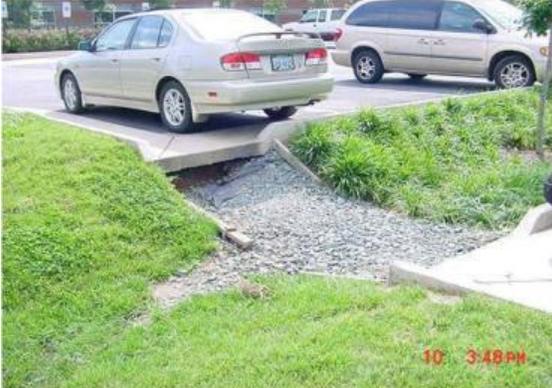
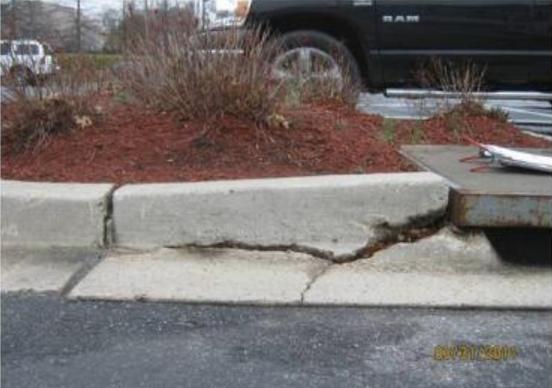
| PASS | MINOR |
|--|---|
| MODERATE | SEVERE |

| PASS | MINOR |
|--|---|
| <p><i>Inlet elevation drop too steep leading to erosion within the facility. Reinforcement needed immediately to prevent collapse.</i></p> | <p><i>Major problems with adjacent curbs and/or pavement. Design repair needed.</i></p> |

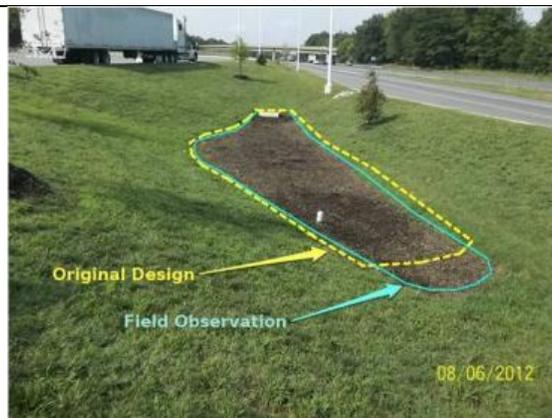
PASS

The surface area of this bioretention facility slightly deviates from the original design but not significantly to impact the pollutant reduction functions of the facility.

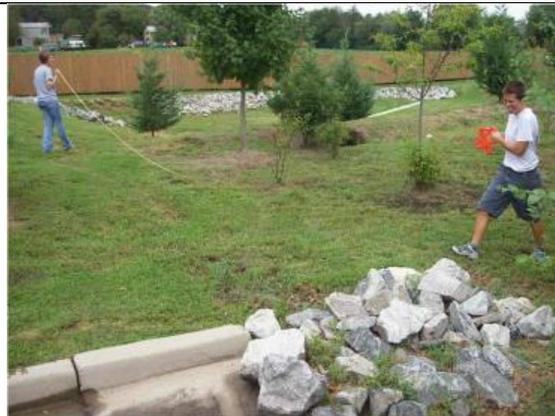
SEVERE

Inspectors measure the surface area of a bioretention facility.

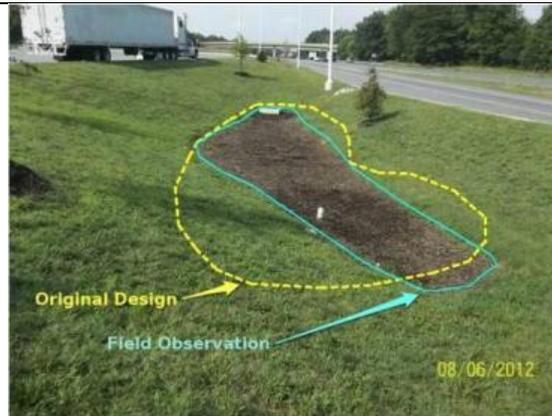
The surface area of this bioretention facility significantly deviates from the original design.

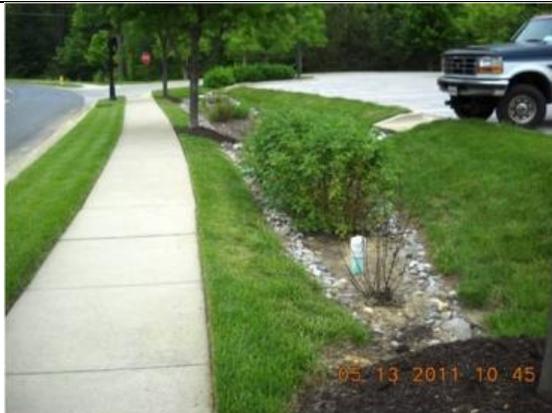
PASS

There is no evidence of side slope erosion occurring in this bioretention.

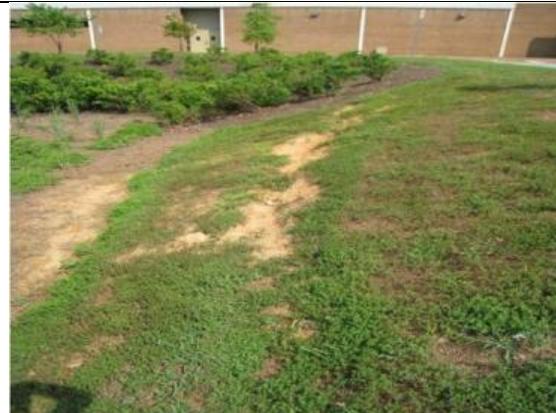
MINOR

There is minor side slope erosion occurring as a result of overland flow of water into the bioretention facility.

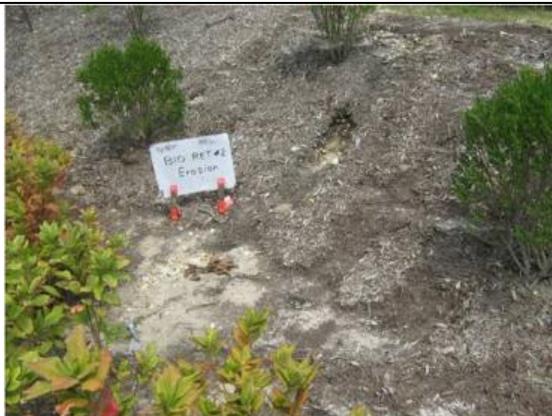
MODERATE

The side slopes in this bioretention are too steep which is causing moderate erosion.

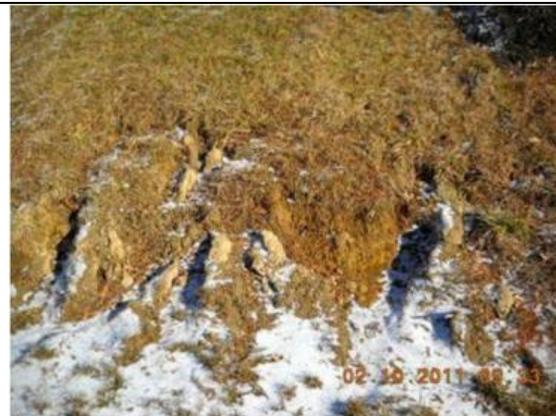
SEVERE

Severe side slope erosion is occurring.

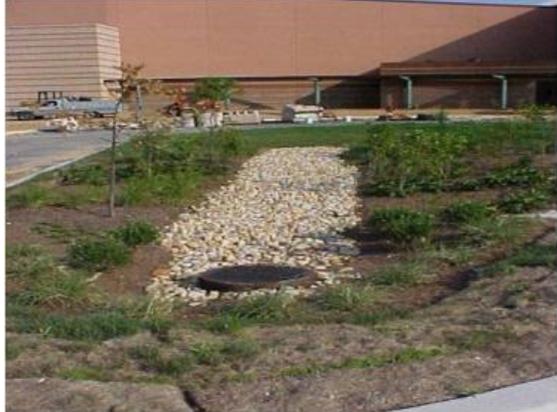
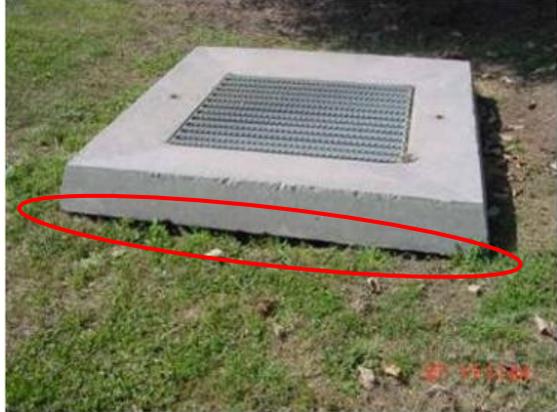
| PASS | MINOR |

Description: This indicator determines whether the facility is fully utilizing its design ponding capacity or is short-circuiting or not using full ponding depth for some other reason.

| PASS | MINOR |
|---|--|
| <p><i>Runoff spreads evenly through the entire facility and uses the entire ponding depth</i></p> | <p><i>Water leaves the facility through the gap at the bottom of the outlet structure before having a chance to fill up the basin.</i></p> |

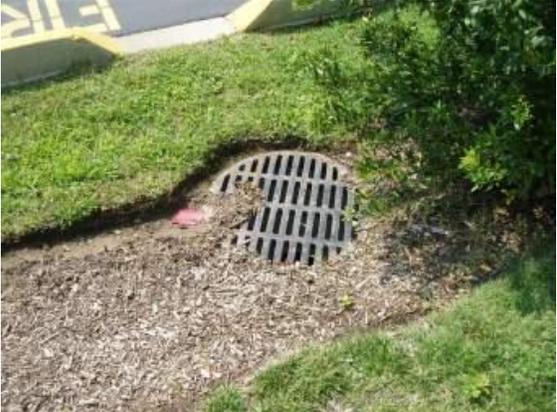
| PASS | MINOR |
|---|--|
| <p><i>Water that enters the facility leaves before infiltrating into the filter bed.</i></p> | <p><i>Water is unable to enter the facility due to incorrect elevations.</i></p> |

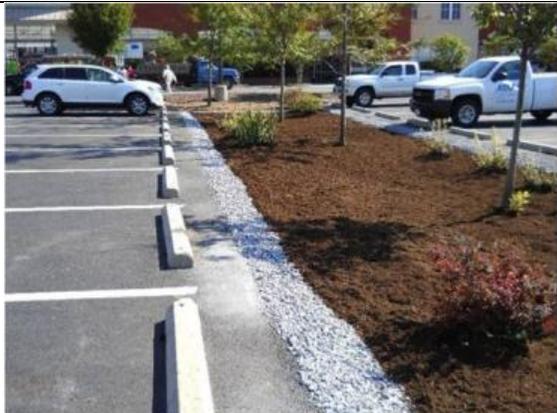
| PASS | MINOR |
|---|--|
| <i>Even, flat bed, with no evidence of sinking</i> | <i>Minor, localized sinking occurring</i> |

| | MAINTENANCE TRIGGER | TASK/INVESTIGATION |
|---|--|---|
| MINOR | 3-6" of localized bed sinking and/ or sediments observed in underdrain | Provide spot mulch and/or media refills, rake level |

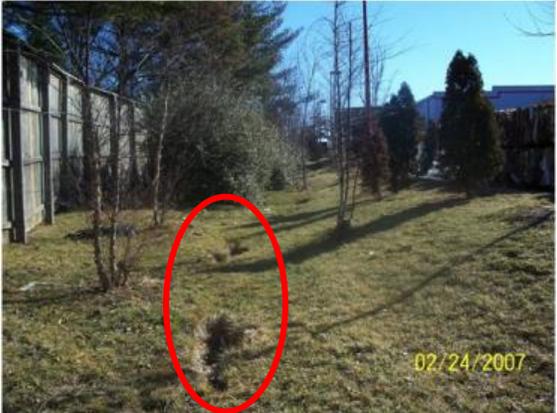
| PASS | MINOR |
|---|--|
| <i>Moderate, localized sinking occurring</i> | <i>Severe sinking occurring at overflow structure.</i> |

| | MAINTENANCE TRIGGER | TASK/INVESTIGATION |
|---|--|---|
| MODERATE | 6"-12" of localized bed sinking and/ or sediments observed in underdrain | Schedule second visit to fill in depressions with mulch and/or media, and replant |

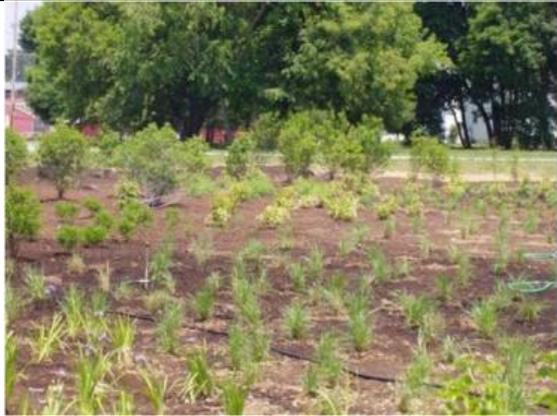
| PASS | MINOR |
|---|--|
| <i>Bioretention in good condition. Free of sediment and caking.</i> | <i>Caking occurring on the bioretention bed surface.</i> |

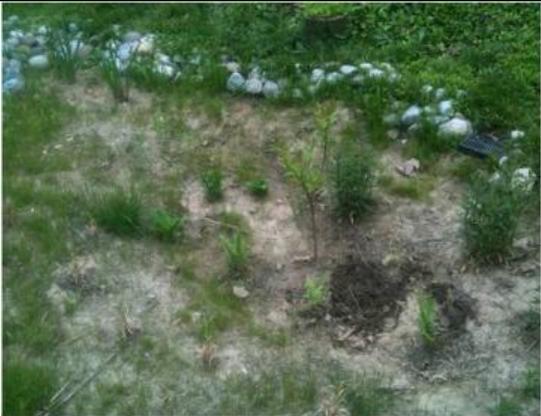
| PASS | MINOR |
|---|--|
| <i>Moderate sedimentation occurring.</i> | <i>Severe sedimentation occurring; bioretention most likely clogged</i> |

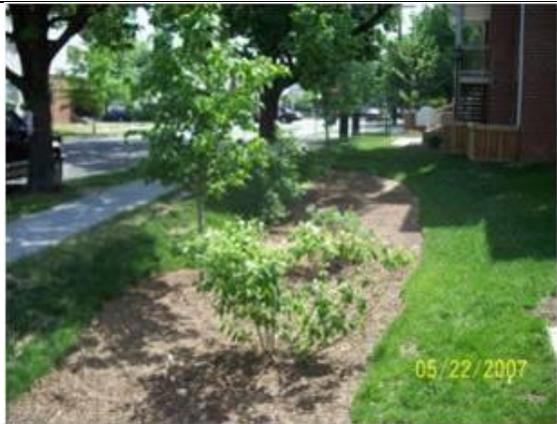
| PASS | MINOR |
|---|--|
| <p><i>Bioretention in good condition, no evidence of standing water.</i></p> | <p><i>Saturated soils indicate presence of standing water.</i></p> |

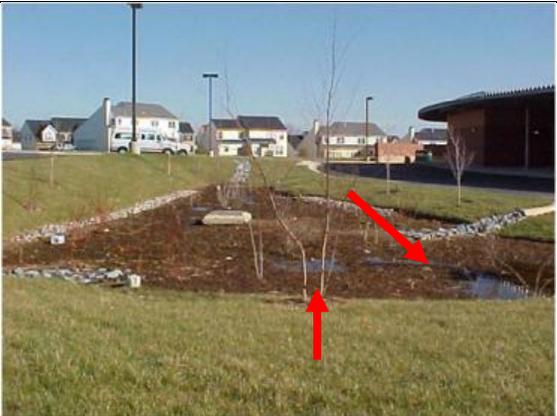
| PASS | MINOR |
|---|--|
| <p><i>1-3" of standing water after 72 hours</i></p> | <p><i>Standing water for more than 72 hours indicates facility failure</i></p> |

| | MAINTENANCE TRIGGER | TASK/INVESTIGATION |
|---|---|---|
| MODERATE | 1-3" of standing water after 48 hrs | Note as a potential risk for failure and schedule for more frequent inspection. |

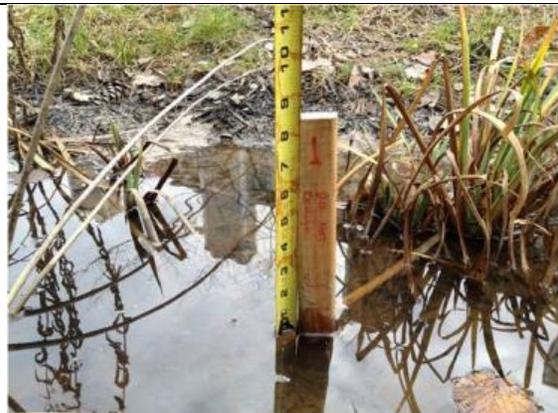
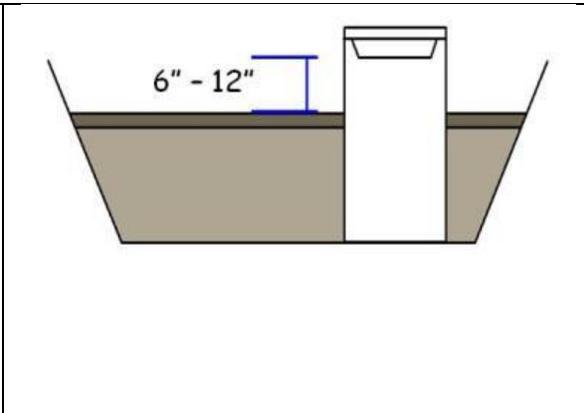
PASS

Ponding depth should be measured and compared to the original design. 6-12" is standard for most bioretention facilities (however ponding depth limits vary by state, check your state stormwater manual for guidance).

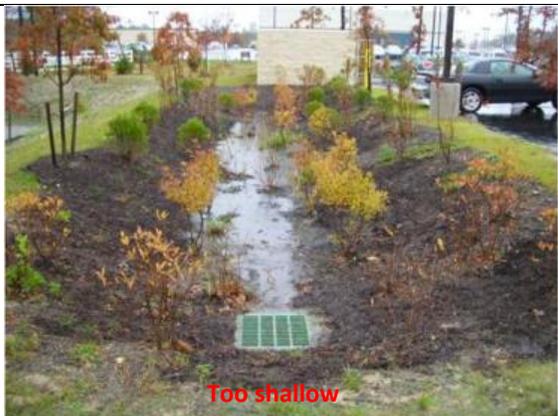
The ponding depth of this facility is significantly shallower than originally designed

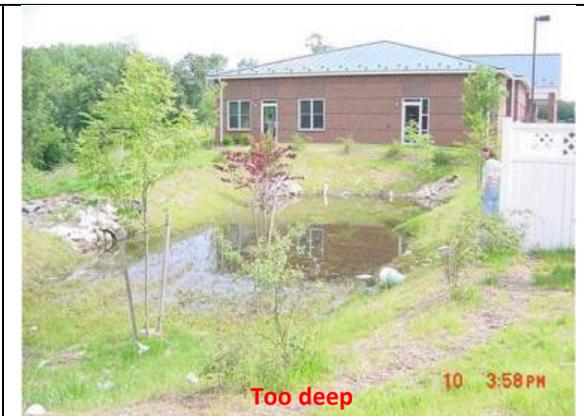
The ponding depth of this facility is significantly deeper than as originally designed

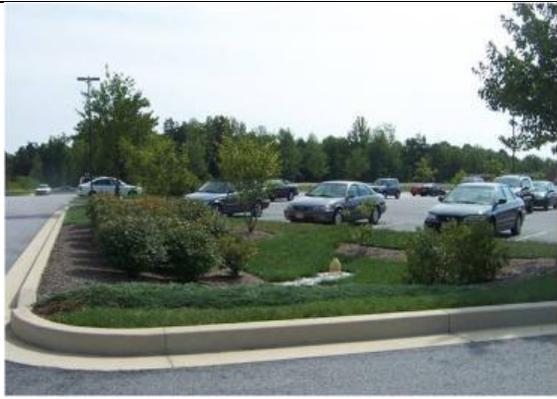
| PASS | MINOR |
|---|--|
| <p><i>Bioretention in good condition. Good mulch depth and/or ground cover.</i></p> | <p><i>Slight displacement occurring. Replace mulch and/or add ground cover.</i></p> |

Description: This indicator assesses the mulch depth and condition in the bioretention area which should be 2-3” deep unless the bed has significant ground cover (>75%). This visual indicator also assesses that there isn’t too much mulch in the facility which could lead to nutrient leaching or the loss of ponding depth.

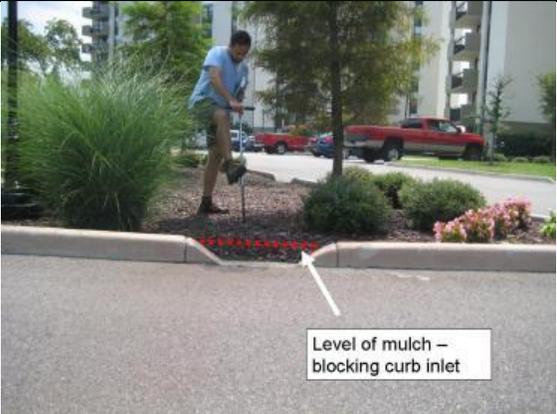
| PASS | MINOR |
|---|--|
| <p><i>Level of mulch is blocking curb inlet.</i></p> | <p><i>10” of mulch indicates maintenance crew not aware of function of facility.</i></p> |

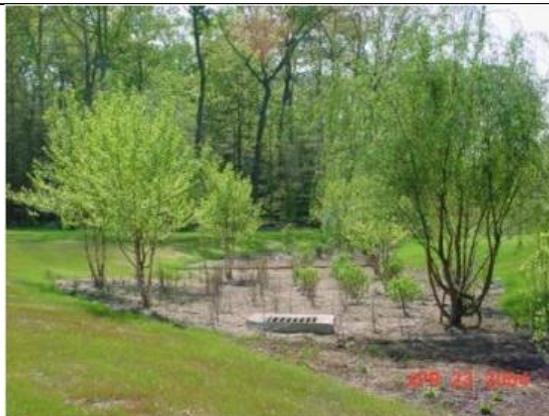
PASS

Bioretention in good condition, no evidence of trash.

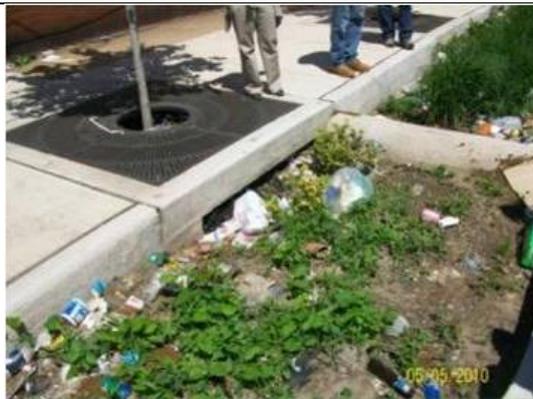
FAIL

Bioretention full of trash and needs to be cleaned out.

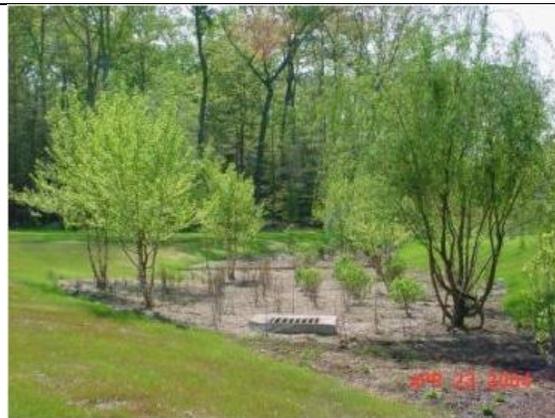
PASS

Bioretention in good condition – no bed erosion occurring.

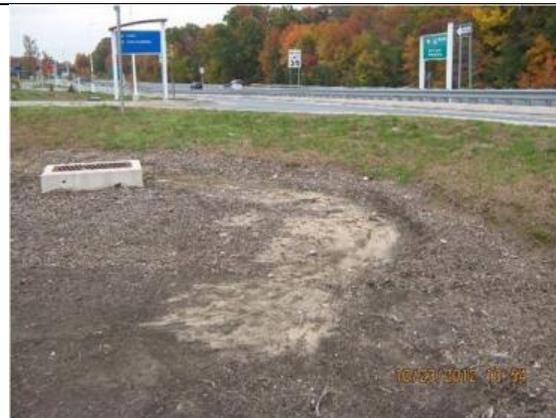
MINOR

Minor bed erosion or displacement occurring as a result of a larger storm event.

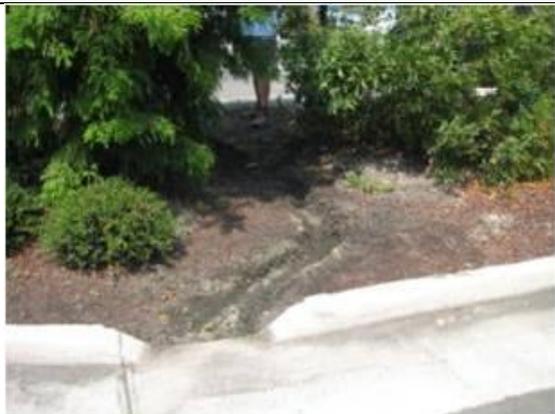
MODERATE

Significant bed erosion occurring leading to a preferential flow path.

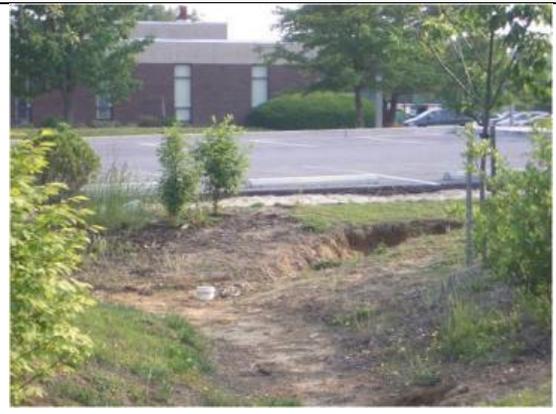
SEVERE

Severe bed erosion demonstrates that the bioretention may be undersized for the amount of volume it is receiving or pretreatment is needed

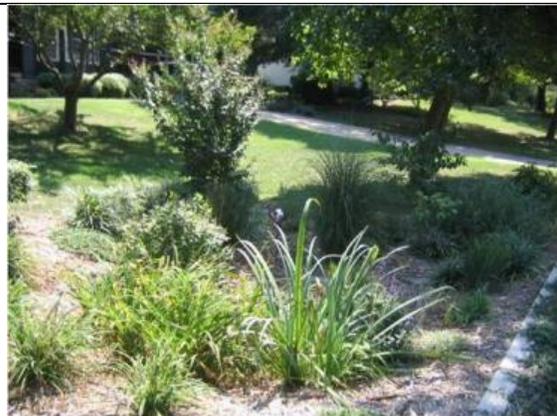
PASS

This bioretention has good vegetative cover.

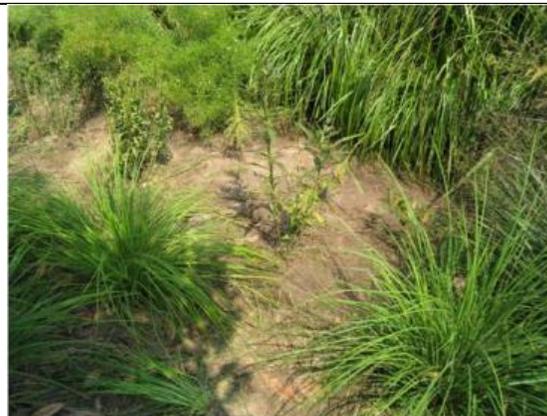
MINOR

This bioretention has a few bare spots and could use either spot planting or the addition of mulch.

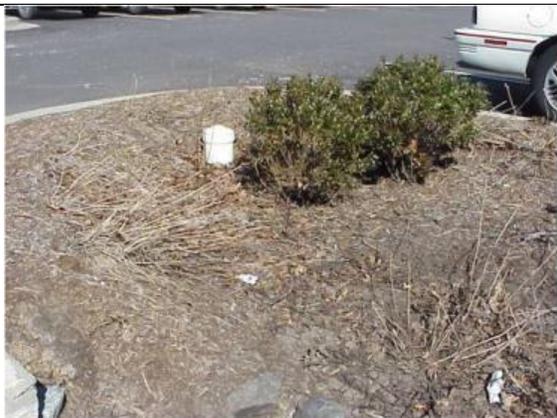
MODERATE

This bioretention has less than 75% vegetative coverage and is probably not functioning to its full potential

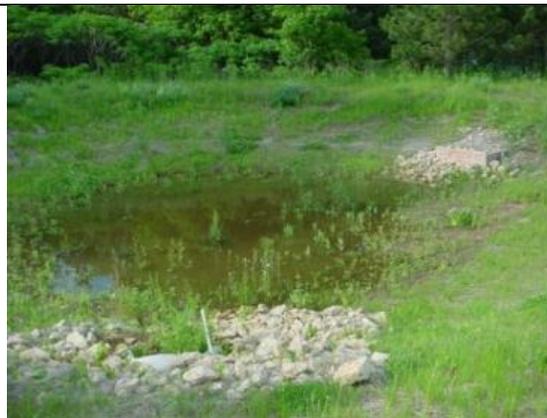
Vegetation is not growing in this bioretention as a result of it not being an environment conducive to vegetation or poor maintenance is occurring.

| | TRIGGER | TASK/INVESTIGATION |
|---|--|---|
| SEVERE | < 35% vegetative cover | Investigate cause of plant mortality. Based on findings, design a revised planting plan for facility. |

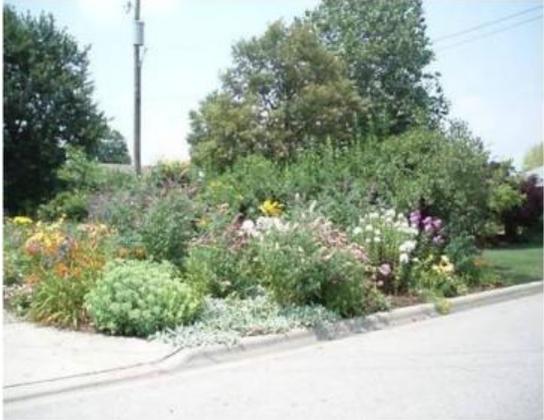
| PASS | MINOR |
|--|---|
| <i>Plants alive and in good condition</i> | <i>Spot weeding needed.</i> |

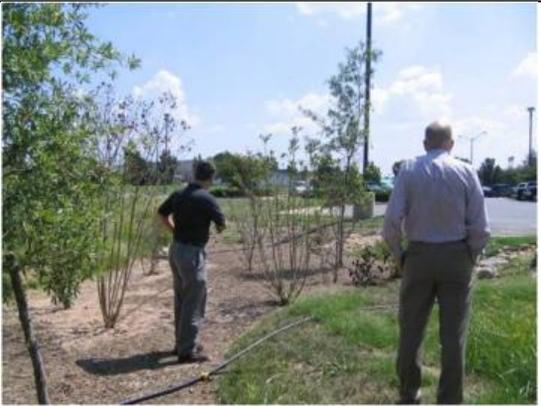
| PASS | MINOR |
|--|---|
| <i>Plants are dead or diseased in this bioretention facility.</i> | <i>This bioretention is overrun with invasive plants.</i> |

| | MAINTENANCE TRIGGER | TASK/INVESTIGATION |
|---|--|---|
| MODERATE | Some plants are dead or diseased or some invasive plants. | Determine the cause of plant mortality, replant |

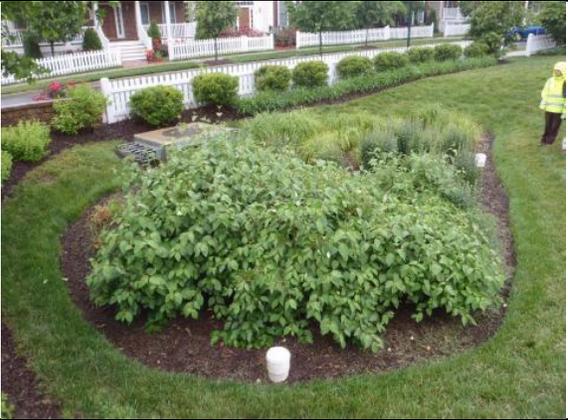
| PASS | MODERATE |
|---|--|
| <i>Well-maintained</i> | <i>Tree and/or shrubs overgrown in facility; removal is needed</i> |

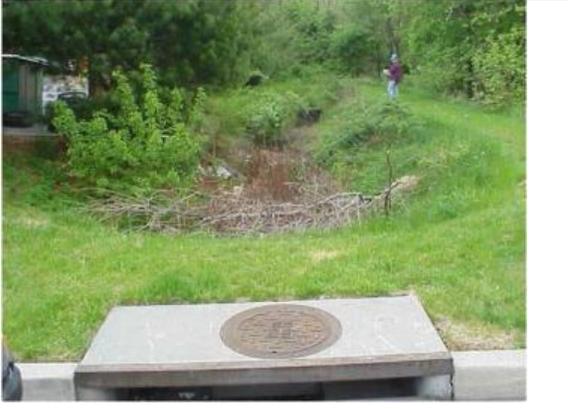
| PASS | MODERATE |
|---|--|
| <i>Major tree and/or shrub removal needed</i> | |

| | MAINTENANCE TRIGGER | TASK/INVESTIGATION |
|---|---|---|
| SEVERE | Needs major tree/shrub removal | Bush hog the entire facility and replace vegetation. |

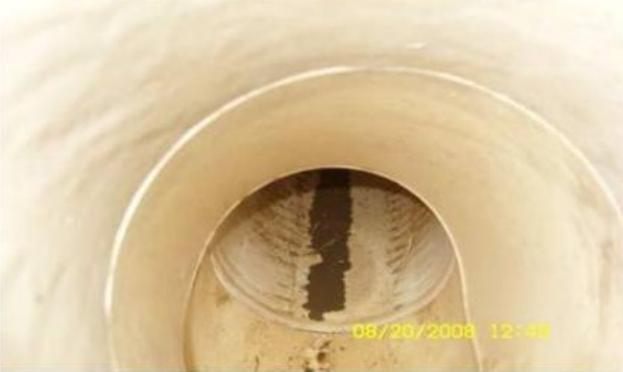
| PASS |

| <i>This underdrain is mainly free of sediment and debris.</i> |

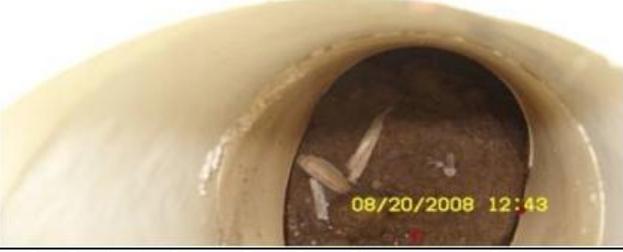
| SEVERE |

| <i>This underdrain is clogged with sediment. Further investigation is needed to determine the cause of the problem.</i> |

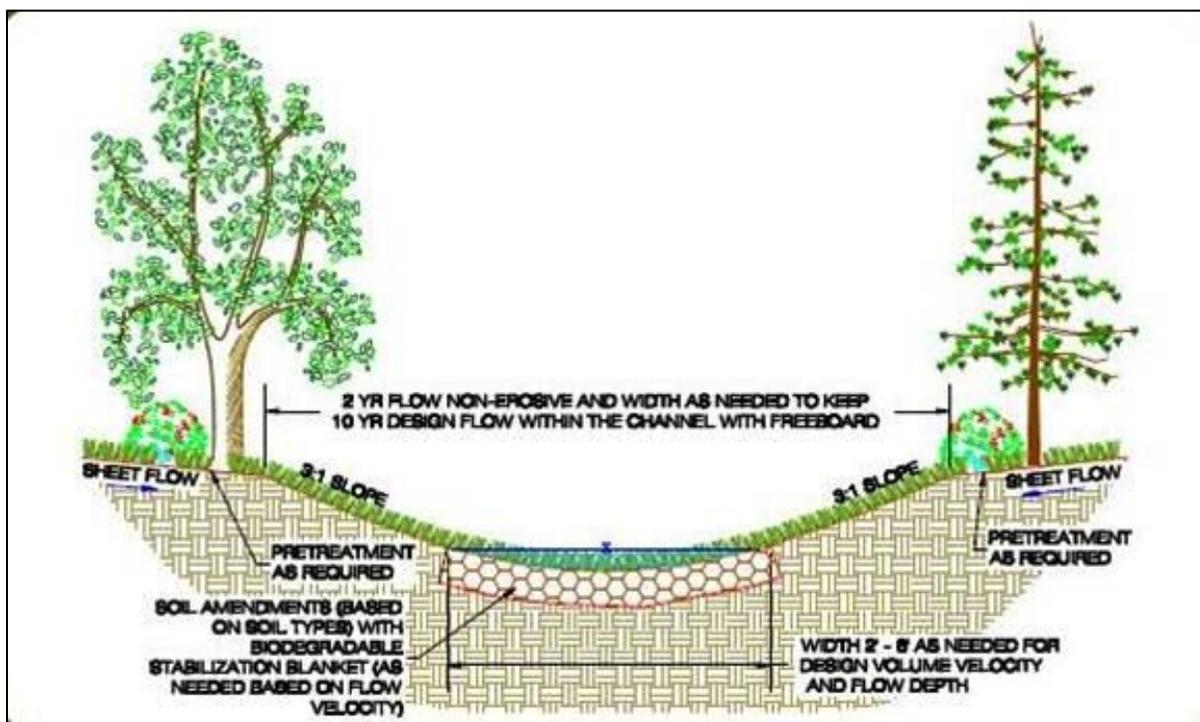
Figure B-1. Schematic of a Grass Channel (WVDEP, 2012)

Grass Channels are vegetated open channels that are used as part of the stormwater conveyance system. Grass channels reduce runoff and manage pollutants by slowing the flow of stormwater through the channel and providing the opportunity for infiltration. Figure B-1 shows a schematic of a grass channel (WVDEP). Figure B-2 is a photo of a Grass Channel in “good condition”.

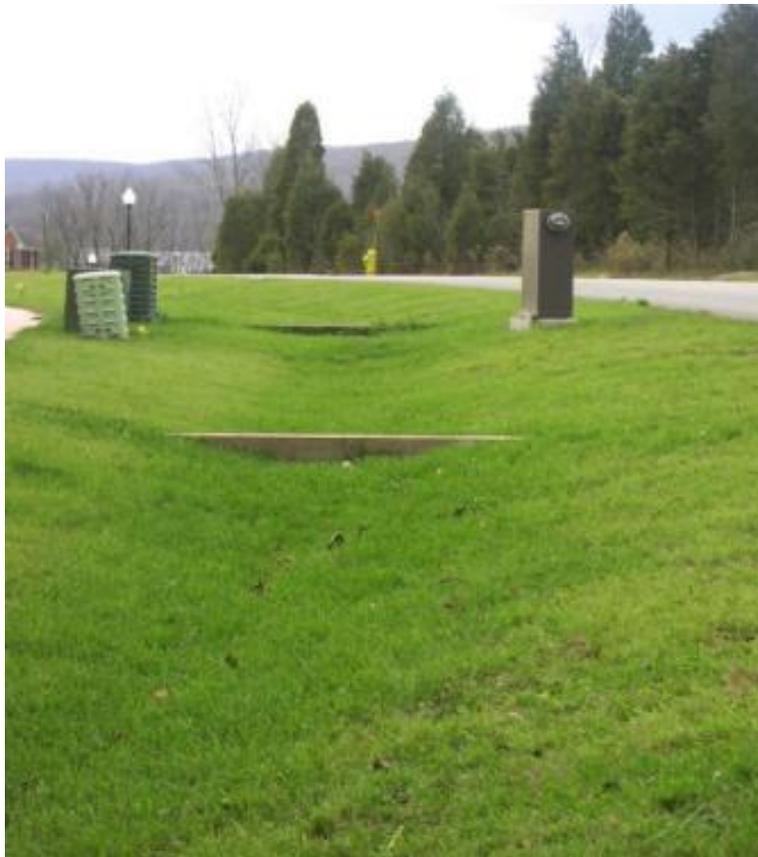
Figure B-2. Photo of a Grass Channel in Good Condition

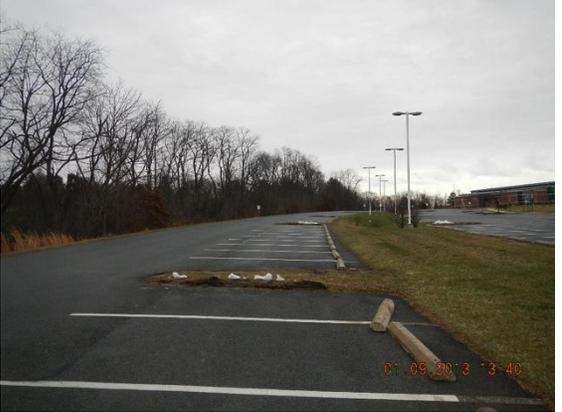
| # | INDICATOR | Description & Rationale | Picture |
|---|---|--|---|
| 1 | CDA Condition | Has the area or land cover in the CDA materially changed from original design assumptions? | <p><i>Check that the drainage area has not changed.</i></p> |

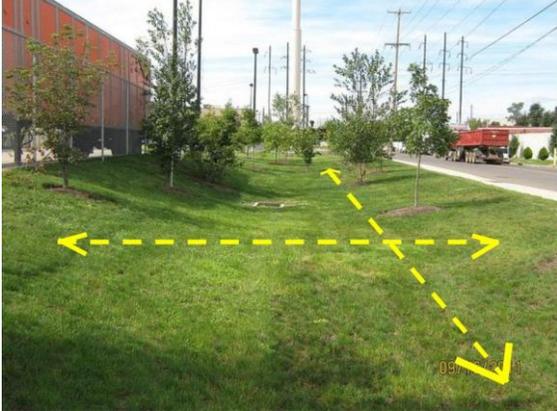
| # | INDICATOR | Description & Rationale | Picture |
|---|---|--|---|
| 2 | Surface Dimensions | Has the width and length of the swale remained the same? | <p><i>Check the size of the facility to see if it has been altered.</i></p> |

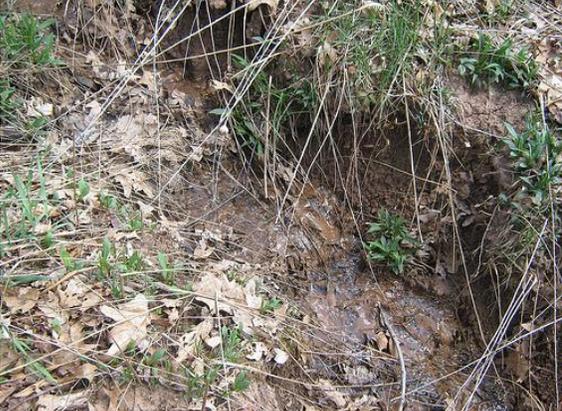
| # | INDICATOR | Description & Rationale | Picture |
|---|---|--|---|
| 3 | Flow Distribution | Are flows effectively distributed over the width of the swale or is their visual evidence of gully or channel formation? | <p><i>Uneven or concentrated flow causes erosion.</i></p> |

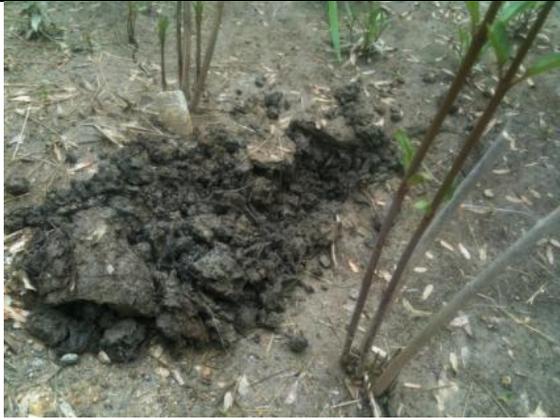
| <p>4</p> | <p>Sediment Deposition</p> | <p>Is there evidence of deposition or caking on the swale bed?</p> | <p><i>Severe caking on the channel bed.</i></p> |

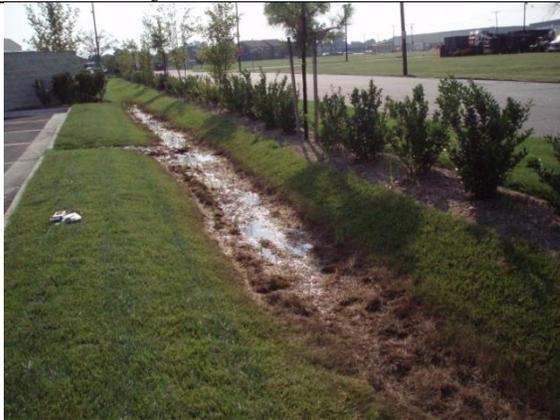
| <p>5</p> | <p>Standing Water or Saturated Soils</p> | <p>Any evidence of standing water, ponding, and/or saturation of surface soils w/in the swale 24 hours after storm?</p> | <p><i>Standing water in grass channel</i></p> |

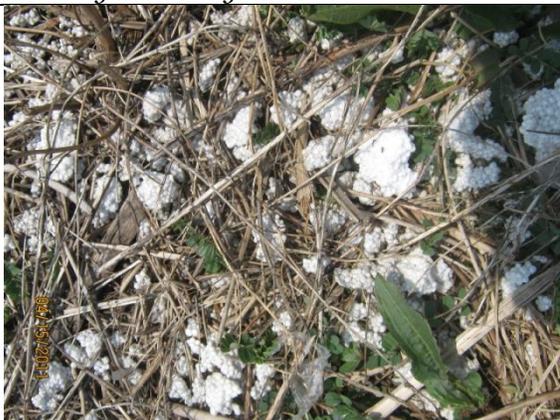
| <p>6</p> | <p>Trash/Dumping</p> | <p>Any evidence of excessive trash/dumping that affects aesthetics or interferes with basic mowing operation?</p> | <p><i>Styrofoam pieces in facility.</i></p> |

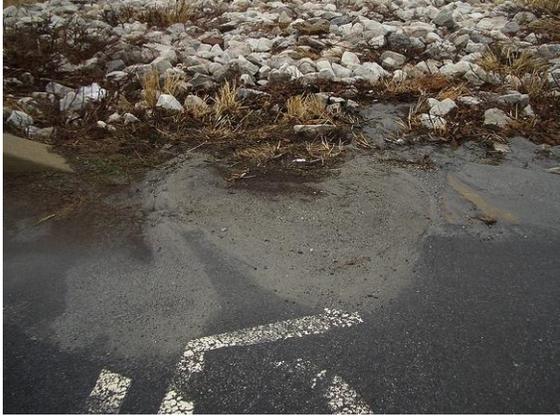
| <p>7</p> | <p>Inlet Obstruction¹</p> | <p>Any evidence that runoff cannot enter the top or lateral sides of the swale due to sediment/turf build up?</p> | |

Sediment accumulation at curb cut inflow.

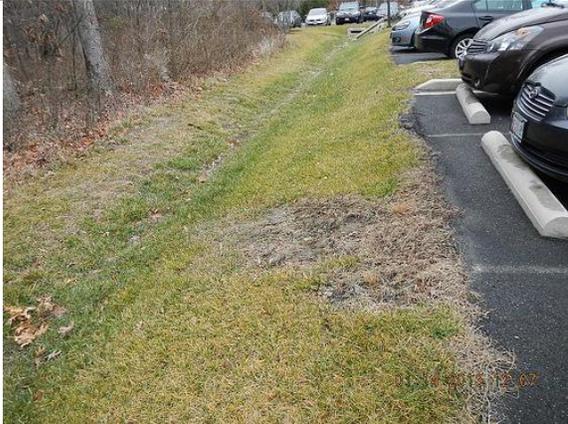
| <p>8</p> | <p>Inlet Erosion</p> | <p>Any erosion occurring at storm drain pipe or inflow to head of swale?</p> | |

Erosion at pavement edge where stormwater enters facility.

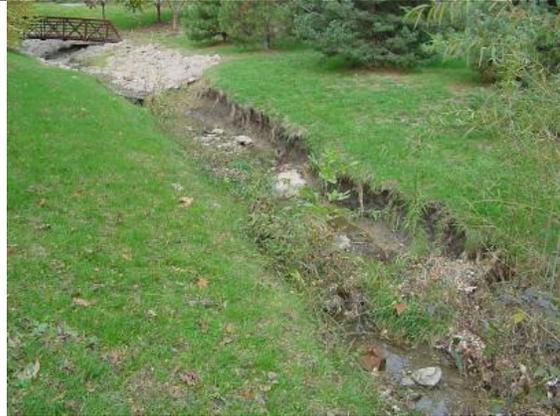
| <p>9</p> | <p>Swale Erosion</p> | <p>Any evidence of concentrated overland flow, and/or rill or gully erosion within the swale?</p> | |

Severe erosion in the bed of the channel.

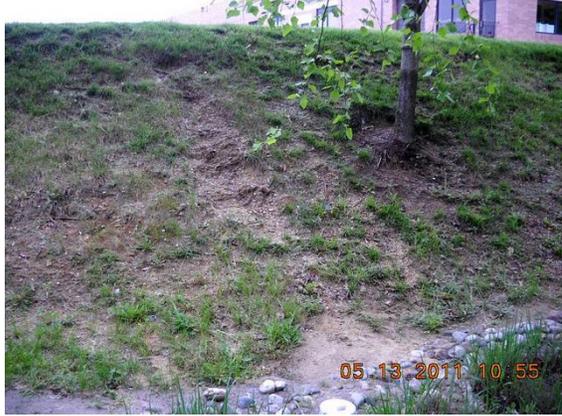
| <p>10</p> | <p>Side Slope Erosion</p> | <p>Do swale side slopes show evidence of gully or rill erosion?</p> | |

Erosion of side slope.

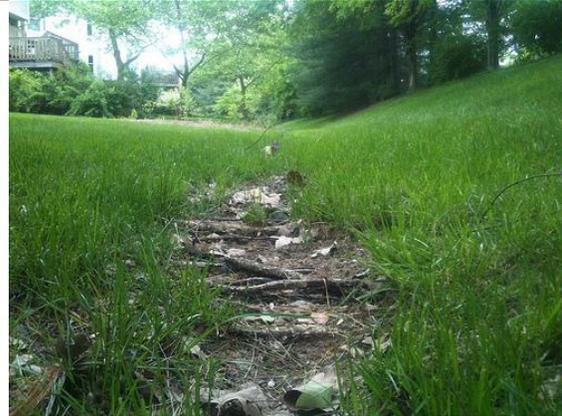
| <p>11</p> | <p>Vegetative Cover</p> | <p>Does the swale meet numerical targets for turf cover density?</p> | |

Bare area in bottom of facility.

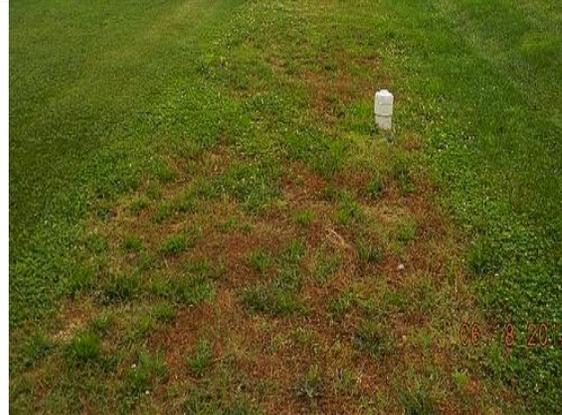
| <p>12</p> | <p>Vegetative Condition</p> | <p>Is the facility's vegetation in good condition, and is free of weeds?</p> | |

Grass in poor condition.

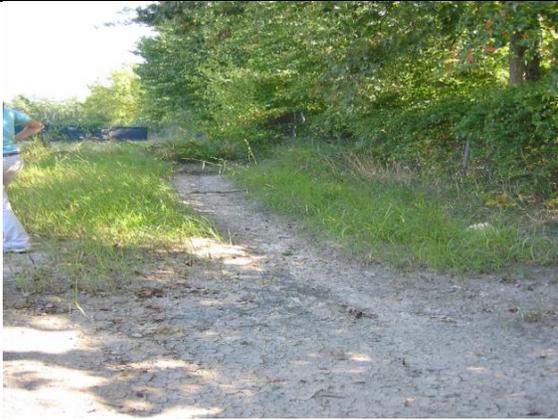
| <p>13</p> | <p>Check Dams (if applicable)</p> | <p>Are structures intact and providing intended design function? (i.e., no evidence of sediment buildup, hydraulic jump, down-gradient erosion or outflanking).</p> | <p><i>Sediment build-up behind check dams.</i></p> |

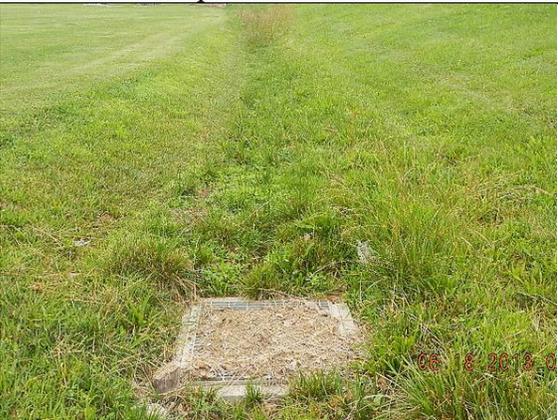
| <p>14</p> | <p>Outflow Obstruction</p> | <p>If swale discharges to a storm drain or catch basin, is there evidence of clogging, sediment deposition or erosion?</p> | <p><i>Inlet in a grass swale covered by debris.</i></p> |

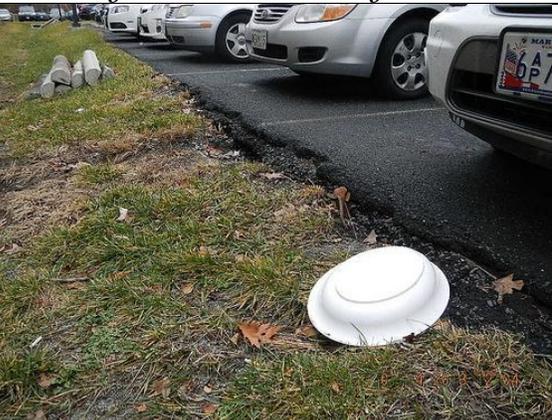
| <p>15</p> | <p>Pavement Edge Integrity</p> | <p>Any evidence that the pavement edge is deteriorating or that utilities or other infrastructure are at risk?</p> | <p><i>Erosion at pavement edge.</i></p> |

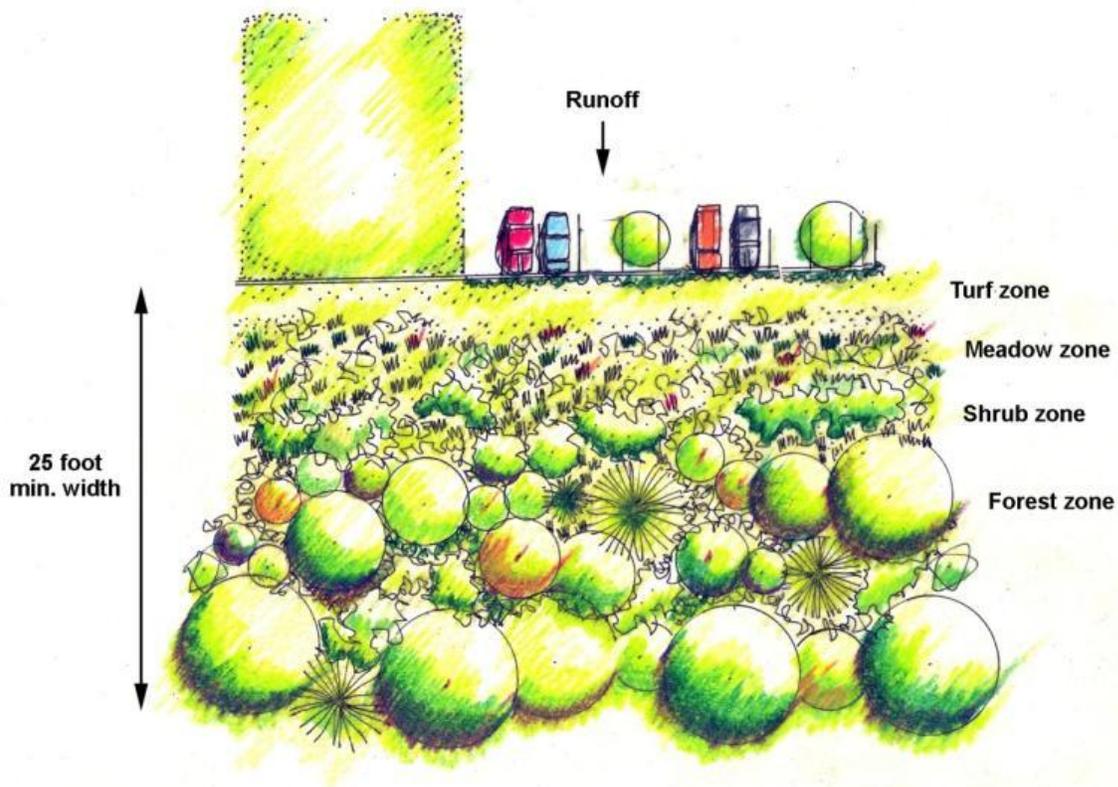
Figure B-3. Schematic of a Filter Strip

Vegetated Filter Strips are an engineered practice designed to receive runoff from adjacent land areas. Buffers are areas of conserved open space, conserved or restored riparian buffers. Figure B-3 is an overhead schematic of how runoff is treated by a filter strip or buffer. Figure B-4 is a photo of a filter strip in good condition.

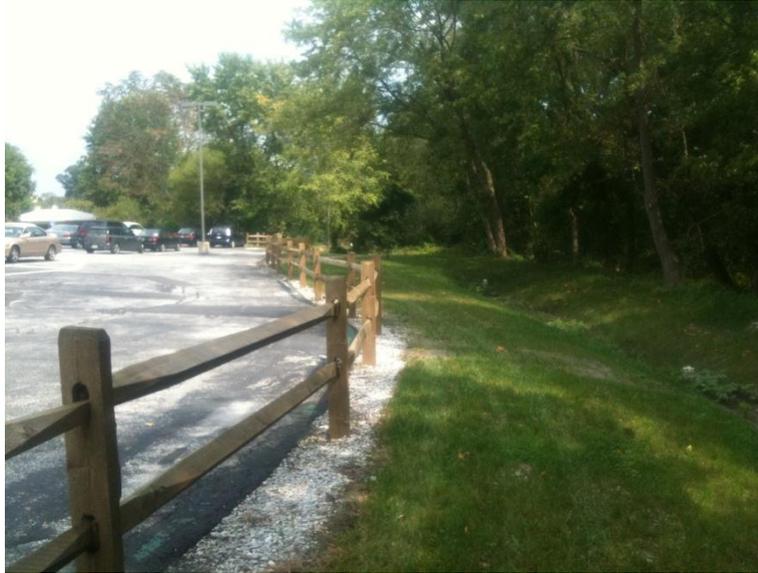
Figure B-4. Picture of a Filter Strip in Good Condition

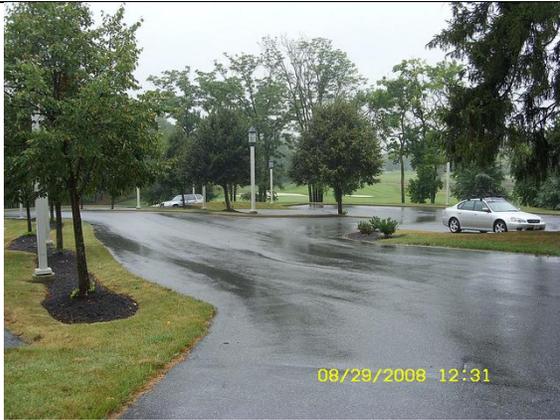
| Table B-4 | | | |
|---|---|--|---|
| 1 | CDA Condition | Has the area or land cover in the CDA materially changed from original design assumptions? | <p><i>A change in drainage area means a change in the volume of water entering a facility.</i></p> |

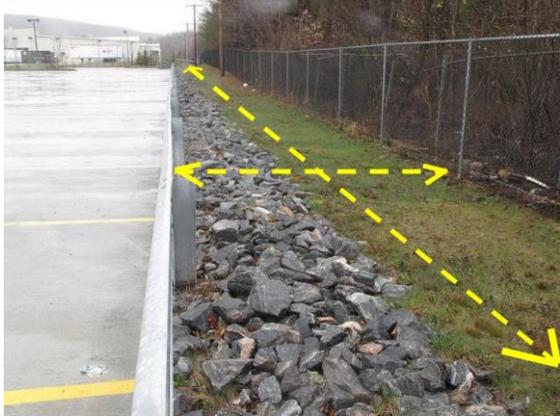
| Table B-4 | | | |
|---|---|--|---|
| 2 | Surface Dimensions | Has the width and length of the filter remained the same? | <p><i>Measure the length and width of the facility.</i></p> |

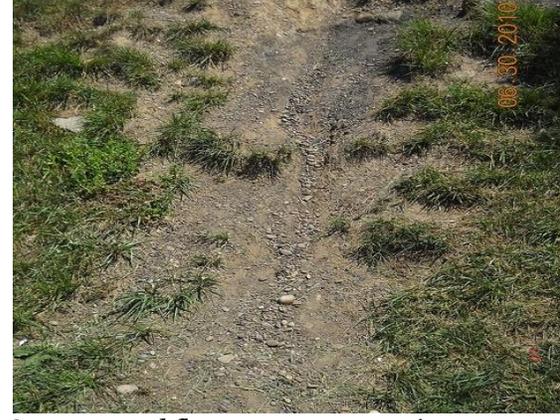
| Table B-4 | | | |
|---|---|--|---|
| 3 | Flow Distribution | Are flows effectively distributed over the filter width, or is there visual evidence of channel formation? | <p><i>Concentrated flows can cause erosion.</i></p> |

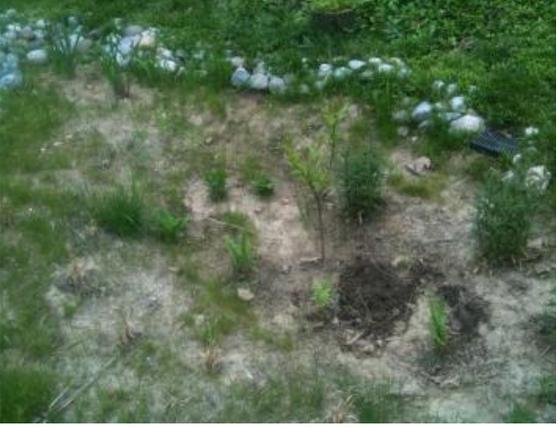
| <p>4</p> | <p>Sediment Deposition</p> | <p>Is there evidence of deposition or caking within the filter?</p> | <p><i>Sediment deposition in a facility.</i></p> |

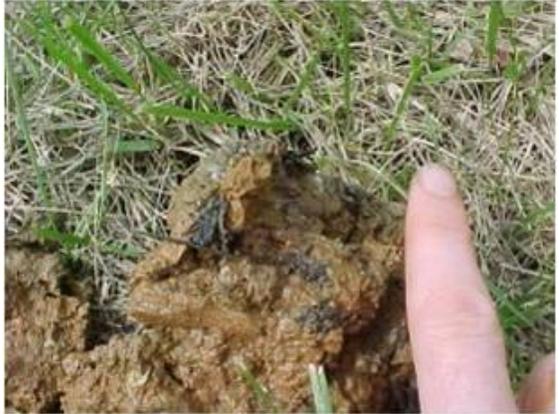
| <p>5</p> | <p>Saturated Soils</p> | <p>Any evidence of saturation of surface soil days after a storm?</p> | <p><i>Saturated soil days after a storm indicates poor drainage.</i></p> |

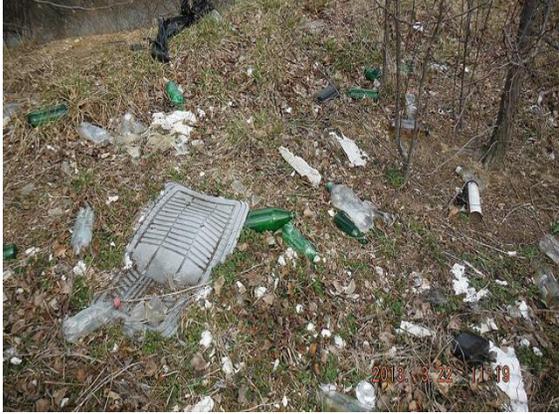
| <p>6</p> | <p>Trash/Dumping</p> | <p>Any evidence of excessive trash/dumping that affects aesthetics or interferes with basic mowing operations?</p> | <p><i>Litter in a facility.</i></p> |

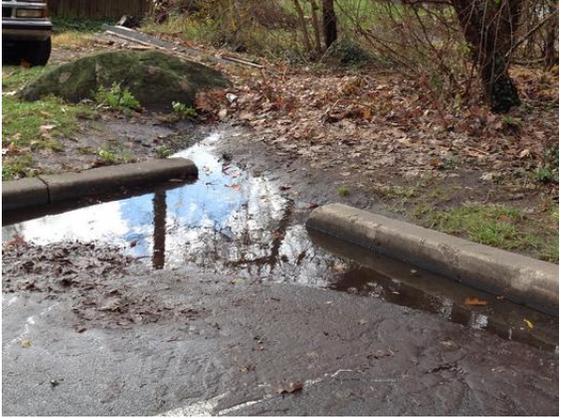
| <p>7</p> | <p>Inlet Obstruction</p> | <p>Any evidence that runoff cannot enter the filter strip or level spreader due to sediment/turf buildup?</p> | |

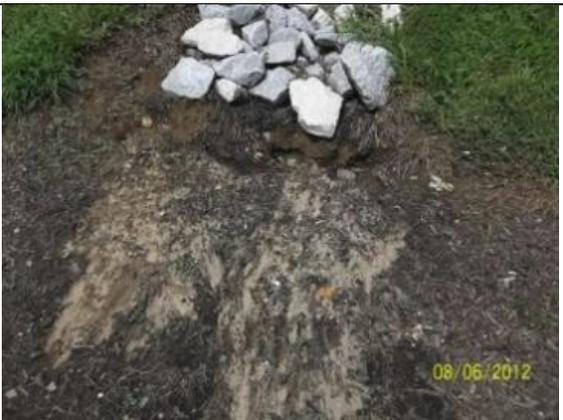
| <p>8</p> | <p>Inlet Erosion</p> | <p>Any evidence of outflanking or erosion below the level spreader?</p> | |

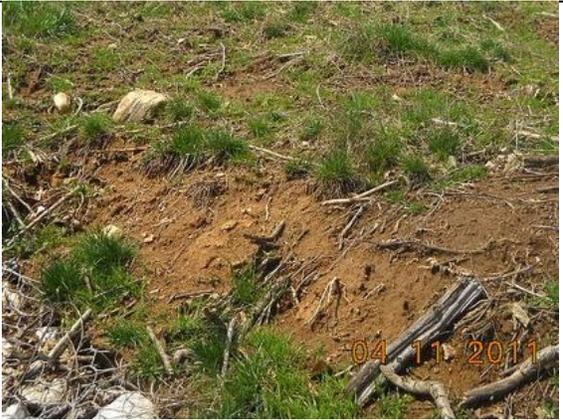
| <p>9</p> | <p>Filter Strip Erosion</p> | <p>Any evidence of concentrated overland flow, and/or rill or gully erosion along the filter strip gradient?</p> | |

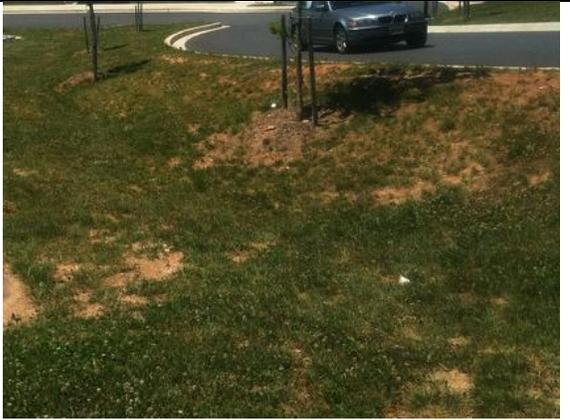
| <p>10</p> | <p>Vegetative Cover</p> | <p>Does the filter meet its numerical targets for turf or riparian cover?</p> | <p><i>Erosion can occur wherever there is a lack of vegetative cover.</i></p> |

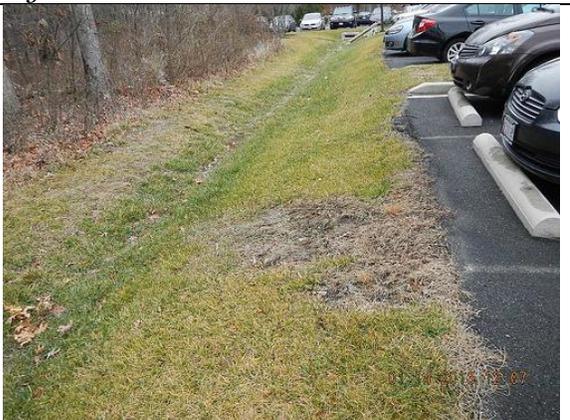
| <p>11</p> | <p>Vegetative Condition</p> | <p>Is the filter in good grass or meadow condition and weed- free?</p> | <p><i>Vegetation in poor condition.</i></p> |

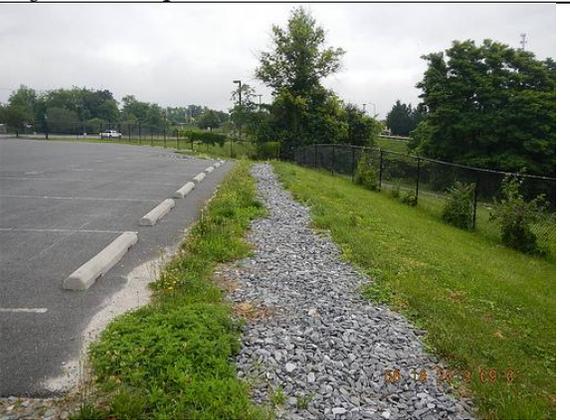
| <p>12</p> | <p>Level Spreaders</p> | <p>Is the structure intact and providing its intended design function? (i.e., no evidence of sediment buildup, hydraulic jump or out-flanking)</p> | <p><i>Accumulation of sediment along a level spreader. Vegetation is growing in the sediment at the edge of the pavement.</i></p> |
