CSN TECHNICAL BULLETIN

Bioretention Illustrated:

A Visual Guide for Constructing, Inspecting, Maintaining and Verifying the Bioretention Practice

Version 2.0
October 20, 2013

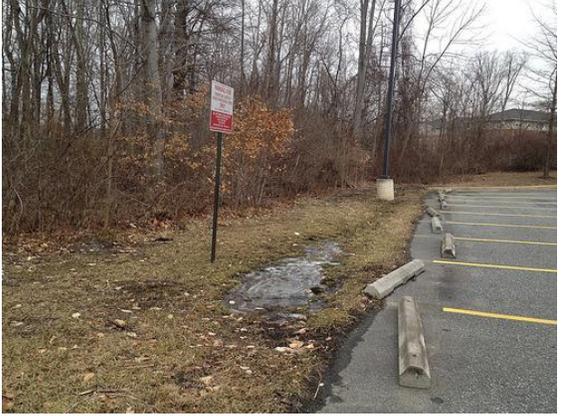
| 13 | Outflow Condition | Does the grass filter effectively transition to a stream buffer or forest? | <p><i>Stormwater first flows through the grass filter strip, and then a strip of forest before reaching the stream.</i></p> |

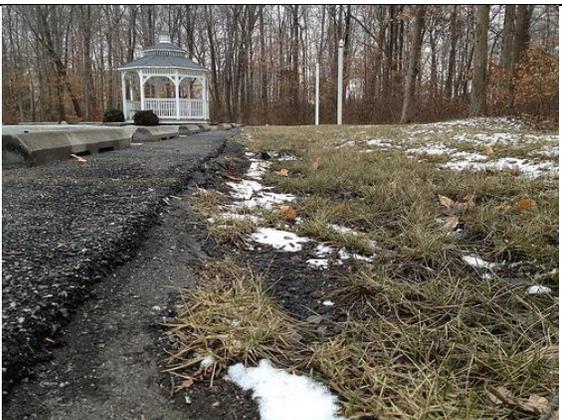
| 14 | Pavement Edge Integrity | Any evidence that the pavement edge is deteriorating or that utilities or other infrastructure are at risk? | <p><i>Erosion at pavement edge.</i></p> |

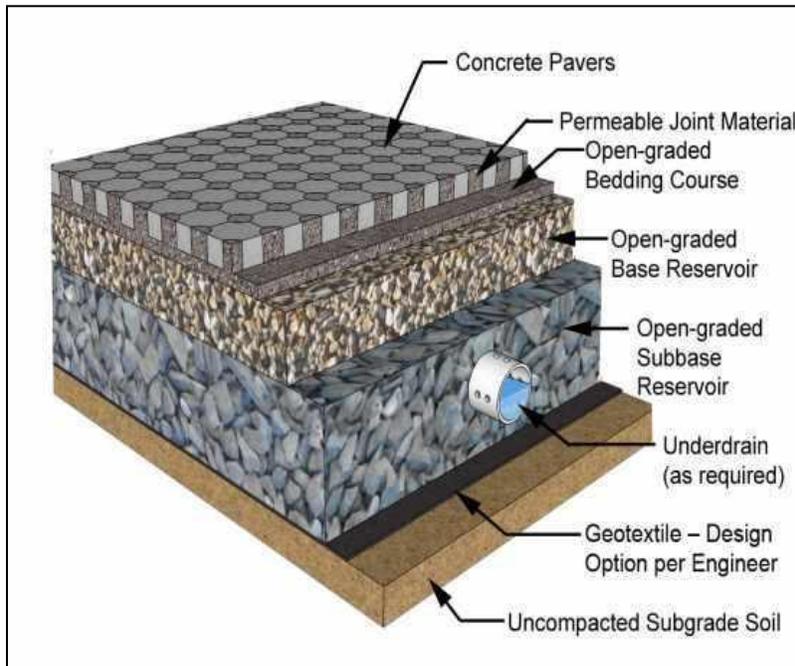
Figure B-5. Schematic Profile for Typical Permeable Pavement Section (Source: David Smith, ICPI).

Permeable pavements are alternative paving surfaces that allow stormwater runoff to filter through voids in the pavement surface into an underlying stone reservoir, where it is temporarily stored and/or infiltrated. Figure B-5 is a schematic of permeable pavement; Figure B-6 is a photo of permeable pavement in good condition.

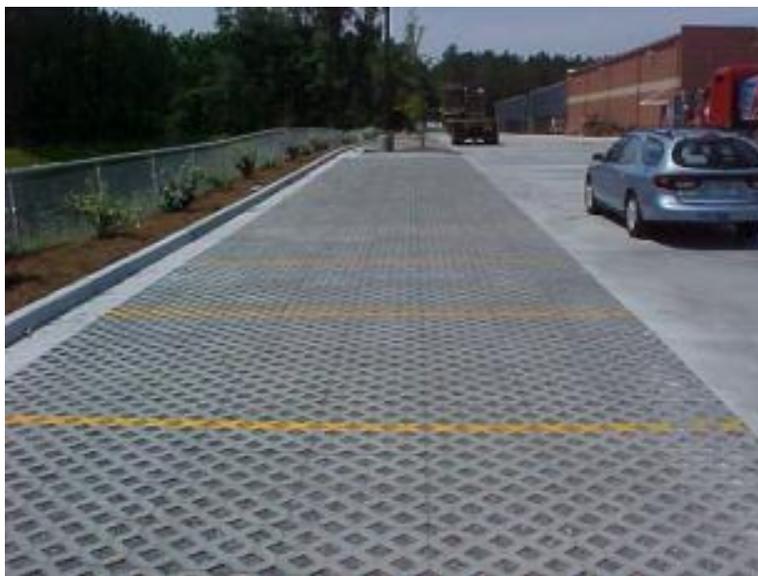
Figure B-6. Photo of Permeable Pavement in Good Condition

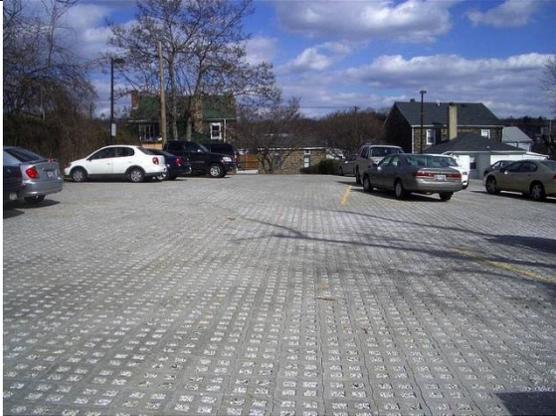
| Table B-7 Permeable Pavement Visual Indicators¹ | | | |
|---|---|--|---|
| 1 | CDA Run-on | For facilities with a CDA: stable, no exposed soils, no increase in CDA, no mulch or grass clippings discharging to pavement. Upgradient asphalt CDA should be free and clear of grit and fines. | <p><i>Contributing drainage area should be clear of materials that might clog porous/permeable pavement.</i></p> |

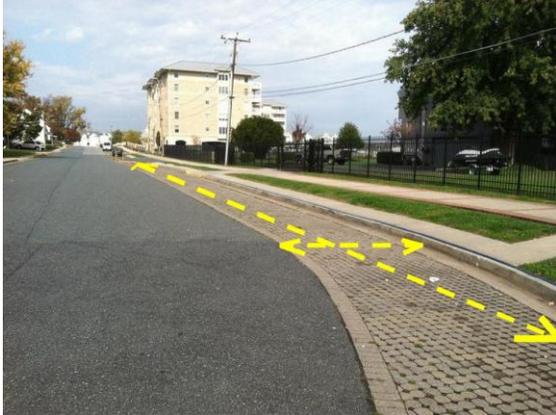
| Table B-7 Permeable Pavement Visual Indicators¹ | | | |
|---|---|--|---|
| 2 | Pavement Surface Area | Surface area of permeable pavement matches design, and has not been sealed or re-paved with non-permeable materials | <p><i>Compare the size of the facility with the plans.</i></p> |

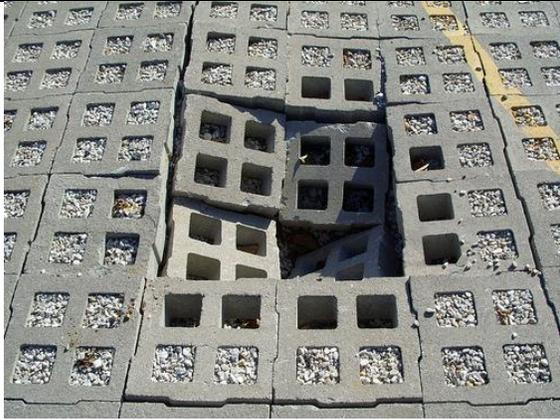
| <p>3</p> | <p>Pavement Sinking</p> | <p>Surface should match design slope, with no low points or depressions that promote concentrated inflow or indicate stone reservoir is settling</p> | <p><i>Sunken area in permeable pavement parking lot.</i></p> |

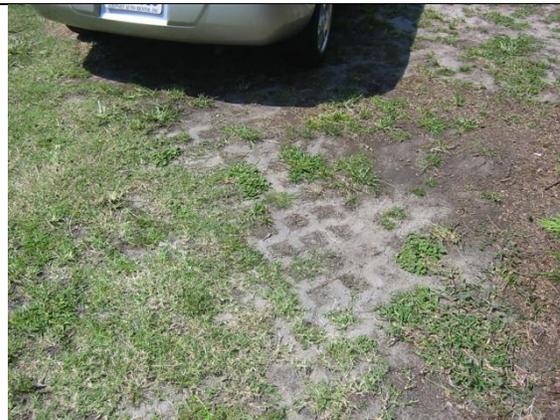
| <p>4</p> | <p>Surface Clogging</p> | <p>Evidence of sediment or vegetative accumulation on pavement surface or within pavement voids</p> | <p><i>Sediment clogging permeable pavement.</i></p> |

| Table B-9 Defining Numeric Triggers to Classify Permeable Pavement Maintenance Condition | | | | | |
|---|---|--|--|---|---|
| 4 | Surface or Void clogging | Surface is clean and voids are particle free | Enough particles are present to warrant increased vacuuming | Significant sediment accumulation on surface and or in pavement void spaces | Sediment particles prevent flow through pavement, or vegetative growth observed |

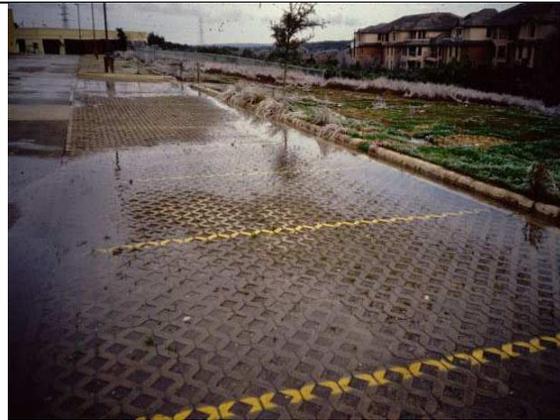
| <p>5</p> | <p>Standing Water</p> | <p>Evidence that stormwater is not getting thru the pavement in all or part of the facility</p> | <p><i>There should be no standing water on permeable pavement after a rain event.</i></p> |

| Table B-9 Defining Numeric Triggers to Classify Permeable Pavement Maintenance Condition | | | | | |
|---|---|--|--|---|---|
| 5 | Standing Water | None | Isolated surface moisture | Ponding on up to 10% of surface | Ponding on more than 10% of surface |

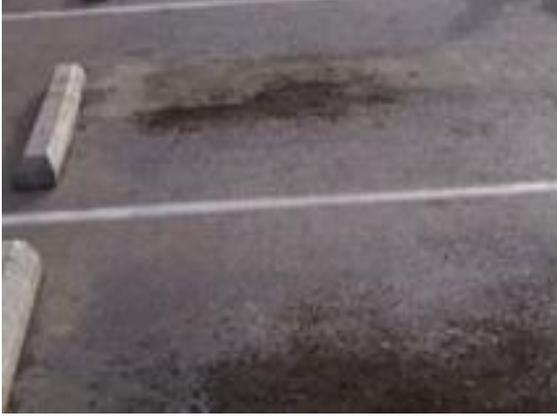
| <p>6</p> | <p>Pavement Staining</p> | <p>Evidence of hydrocarbons or other pavement staining that could impair performance</p> | <p><i>Oil stains on permeable pavement.</i></p> |

| Table B-9 Defining Numeric Triggers to Classify Permeable Pavement Maintenance Condition | | | | | |
|---|---|--|--|---|---|
| 6 | Surface Staining | No Staining | Isolated water stains | Stains on up to 10% of surface | Stains on more than 10% of surface |

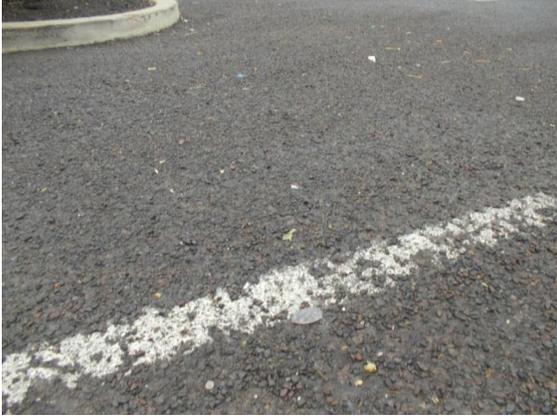
| <p>7</p> | <p>Surface Deterioration</p> | <p>Evidence of spalling, cracking or breakup of pavement or paver blocks, in all or part of the facility</p> | <p><i>Loose gravel on permeable pavement.</i></p> |

| Table B-9 Defining Numeric Triggers to Classify Permeable Pavement Maintenance Condition | | | | | |
|---|---|--|--|---|---|
| 7 | Surface Deterioration | Good Condition | Deterioration of less than 5% of surface, cracks less than half inch | Problems found on less than 10% of surface, cracks deeper than 1/2 in | Problems found on more than 10% of surface. Major cracking/separation |

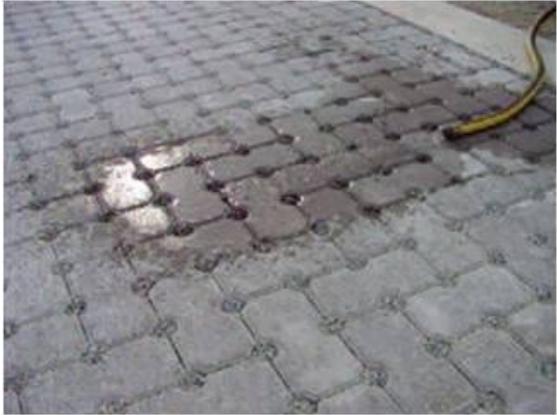
| <p>8</p> | <p>Flow Test</p> | <p>Rapid test to determine whether pavement flow thru is compromised in “at risk” sections of facility</p> | <p><i>A flow test checks for clogging on the surface.</i></p> |

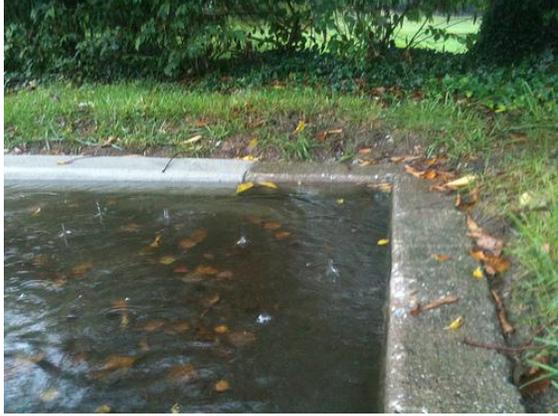
| <p>9</p> | <p>Overflow Obstruction</p> | <p>Evidence that runoff from larger storms safely conveys from the facility</p> | <p><i>Flooding due to obstruction of overflow.</i></p> |

| Table B-9 Defining Numeric Triggers to Classify Permeable Pavement Maintenance Condition | | | | | |
|---|---|--|--|---|---|
| 9 | Overflow Condition | Good | Minor problems | Partially obstructed | Totally obstructed |

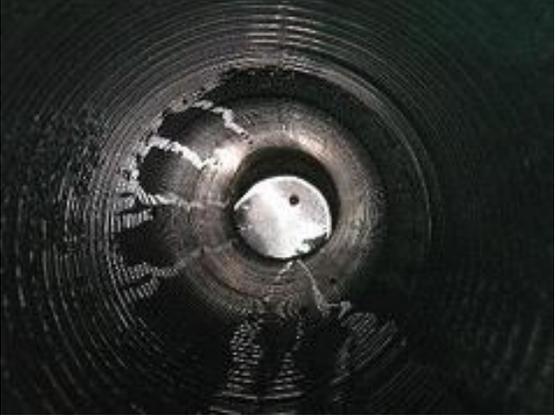
| <p>10</p> | <p>Underdrain or Observation Well</p> | <p>Evidence of sediment or blockage or poor stormwater clearance after a storm</p> | <p><i>Underdrain cleanouts and observation wells should be clear of water after a rain event.</i></p> |

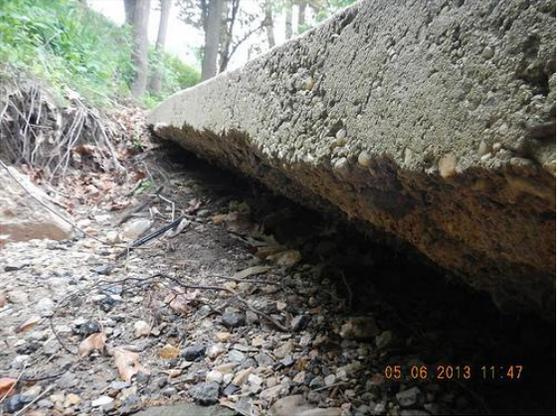
| <p>11</p> | <p>Structural Integrity</p> | <p>Evidence of water-based damage to pavement edge, curbs, sidewalks or infrastructure</p> | <p><i>Erosion at pavement edge.</i></p> |

| Table B-9 Defining Numeric Triggers to Classify Permeable Pavement Maintenance Condition | | | | | |
|---|---|--|--|---|---|
| 11 | Structural Integrity | Good | Some water entry where it is not desired | Early signs of failure | Failure |

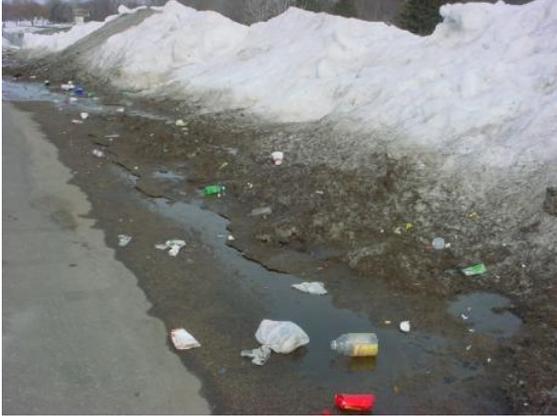
| 12 | Parking Lot Management Practices | Good practices on parking lot and adjacent CDA (no over-size vehicles, no outdoor material storage, leaky dumpsters, proper winter maintenance (no sand or salt), healthy landscaping, leaking dumpsters, etc) | |

Sediment accumulation after snow removal.

| Table B-9 Defining Numeric Triggers to Classify Permeable Pavement Maintenance Condition | | | | | |
|---|---|--|--|---|---|
| 12 | Parking Management Practice | No Risk | Minor Risk for Clogging | Strong Risk of Clogging | Practices causing failure |

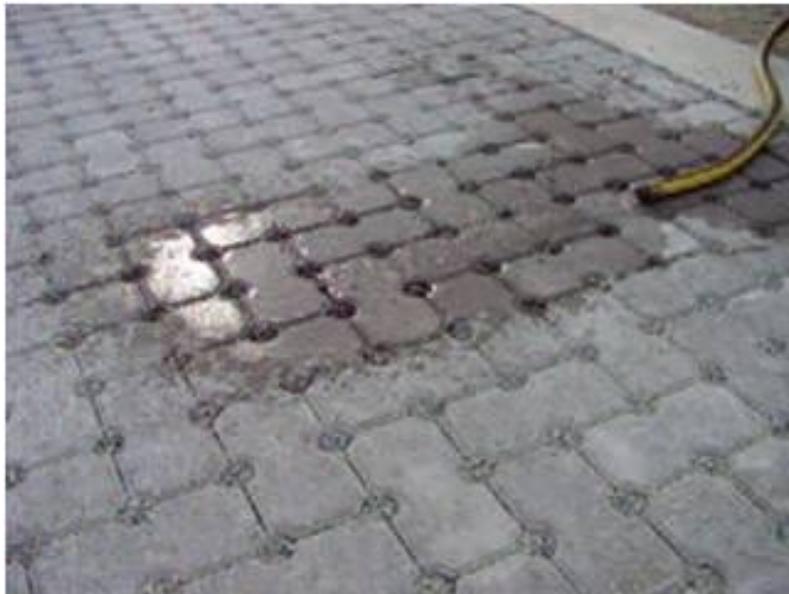
A simple flow through test should be conducted in at-risk pavement sections

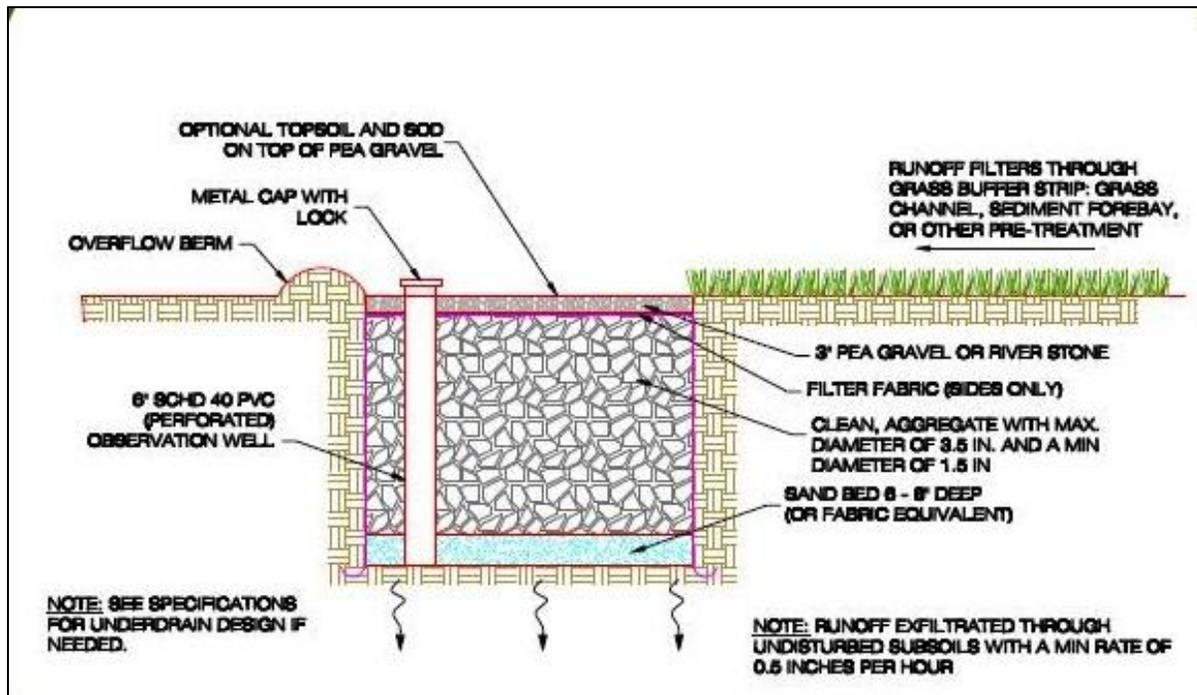
Figure B-7. Schematic of Infiltration Practice

Infiltration practices capture and temporarily store runoff before allowing it to infiltrate into the underlying soil over a period of approximately two days. Figure B-7 is a schematic of an infiltration practice; Figure B-8 is a picture of an infiltration basin in good condition.

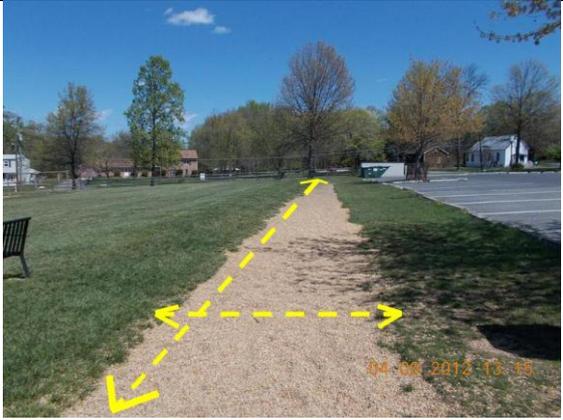
| Table B-10 Visual Indicators for Infiltration Practices | | | |
|--|---|--|---|
| 1 | Surface Area | Surface dimensions agree with design | <p><i>Check the dimensions of the facility.</i></p> |

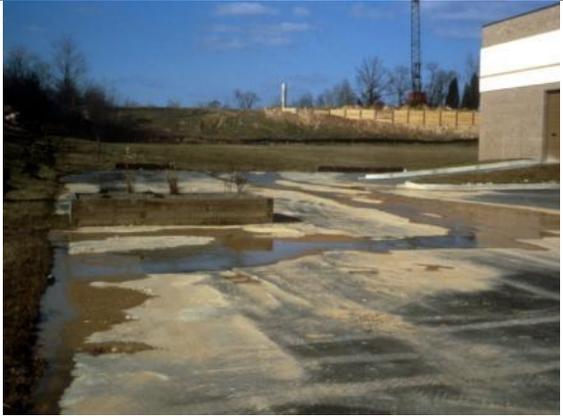
| Table B-10 Visual Indicators for Infiltration Practices | | | |
|--|---|--|---|
| 2 | CDA Condition | Stable, no exposed soils, no increase in CDA from design assumptions | <p><i>The contributing drainage area should be clear of sediment and debris that will compromise the facility.</i></p> |

| # | INDICATOR | PASS | MINOR | MODERATE | SEVERE |
|---|---|---|--|---|---|
| 2 | CDA Condition | CDA in good condition | CDA has some isolated spots that generate sediment | CDA in fair to poor condition, and has a risk for sediment, grass clipping or much delivery | Exposed soils or erosion in CDA is clearly delivering sediment to practice |

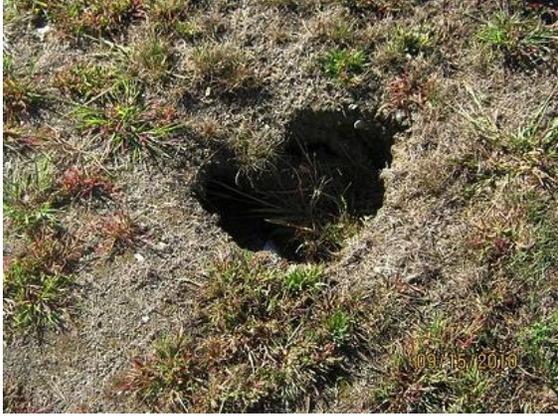
| <p>3</p> | <p>Surface Sinking</p> | <p>Surface is not flat, or has low points or depressions, particularly near perimeter edges</p> | <p><i>Sinkhole in a facility.</i></p> |

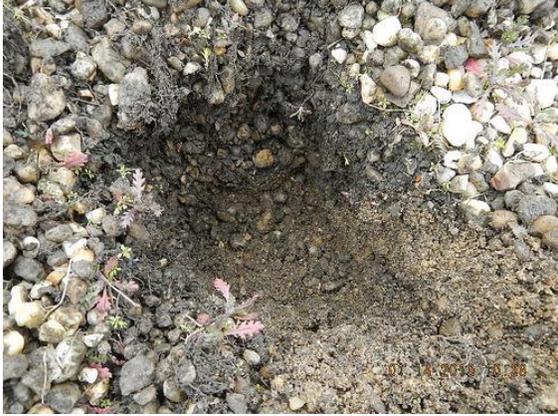
| <p>4</p> | <p>Sedimentation or Plant Growth</p> | <p>Sediment or plant growth observed on the surface of the infiltration bed</p> | <p><i>Test pit showing sediment accumulation in gravel layer.</i></p> |

| # | INDICATOR | PASS | MINOR | MODERATE | SEVERE |
|---|---|---|--|---|---|
| 4 | Sediment/ Plant Growth | No deposits or plant growth | Minor deposits of particles on surface | Sediment and organics found to a depth of 6 inches in practice | Sediment particles prevent flow into or distribution across practice and vegetative growth observed |

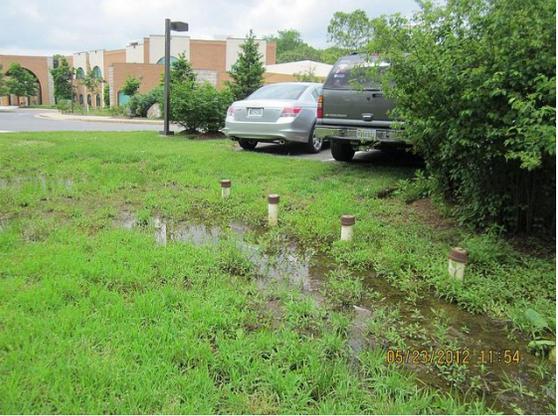
| <p>5</p> | <p>Standing Water</p> | <p>Standing water on surface within 6 hours after a storm</p> | <p><i>Standing water should infiltrate into a facility immediately.</i></p> |

| # | INDICATOR | PASS | MINOR | MODERATE | SEVERE |
|---|---|---|--|---|---|
| 5 | Standing Water | None | Some moisture in first foot | Ponding on up to 10% of surface 6 hours after storm | Ponding on up to 10% of surface 12 hours after storm |

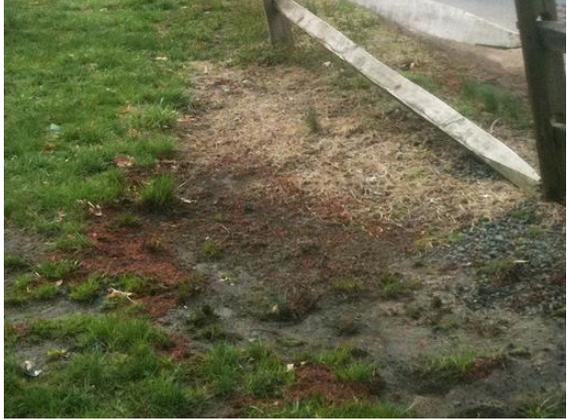
| <p>6</p> | <p>Surface Staining</p> | <p>Evidence of hydrocarbon or other staining on surface</p> | <p><i>Stain on surface of a facility.</i></p> |

| # | INDICATOR | PASS | MINOR | MODERATE | SEVERE |
|---|---|---|--|---|---|
| 6 | Surface Staining | None | Isolated minor stains | Stains on up to 10% surface | Stains on more than 10% of surface |

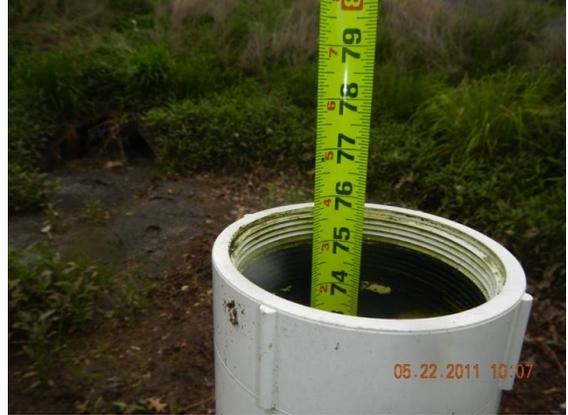
| <p>7</p> | <p>Poor Observation Well Measurement</p> | <p>Standing water observed in observation well (OW) after 72 hours of a storm</p> | <p><i>Water inside an observation well might indicate poor drainage from a facility.</i></p> |

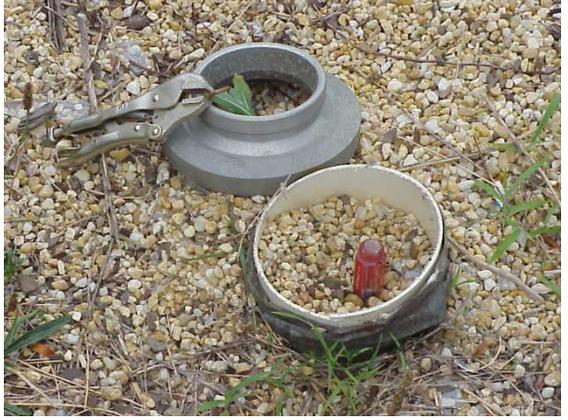
| <p>8</p> | <p>Observation Well & Cap</p> | <p>Well and cap are not intact, cannot be opened or allow for measurement of water clearance rate</p> | <p><i>Damaged observation well.</i></p> |

| # | INDICATOR | PASS | MINOR | MODERATE | SEVERE |
|---|---|---|--|---|---|
| 8 | Observation Well & Cap | Intact, clean and dry | Minor deposits of sediment or gravel (< 3 in) | 3 to 6 inches of sediment or gravel in the well | OW is broken, missing, obstructed or not accessible |

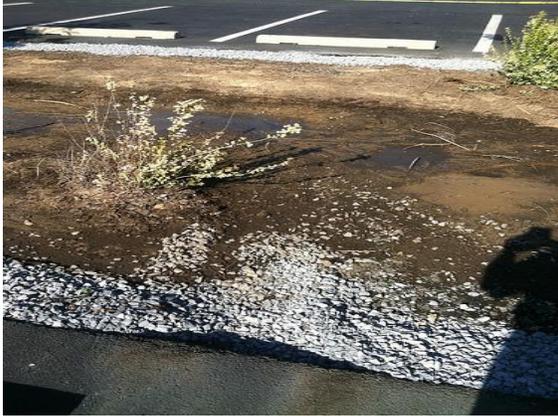
| <p>9</p> | <p>Pretreatment Condition</p> | <p>Pretreatment not in working condition and has insufficient capacity to trap sediment/debris</p> | <p><i>Strong flows are dispersing the stone and eroding the pretreatment.</i></p> |

| # | INDICATOR | PASS | MINOR | MODERATE | SEVERE |
|---|---|---|--|---|---|
| 9 | Pretreatment Condition | Good | Minor sediment accumulation to remove. | More than 50% of pretreatment capacity lost, need cleanout or renovation | Pretreatment is missing, or no longer functioning to trap sediment |

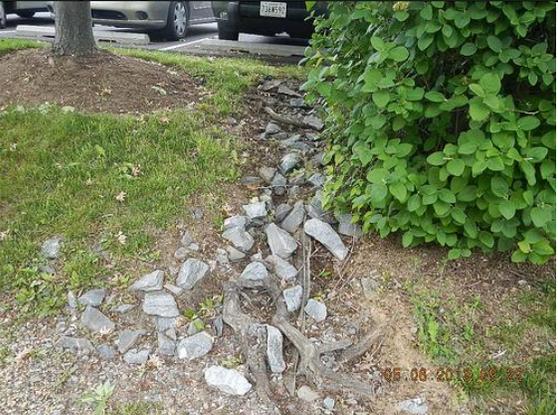
| <p>10</p> | <p>Inlet Conditions</p> | <p>Runoff cannot enter the bed and/or erosion observed at the inlet boundary</p> | <p><i>Erosion at a curb cut inflow.</i></p> |

| # | INDICATOR | PASS | MINOR | MODERATE | SEVERE |
|---|---|---|--|---|---|
| 10 | Inlet Obstruction | None, all runoff enters filter | Future risk of bypass | Evidence that some portion of runoff is bypassing practice | Most runoff cannot enter the infiltration practice |

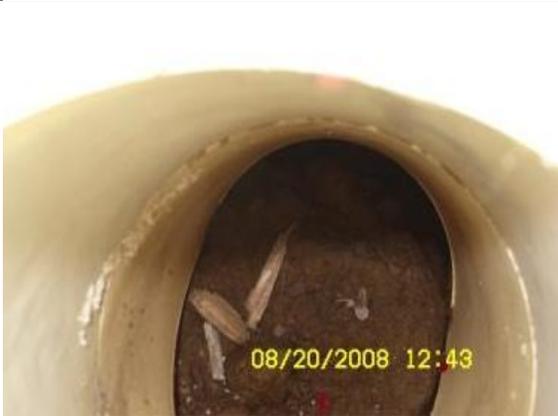
| <p>11</p> | <p>Underdrain</p> | <p>Evidence of stone or sediment, blockage or dry weather flows well after a storm</p> | <p><i>Sediment inside underdrain.</i></p> |

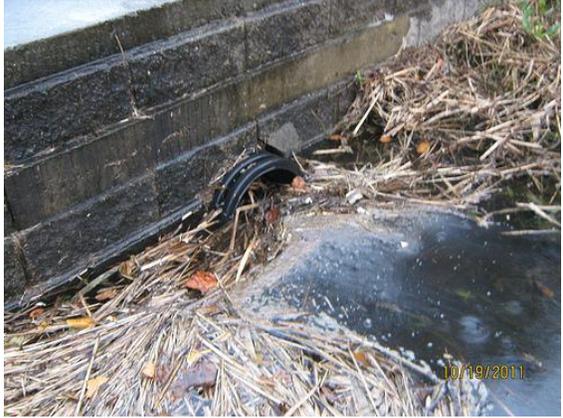
| 12 | Overflow Condition | The outlet or overflow does not have full capacity to convey flow events that exceed the water quality storm design event | <p data-bbox="841 611 1182 642"><i>A clogged outflow structure.</i></p> |

| # | INDICATOR | PASS | MINOR | MODERATE | SEVERE |
|---|---|---|--|---|---|
| 12 | Overflow Condition | Good | Minor problems | Partially obstructed | Totally obstructed |

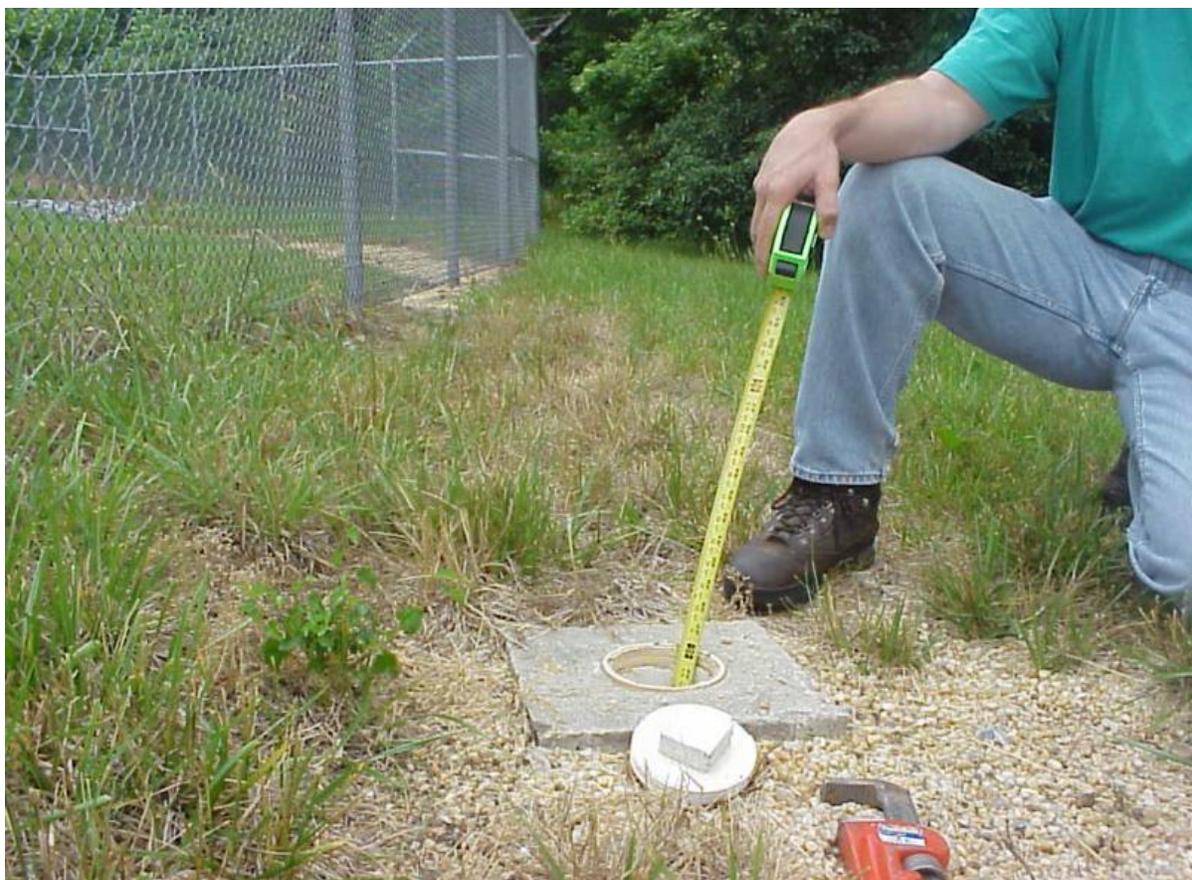
A quick check of the depth of water in the observation well should be done in every inspection
