# Skagit Stream Team Water Quality Report

*Citizen Monitoring Summary for Samish Bay, Padilla Bay,  
Ace of Hearts, Gages Slough, Trumpeter Basin,  
Kulshan Creek and Nookachamps Creek*

## 2021 - 2021 Annual Water Quality Report

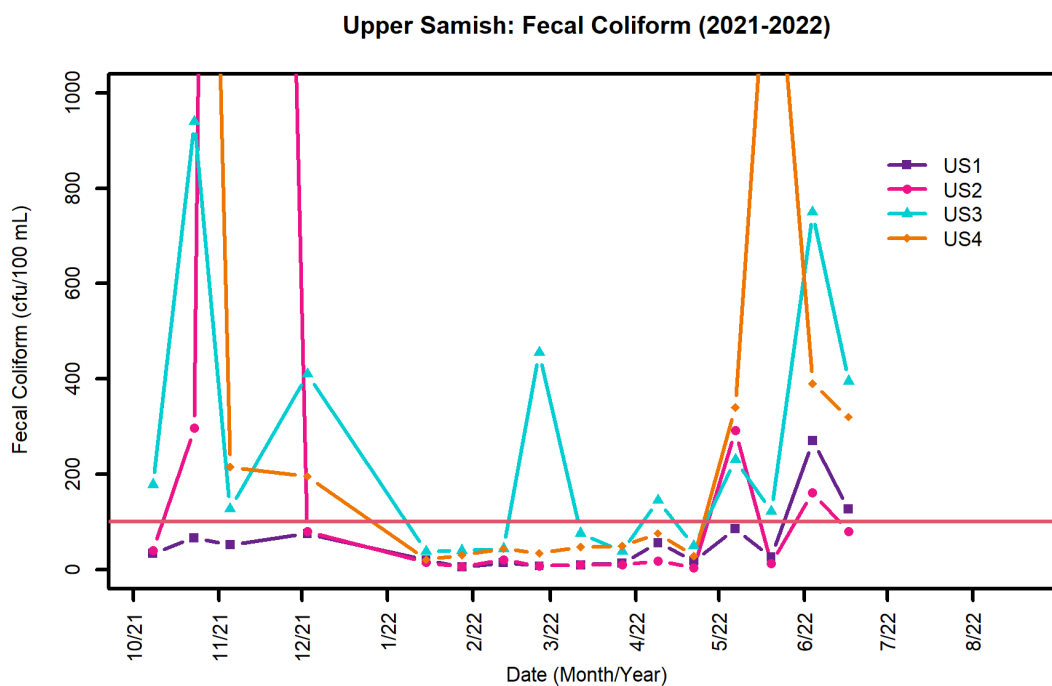
Fecal coliform (FC) levels in the Upper Samish watershed in 2021-2022 samples failed to meet both standards criteria in all sites but US1, Pomona Grange (Table 10). US2, Swede Creek samples passed criterion 1 (The geomean of FC samples was greater than 100 CFU/100mL.) but failed criterion 2 (More than 10% of geomeans were greater than 200 CFU/100mL.). US3 and US4 failed both criteria. Samples

Figure 16. Upper Samish River Fecal Coliform (colonies per 100mL) 2021-2022
